# INDIANA UNIVERSITY

## ON-SITE ROLLOVER INVESTIGATION

CASE NUMBER - IN09004  
LOCATION - Wisconsin  
VEHICLE - 2007 SUBARU FORESTER X  
CRASH DATE - January 2009

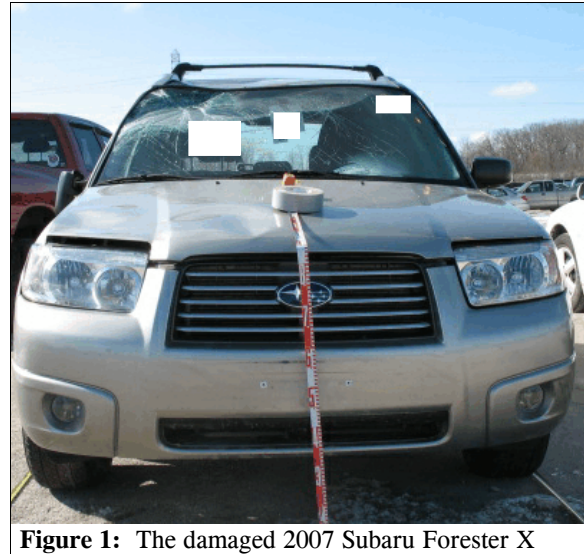
This crash was brought to the National Highway Traffic Safety Administration's (NHTSA) attention on February 20, 2009 by the sampling activities of the National Automotive Sampling System-General Estimates System and was assigned on February 26 2009. This crash involved a 2007 Subaru Forester X (**Figure 1**), which departed the roadway and rolled over. The crash occurred in January, 2009 at 0848 hours, in Wisconsin and was investigated by the applicable Sheriff's department. The focus of this on-site investigation was the Subaru's rollover. This contractor inspected the crash scene and the Subaru on March 2, 2009 and interviewed the driver on March 20, 2009. This report is based on the police crash report, crash scene and vehicle inspections, driver interview, exemplar vehicle inspection, occupant kinematic principles, and this contractor's evaluation of the evidence.

**Figure 1:** The damaged 2007 Subaru Forester X

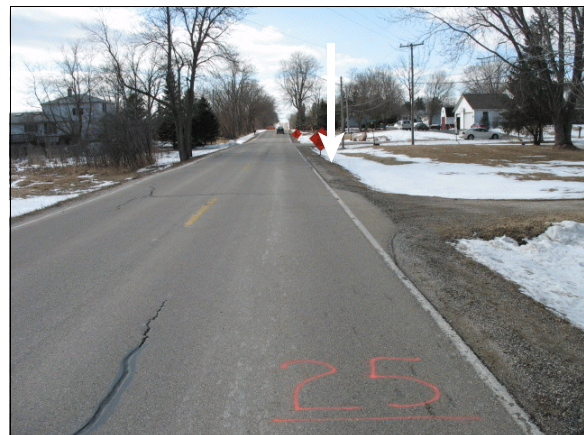
**Pre-Crash:** The Subaru's restrained 48-year-old male driver was traveling west (**Figure 2**) at a driver estimated speed of 48 km/h (30 mph), and he intended to continue west. A snowplow was approaching the vehicle from the east. The Subaru's driver applied the brakes and steered to the right partially onto the north shoulder to allow

**Figure 2:** Subaru's approach to the area of roadway departure (arrow)

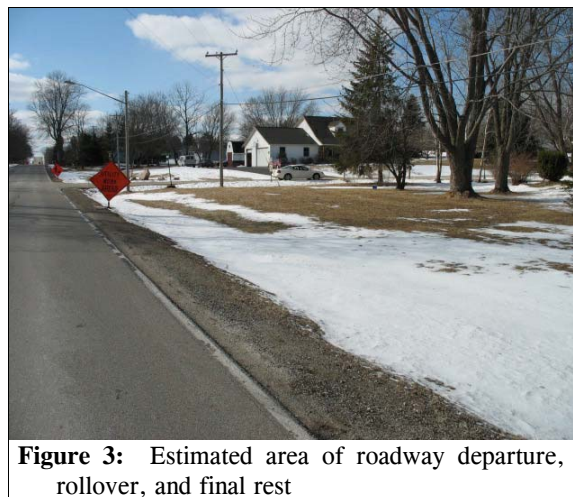
**Crash:** As the Subaru rotated clockwise it departed the north shoulder and traveled a short distance across a negative 20% grade, at which point the left side wheels plowed into the snow and the vehicle tripped and rolled over left side leading 3 quarter turns across an estimated distance of 6 m (19.7 ft). The vehicle came to final rest on its right side heading northeast in the front yard of a residence (**Figure 3**). Due to the snow covered ground at the time of the crash and subsequent snow melt since the crash, there was

**Figure 3:** Estimated area of roadway departure, rollover, and final rest

no physical evidence present at the time of the crash scene inspection. The police took no photographs of the crash scene. The number of quarter turns was based on the damage to the vehicle and the police crash schematic. The rollover distance was estimated based on the police crash schematic and the vehicle's height and width specifications.

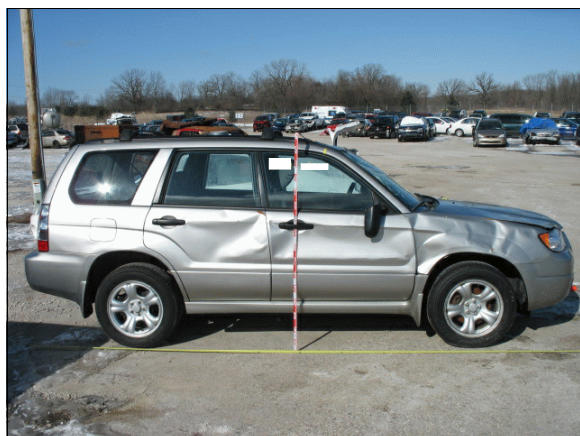
**Exterior Damage:** The Subaru's residual damage was located on its top and right side planes. Because the vehicle rolled over onto heavy snow, there were none of the typical rollover-type scratches found on the vehicle. The damage to the right side plane started 44 cm (17.3 in) forward of the right front axle and extended 334 cm (131.5 in) rearward along the fender and door panels (**Figure 4**). The damage to the top plane began at the front of the hood and extended onto the front portion of the roof. The damage to the roof extended across its full width, 108 cm (43 in). The maximum residual vertical crush was 4 cm (1.6 in) and occurred on the roof (**Figure 5**) 28

Figure 4: Right side damage

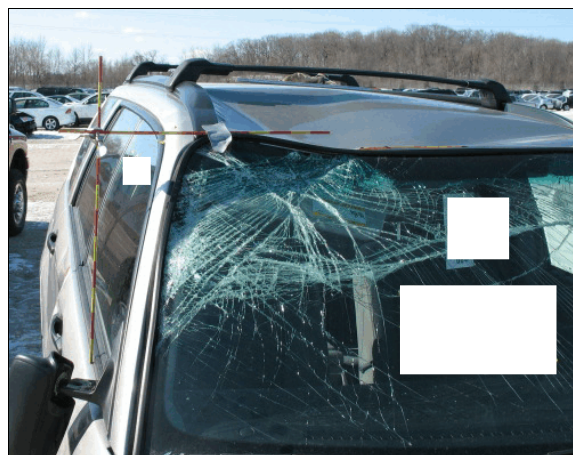
cm (11 in) left of the top of the right A-pillar and 10 cm (4 cm) rear of the windshield header. The roof structure sustained no lateral crush. The induced damage involved the roof, hood, both fenders, and the right rear door.

Figure 5: Subaru's maximum roof crush

**Damage Classification:** The Subaru's Collision Deformation Classification was **00-TYDO-3**. The severity of the rollover damage was moderate.

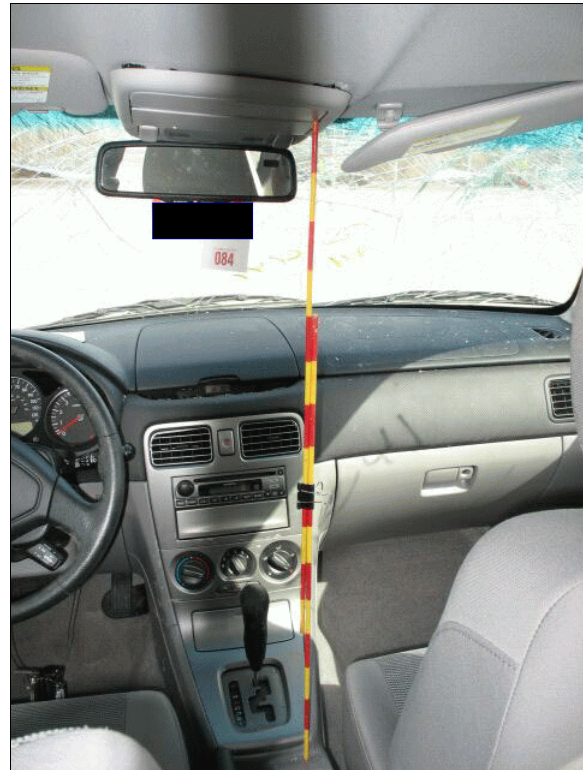
**Vehicle Interior:** The inspection of the Subaru's interior revealed no discernable occupant contact evidence. The passenger compartment intrusion involved the roof and windshield header. The maximum intrusion occurred on the roof (**Figure 6**), which intruded vertically 6 cm (2.4 in) into sector 12. All of the window glazing was either closed or fixed. The windshield glazing was in place and cracked from impact forces but all other window glazing was undamaged. All the doors remained closed and operational.

**Figure 6:** Maximum interior roof crush with vertical scale

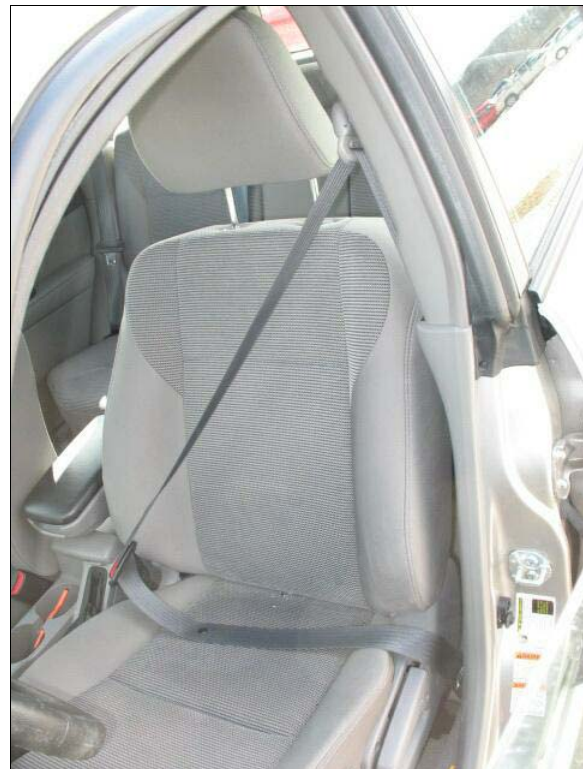
Inspection of the driver's seat belt assembly revealed historic usage scratches on the latch plate and the belt webbing (**Figure 7**) was slightly stiff with a slight stretched appearance. The evidence was consistent with usage of the seat belt in the

**Figure 7:** Driver's seat belt system

crash and the driver's statement that he was restrained. The remaining seat positions were unoccupied.
