**CALSPAN ON-SITE AMBULANCE CRASH INVESTIGATION
SCI CASE NO: CA09005**

**VEHICLE: 1998 FORD E350 TYPE III AMBULANCE
LOCATION: SOUTH CAROLINA**

CRASH DATE: FEBRUARY, 2009

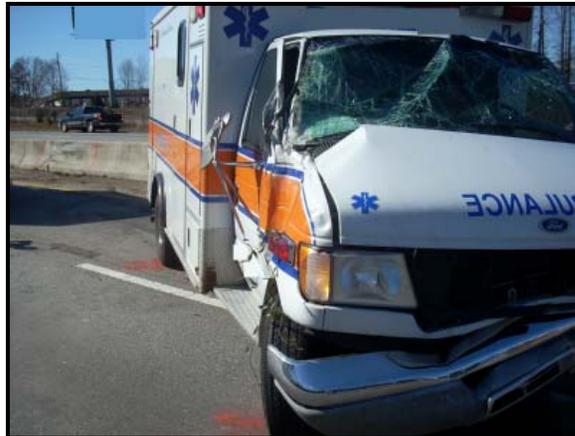
The ambulance traversed the traffic lanes and the front left aspect of the vehicle impacted the center barrier (Event 4). The orientation of the front of the ambulance to the barrier resulted in an 11 o'clock direction of force to the Ford. The left frame member deformed inboard and the

left tire/wheel fractured at the suspension. The left front tire/wheel deformed rearward and inboard under the center of the vehicle as the ambulance mounted the center barrier and was redirected to the right. The front of the ambulance disengaged from the barrier with a southeast trajectory. The left rear aspect of the patient compartment contacted the barrier (Event 5) and was abraded as the vehicle slid to rest. The ambulance came to rest straddling the inboard traffic lane 16 m (52 ft) from the impact. **Figure 7** is a view of the vehicle's final rest.

Figure 7: On-scene police image of the final rest of the ambulance

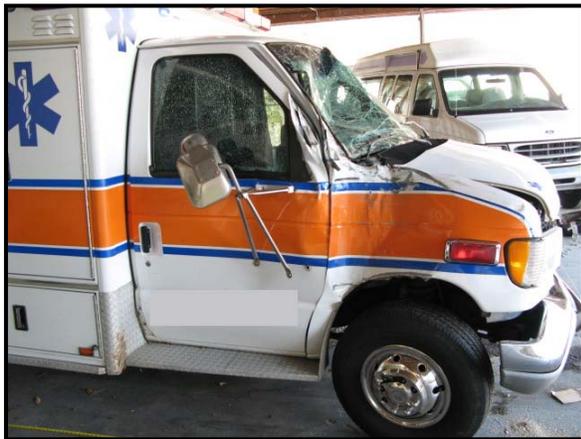
The 1998 Ford E350 ambulance sustained impact damage to the right, front, and left planes as a result of the multiple event crash sequence. The right plane/sign post impact (Event 1) resulted in a direct contact damage pattern that began on the leading aspect of the fender 53 cm (21 in) forward of the right front axle and extended rearward 109 cm (43 in) ending at the mid-aspect of the A-pillar. **Figure 8** is a right view of Ford's cab damage. A pocketing of the sign post into the fender occurred within this damage region above the level of the right front tire. The length of the pocketed deformation measured 53 cm (21 in) and the maximum lateral crush was 10 cm (4 in). The Collision Deformation Classification (CDC) of this impact was 12-RFHW2

The leading vertical edge of the patient compartment, at its junction with the cab, then struck the sign post (Event 2). This contact region began 137 cm (54 in) above the ground and extended to the top of the compartment. The contact then continued rearward along the top aspect of the box to the back plane. Several regions of body damage resulted with a maximum lateral deformation of 2 cm (1 in). The CDC of this contact was 12-RZGS1. **Figure 9** is a right side view of the patient compartment.

Figure 8: Right view of the Ford cab.

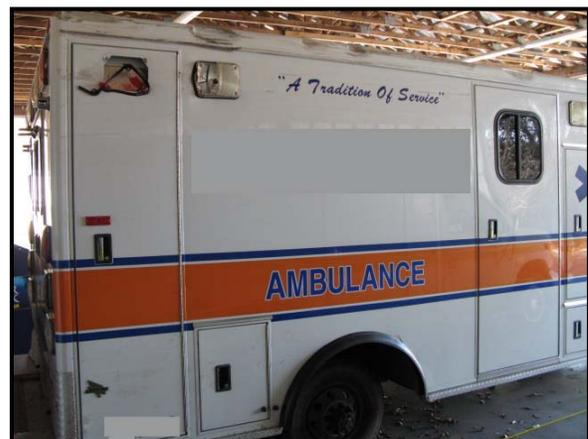
Figure 9: Right side plane damage.

The right side plane of the patient compartment also sustained surface abrasions as a result of contact to the tree line (Event 3). The abrasions began 225 cm (88.5 in) rearward of the right front axle and extended 339 cm (133 in) to the back plane. The CDC of this contact was 12-RZAS1

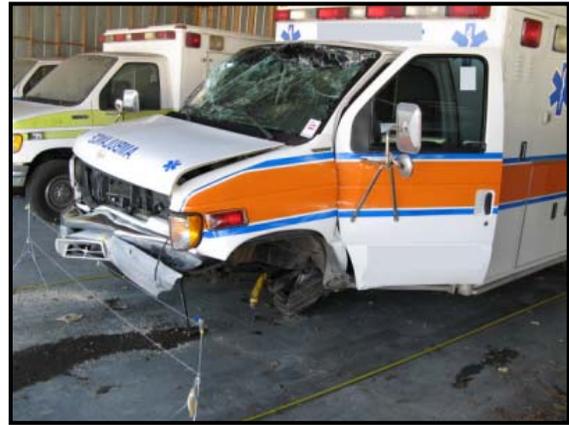
The front plane of the ambulance sustained 65 cm (25.5 in) of direct contact damage as a result of the center barrier impact (Event 4). The direct contact began 24 cm (9.5 in) left of center and extended to the left front bumper corner. The combined width of the direct and induced damage extended across the entire 178 cm (70 in) undeformed end width. **Figure 10** is a front left oblique view of the damage. The residual crush profile, measured along the front bumper, was

as follows: C1 = 34 cm (13.4 in), C2 = 14 cm, (5.5 in), C3 = 0, C4 = 0, C5 = 0, C6 = 5 cm (2 in). The force of the angular impact deformed the left frame rail inboard 23 cm (9 in) at the body mount located aft of the left front wheel opening. The left front suspension completely fractured and separated at its attachment to the frame. The left front tire and wheel was forced rearward and inboard. The cab's structure forward of the B-pillar was shifted to the right approximately 23 cm (9 in). The front left door remained closed during the crash. The door was forced open by the driver during his exit. The right front door was jammed closed by compression. The roof of the cab was buckled above the driver's position. The windshield was completely fractured. The left window glazing was intact. The right window glazing had disintegrated but was held in place by an after-market window tint. The right wheelbase measurement was unchanged. The CDC of the impact was 11-FYEW3.

Figure 10: Front left oblique view of the Ford.

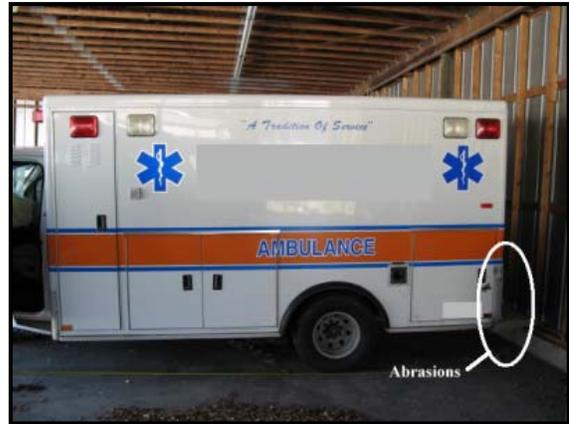
The rear aspect of the ambulance's left side plane contacted the center barrier during the later stages of the crash sequence as the vehicle traveled to final rest (Event 5). Horizontal body panel abrasions were noted to the left rear corner. The abrasions measured approximately 15 cm x 51 cm (6 in x 20 in) length by height. The abrasions and deformation prevented the door of the small compartment at that location from opening. **Figure 11** is a left exterior view of the ambulance. The CDC of this contact was 12-LBES1.

Figure 11: Left side view.

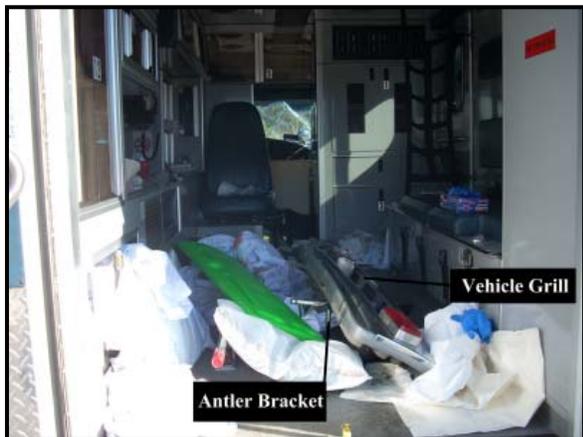
At the time of the crash, the cot was secured to the floor of the ambulance for transport. Numerous unsecured items were dislodged by the frontal impact and were displaced about the interior of the compartment. **Figure 15** is an on-scene police image taken of the patient compartment interior at final rest. For unknown reasons, the antler bracket, that secured the forward (head) aspect of the cot, was removed from its floor mount post-crash. The bracket is visible and highlighted in the on-scene police image (figure 15).

Figure 15: On-scene police image of the patient compartment interior.

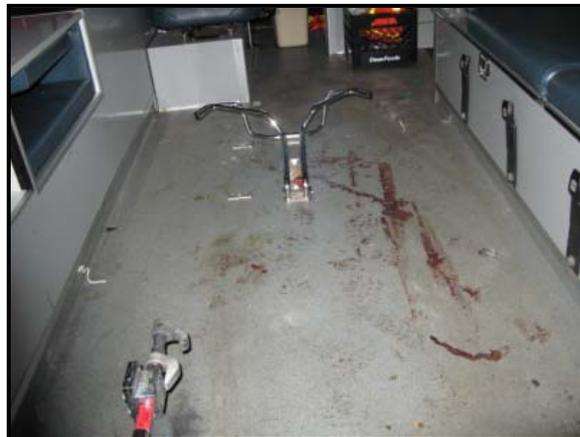
At the time of the SCI inspection, the antler bracket was loose on the floor. Only one of the spinner nuts that fastened the bracket to the floor could be found. The antler bracket was not deformed and the floor mounting locations were not damaged. The floor mounted rail clamp that secured the rear (foot) aspect of the cot was in place and operational. There was no floor deformation in the area of the clamp. The clamp remained closed during the crash sequence and the cot remained secured. **Figure 16** is a view of the patient compartment floor area, antler bracket and rail clamp. Post-crash blood evidence from an unknown source was noted on the floor.

Figure 16: Floor view of the cot antler bracket and the rail clamp.

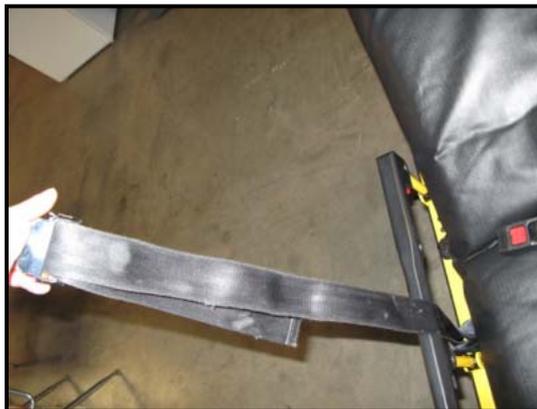
The cot contained a two belt system for securing patients. Each restraint consisted of two adjustable length webbings with a locking latch plate. The fixed end of each webbing was attached to the side frame of the cot. The webbings were positioned at the mid and lower aspects of the cot and could be adjusted longitudinally approximately 13 cm (5 in). At these locations, the webbings could be positioned across a patient's torso and lower legs. Examination of the torso belt revealed evidence of historical use (**Figure 18**). The torso belt webbing was creased in multiple areas. The edges of the webbing fabric were frayed from repeated use. Evidence related to its specific use during this crash could not be verified. The evidence of historical use on the lower belt webbing was not as apparent. The cot was not equipped with a shoulder harness system.

Figure 18: Historical use evidence observed on the torso belt webbing.
