CALSPAN ON-SITE ROLLOVER CRASH INVESTIGATION
SCI CASE NO: CA09006

VEHICLE: 2007 HONDA CR-V
LOCATION: PENNSYLVANIA
CRASH DATE: DECEMBER 2008

<i>1. Report No.</i> CA09006	<i>2. Government Accession No.</i>	<i>3. Recipient's Catalog No.</i>	
<i>4. Title and Subtitle</i> Calspan On-Site Rollover Crash Investigation Vehicle: 2007 Honda CR-V Location: Pennsylvania		<i>5. Report Date:</i> June 2009	
		<i>6. Performing Organization Code</i>	
<i>7. Author(s)</i> Crash Data Research Center		<i>8. Performing Organization Report No.</i>	
<i>9. Performing Organization Name and Address</i> Calspan Corporation Crash Data Research Center P.O. Box 400 Buffalo, New York 14225		<i>10. Work Unit No.</i> C00500.0000.0122	
		<i>11. Contract or Grant No.</i> DTNH22-07-C-00043	
<i>12. Sponsoring Agency Name and Address</i> U.S. Department of Transportation National Highway Traffic Safety Administration Washington, D.C. 20590		<i>13. Type of Report and Period Covered</i> Technical Report Crash Date: December 2008	
		<i>14. Sponsoring Agency Code</i>	
<i>15. Supplementary Note</i> An investigation of a rollover crash involving a 2007 Honda CR-V.

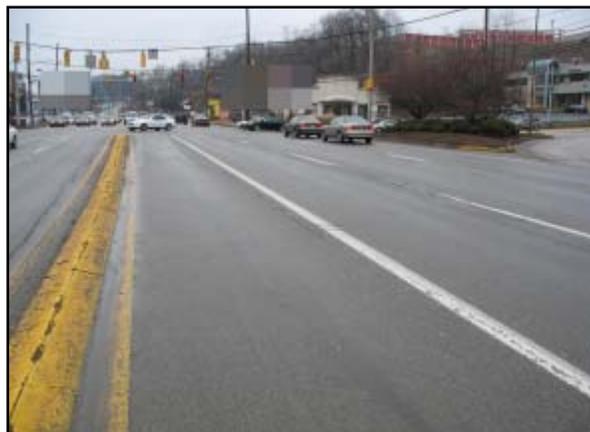
The front left corner of the Honda impacted the right front aspect of the Mercedes-Benz in the left through lane (**Figure 3**). The engagement to the Honda began at the front left corner and extended down the left fender 95 cm (37.4”). The impact fractured the Honda’s left front suspension. This corner impact configuration resulted in a 12 o’clock impact force to the Honda. The corner engagement was outside the scope of the WINSMASH program; therefore, a delta-V could not be calculated for this impact. This frontal impact sequence actuated the driver’s dual safety belt pretensioners and deployed the driver’s frontal air bag.

Figure 3: Area of impact from the Mercedes-Benz approach.

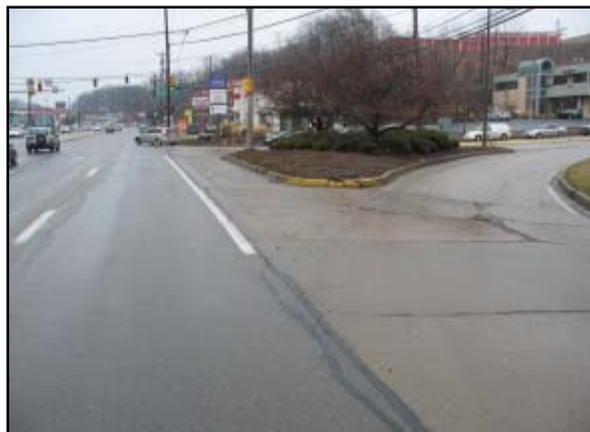
The Honda separated from the impact with the Mercedes-Benz to the right with counterclockwise rotation. As the vehicle rotated, the right front tire rolled under the rim exposing the rim edge to the asphalt surface. This interaction tripped the Honda into a right side leading single quarter-turn rollover event. The Honda travelled approximately 12 meters (39 feet) from the trip point to final rest (**Figure 4**). As a result of the rollover event, the rollover sensors triggered the deployment of the Honda’s left and right inflatable side curtains.

Figure 4: Approximate final rest area of the Honda.

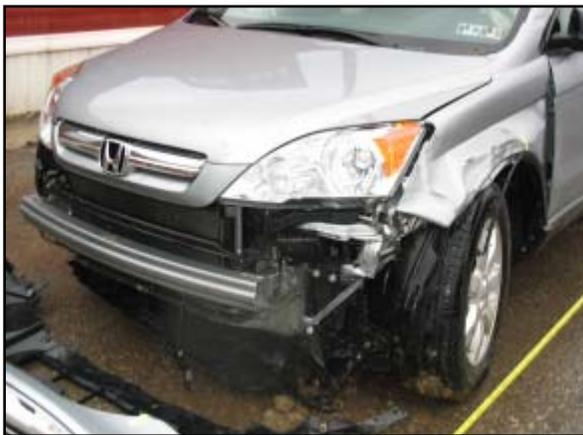
The 2007 Honda CR-V sustained moderate severity damage from this multiple event crash sequence. The direct contact damage for the impact with the Mercedes-Benz began 55 cm (21.8”) left of the centerline and extended 39 cm (15.2”) to the left bumper corner. The front bumper beam exhibited no residual crush from this impact. Due to the corner impact configuration, the direct contact damage extended 95 cm (37.4”) down the left fender. The left side engagement snagged the left front tire and wheel resulting in damage to the suspension components. The suspension damage consisted of a fractured lower control arm. The Collision Deformation Classification (CDC) for this impact was 12-FLEE-5. **Figure 5** is an overall view of the front and left side damage from the impact with the Mercedes-Benz.

Figure 5: Overall view of the residual damage from the impact with the Mercedes-Benz.

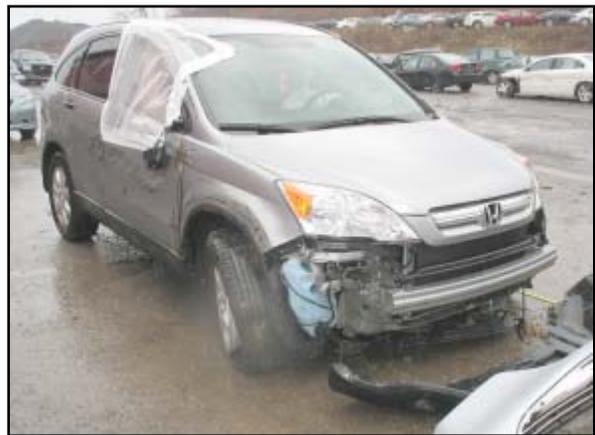
The rollover event resulted in minor severity damage to the right side of the Honda (**Figure 6**). The direct contact damage consisted of surface abrasions to the right front wheel rim and right side plane. Vertically, the direct contact damage extended from the right front wheel to the front right window frame. There was no crush to the side or roof of the Honda. The CDC for this impact was 00-RDAO-2.

Figure 6: Front oblique view of the rollover damage.

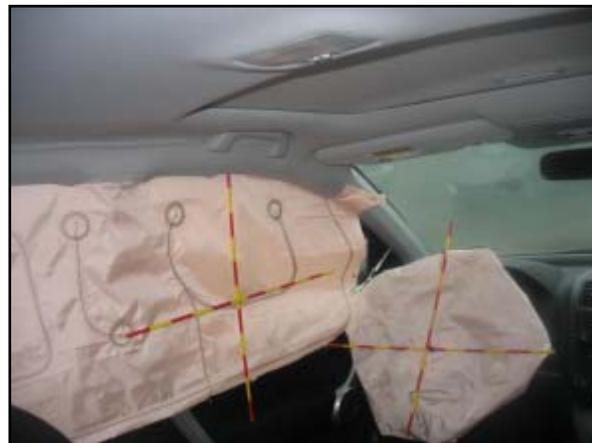
Figure 7: Deployed driver's frontal and left curtain air bags.

were cut post-crash. **Figure 7** depicts the deployed left curtain and driver's frontal air bag.

Vertically, the curtain air bags extended below the beltline at the first and second rows. At the first row, the air bag extended 4 cm (1.5") below the belt line and 3 cm (1") below the beltline at the rear position. A triangular shaped void was present at the A-pillar. This void was approximately 23 cm (9") in height and 23 cm (9") in width. The inflatable side curtains were free of occupant contact points and damage.

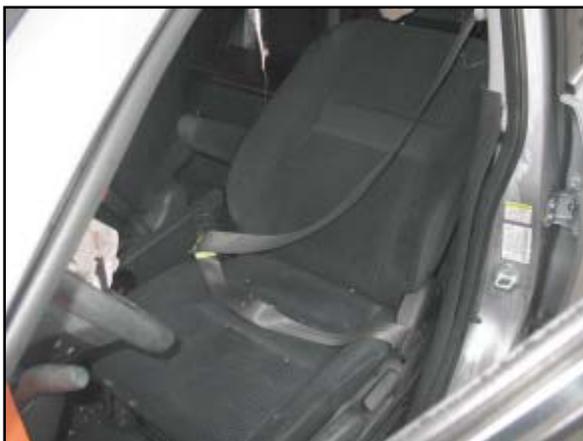
Figure 8: Driver's safety, restricted in the used position.

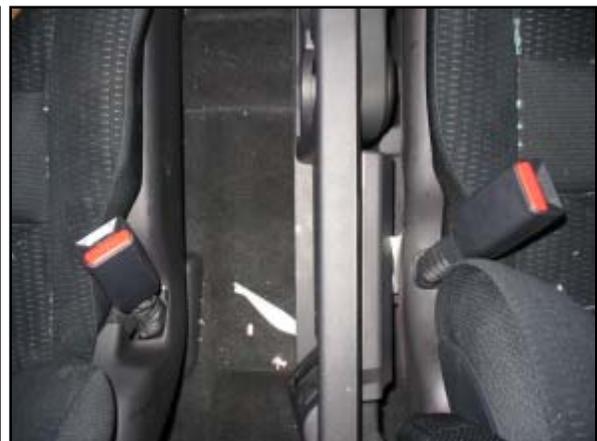
The 2007 Honda CR-V was equipped with manual 3-point lap and shoulder safety belts for the five seating positions. The driver's safety belt was configured with continuous loop webbing, a sliding latch plate, a height adjustable D-ring that was in the full-down position at the time of the SCI inspection, an Emergency Locking Retractor (ELR), and dual pretensioners. The pretensioners were both buckle mounted and retractor mounted. The driver utilized the safety belt during the crash as evidenced by frictional abrasions on the latch plate and actuation of the dual pretensioners. The actuation of the retractor pretensioner locked the safety belt webbing in the used position (**Figure 8**). The total amount of restricted webbing measured 141 cm (55.5"). The buckle stalk was compressed 5 cm (1.8") from the actuation of the buckle mounted pretensioner (**Figure 9**).

Figure 9: Actuated driver's buckle pretensioner (left in image).
