ON-SITE ROLLOVER INVESTIGATION

CASE NUMBER - IN09007
LOCATION - MISSOURI
VEHICLE - 2008 HONDA CR-V EX
CRASH DATE - February 2009

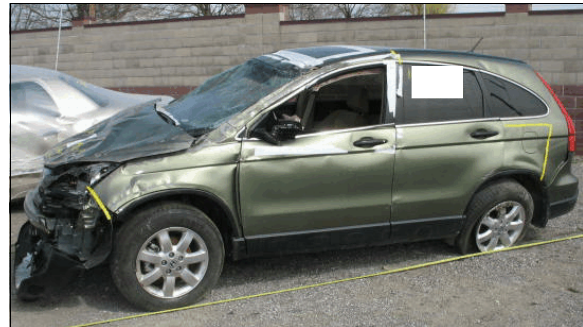
Figure 1: The damaged 2008 Honda CR-V EX

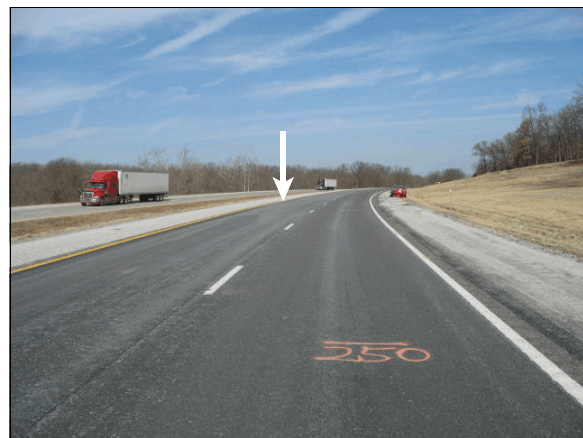
Pre-Crash: The Honda's restrained 58-year-old female driver was traveling north in the straight section of the roadway approaching the right curve. Based on the SCI interview, the driver fell asleep and the vehicle continued straight as it entered the curve and departed the left side of the roadway (**Figure 2**). The driver awoke and initiated a right steering maneuver. The vehicle entered the median and began to rotate clockwise

Figure 2: Approach of the Honda to roadway departure (arrow); number shows feet to departure point from the shoulder into the median

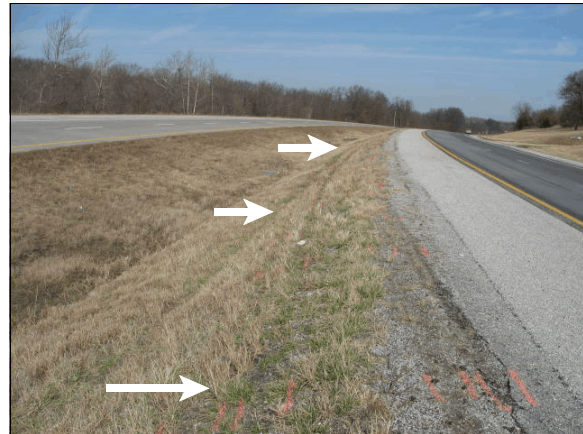
at it traveled along the negative grade of an embankment adjacent to the west shoulder (Figure 3).

Figure 3: Orange paint marks and arrows show Honda's path of travel along the embankment

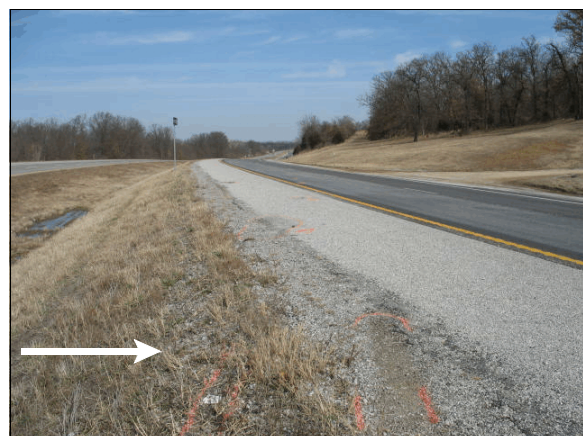
Figure 4: Arrow shows area where vehicle tripped and began to rollover driver side leading

The Honda departed the west side of the roadway and traveled along the embankment for 61 m (200 ft) as the driver continued to steer to the right. As the vehicle approached the top of the embankment, the left side tires furrowed into the ground, which tripped the vehicle and it rolled over, driver side leading, across the shoulder and onto the roadway. The damage from the rollover was located primarily on the hood, tops of the fenders, A-pillars and front portion of the roof (**Figure 5**). The vehicle rolled over 7 quarter turns across a distance of 33.3 m (109.2 ft) and came to final rest in the center of the northbound lanes on its left side heading southwest (**Figure 6**).

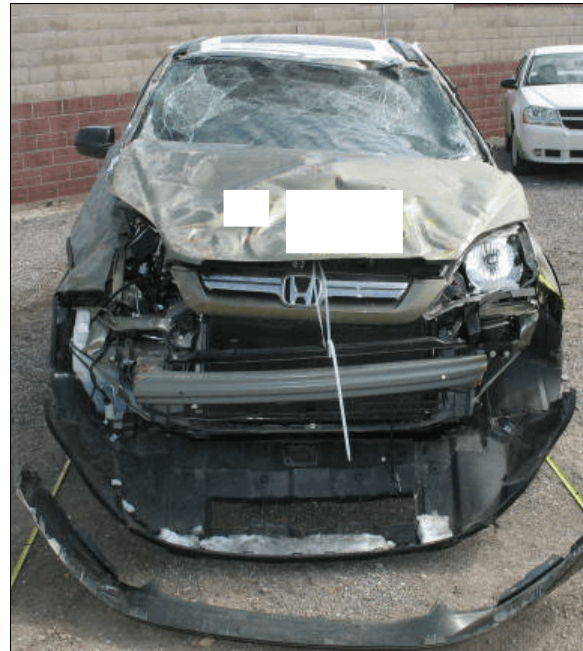
Exterior Damage: The damage from the rollover involved the top and both sides of the Honda. The direct damage on the top plane (**Figures 5 and 7**) began at the front of the hood and extended to 72 cm (28.3 in) rear of the right B-pillar and 4 cm (1.6 in) rear of the left B-pillar. It involved the full width of the roof, 103 cm (40.6 in). The direct damage on the left side (**Figure 1**) began

Figure 5: Front view of the damage from the rollover

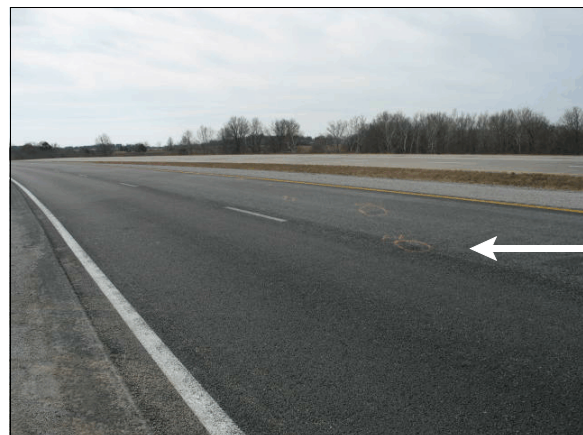
Figure 6: View back through the area of final rest (arrow) to the path of the rollover

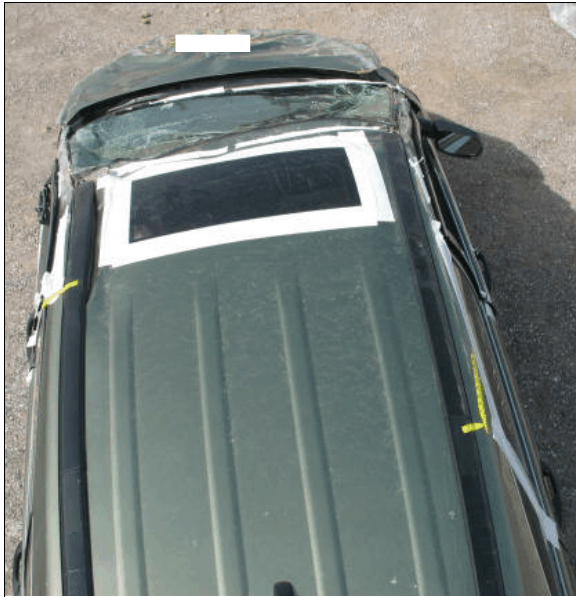
Figure 7: Damage to the top plane

Damage Classification: The Honda's Collision Deformation Classification was **00-TYDO-3**. The WinSMASH program could not be used on this crash because rollovers are out of scope for the program. Based on the extent of the roof crush, the severity of the rollover damage was moderate.

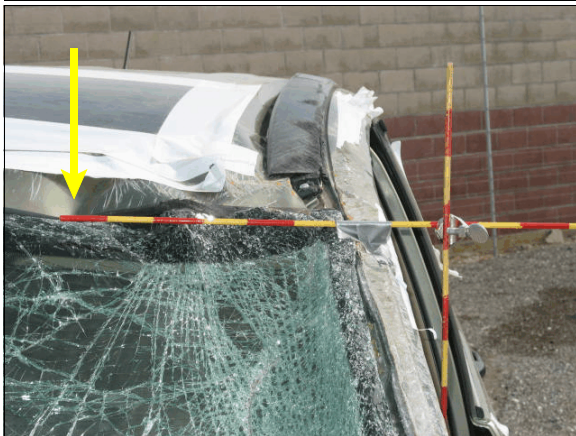
Figure 9: Maximum vertical crush occurred to the windshield header

The vehicle's passenger compartment sustained 11 intrusions due to the rollover. The most severe intrusions into the driver's occupant space involved the left A-pillar, roof, windshield header and the windshield. These components intruded vertically 7 cm (2.8 in), 9 cm (3.5 in), 9 cm (3.5 in), and 16 cm (6.3 in), respectively.

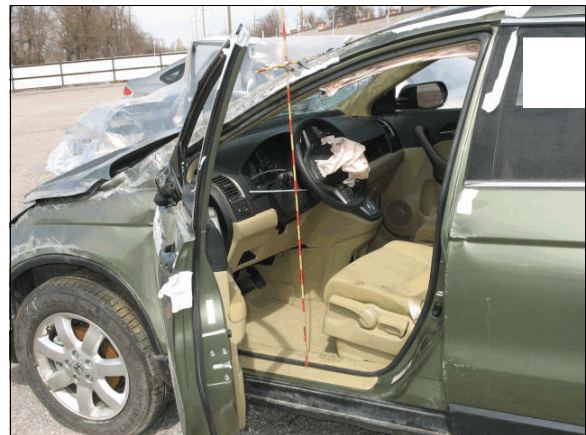
Figure 10: Left side view of measurement scale for maximum vertical crush

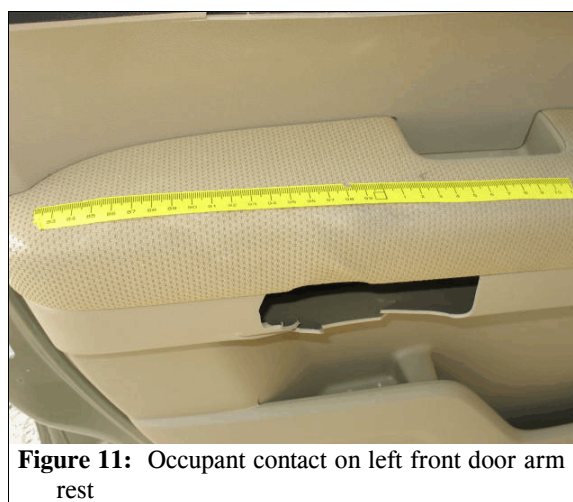
Vehicle Interior: The inspection of the Honda's interior revealed two possible occupant contact scuffs on the frontal air bag, possibly from contact by the driver's forearms. A scuff and slight impression 29 cm (11.4 in) in length was located on the edge of the left front door armrest and the plastic below it was broken (**Figure 11**). It was probably due to the driver's left hip contacting the armrest. Two small scuffs, one on the roof and one on the sunroof panel (**Figure 12**) were located directly above and to the right of the driver's seat. They were possibly related to contact by the driver's right hand. Several small blood stains were also located at the top of the left A-pillar. These appeared to be blood spatter and not direct occupant contact.

Figure 11: Occupant contact on left front door arm rest

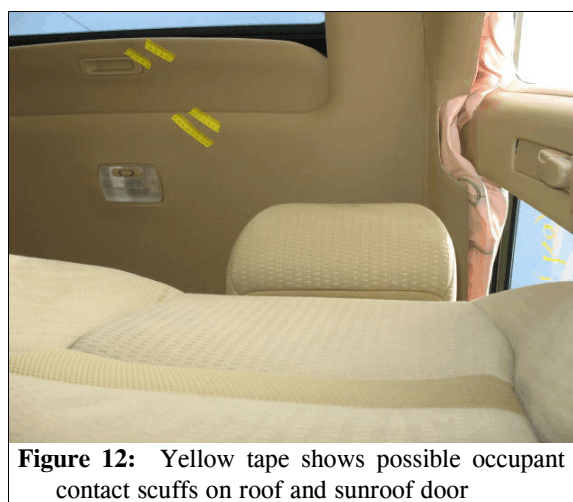
Figure 12: Yellow tape shows possible occupant contact scuffs on roof and sunroof door

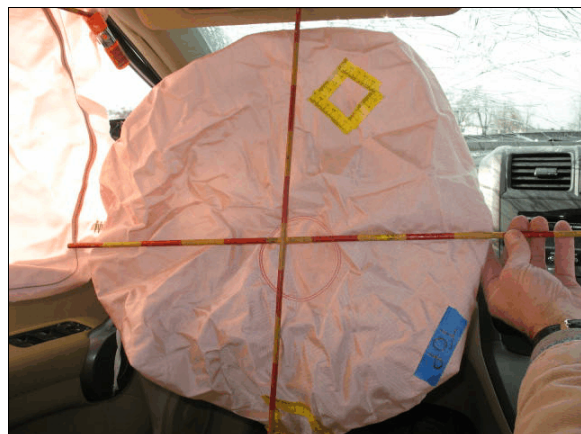
Figure 13: The driver's frontal air bag; each increment on measurement rods is 5 cm (2 in); steering wheel is rotated clockwise approximately 90 degrees

triangular-shaped and was 7.5 cm (3 in) in width and height as measured along the tear seams. An inspection of the air bag module cover flaps revealed that they opened at the designated tear points. The deployed air bag (**Figure 13**) was round with a diameter of 50 cm (19.7 in) and was designed with two 4 cm (1.6 in) vent ports located on the back of the air bag at the 11 and 1 o'clock positions. Inspection of the air bag revealed no damage and two possible occupant contact scuffs. One scuff was located within the left upper quadrant and the other within the right upper quadrant.

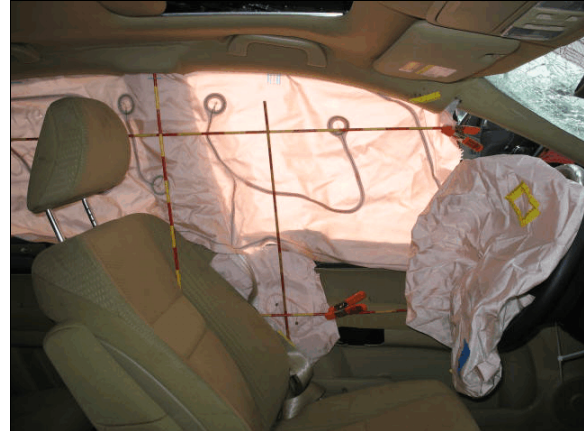
Figure 14: The driver's seat, left inflatable side curtain air bag, seat back-mounted side impact air bag, and frontal air bag

The left inflatable side curtain air bag was located along the left roof side rail (**Figures 14**) inside the headliner and extended from the A-pillar to the D-pillar. It was designed with inflation chambers adjacent to the driver and second row left seat positions. The deployed inflatable side curtain air bag was 166 cm (65.4 in) in width and 44 cm (17.3 inches) in height. It extended 12 cm (4.7 in) below the beltline. The gap between the front center of the air bag and the A-pillar was 28 cm (11 in). The inflatable side curtain air bag was attached at the A-pillar by a 27 cm (10.6 in) rope tether, which had been cut in two, probably by rescue personnel. There was no visible tether at the D-pillar. There was no discernible occupant contact evidence on the air bag and it sustained no damage. The right inflatable side curtain air bag was of the same dimensions and features.

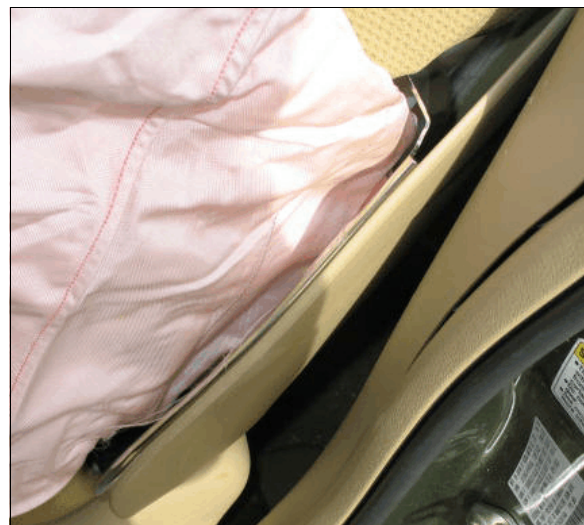
Figure 15: Location of the left front seat back-mounted side impact air bag module

The driver's seat back-mounted side impact air bag was located in the outboard side of the seat back (**Figures 14** and **15**) and deployed from behind a triangular-shaped plastic trim panel on the side of the seat. The deployed air bag was 35 cm (13.8 inches) in height and 28 cm (11 in) in width at the top. Inspection of the deployed air bag revealed no damage and no discernible evidence of occupant contact.

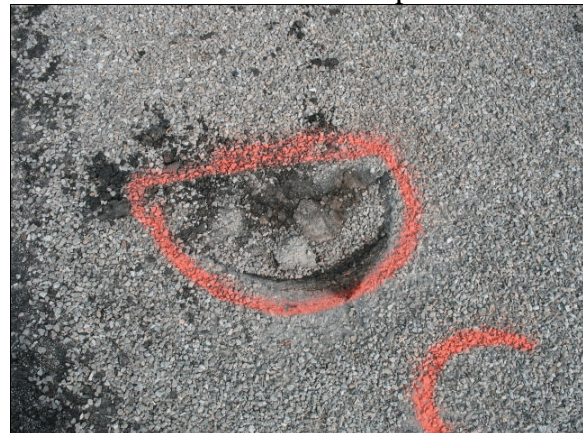
Figure 16: Gouge on the shoulder due to impact by the Honda's left rear wheel

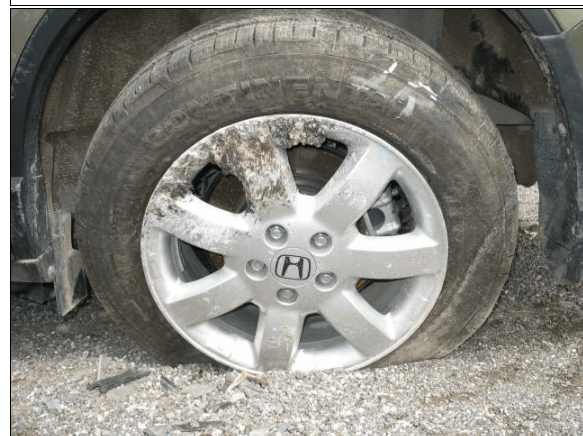
Figure 17: Damage to the Honda's left rear wheel
