CALSPAN ON-SITE CHILD SAFETY SEAT CRASH INVESTIGATION

CASE NO: CA09008

VEHICLE: 1994 SUBARU LEGACY L

CRASH DATE: FEBRUARY 2009

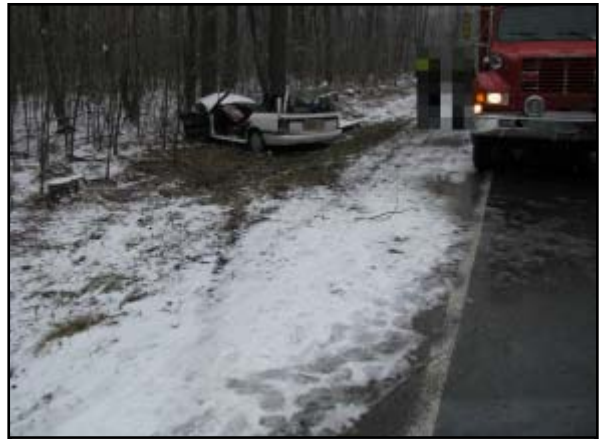
Figure 3. Off-road tire marks from the Subaru.

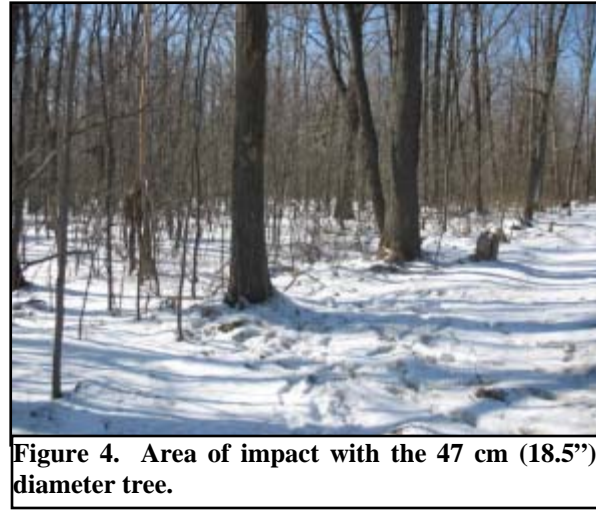
The front of the Subaru impacted a 47 cm (18.5”) diameter tree that was located 5.2 meters (17 feet) south of the road edge (**Figure 4**). The impact location of the vehicle was slightly off-set to the left inducing a counterclockwise rotation. The Subaru rotated approximately 30 degrees and came to rest against the tree. The direction of force for this impact was 12 o’clock. The damage algorithm of the WinSmash program was used to calculate a delta-V for this impact. The total calculated delta-V was 49 km/h (30 mph) with longitudinal and lateral components of -49 km/h (30 mph) and 0 km/h, respectively. As a result of the crash, the driver’s frontal air bag deployed.

Figure 4. Area of impact with the 47 cm (18.5") diameter tree.

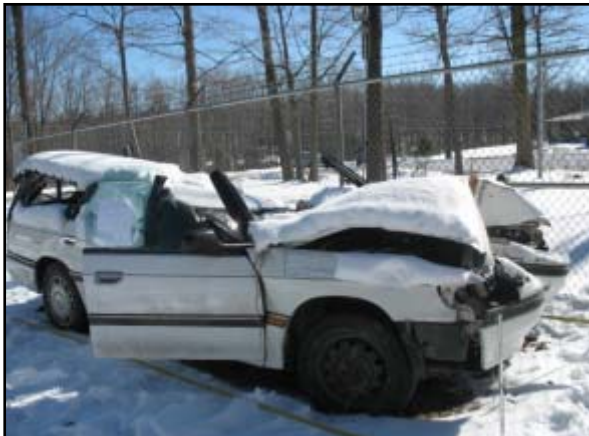
The 1994 Subaru Legacy (**Figure 5 and 6**) sustained severe frontal damage as a result of the impact with the tree. The direct contact damage was confined to the center front aspect of the vehicle and measured 47 cm (18.5"). The direct damage began 24 cm (9.4") right of the centerline and extended to 23 cm (9.1") left of the centerline. The maximum crush measured 69 cm (27.2") and was located 9 cm (3.5") left of the centerline. Six equidistant crush measurements were documented along the bumper beam of the vehicle and were as follows: C1 = 31 cm (12.2"), C2 = 41 cm (16.1"), C3 = 69 cm (27.2"), C4 = 65 cm (25.6"), C5 = 38 cm (15.0"), C6 = 12 cm (4.7"). The Collision Deformation Classification (CDC) for this impact was 12-FCEW-3.

Figure 5. Overall view of the Subaru.

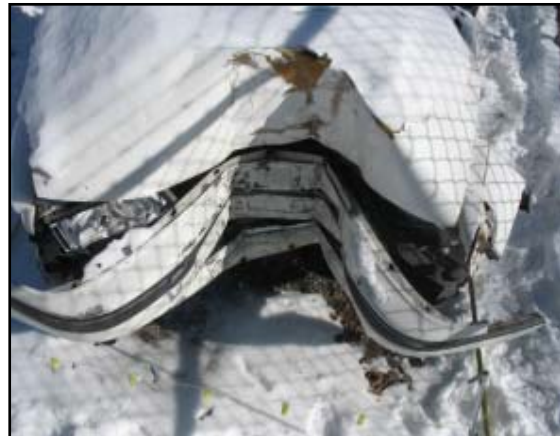
Figure 6. Overhead view of the crush profile.

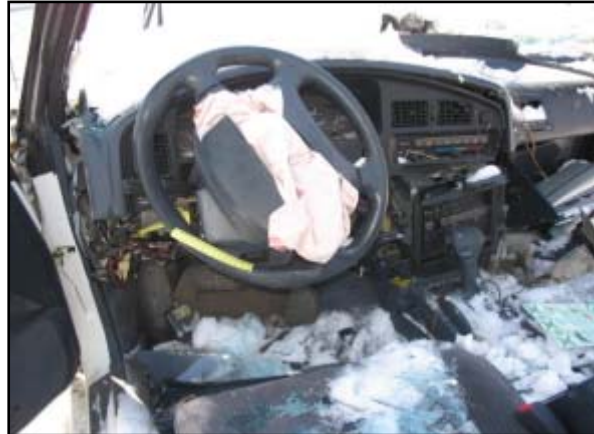
Several discernable occupant contact points were identified during the SCI vehicle inspection. The restrained female driver of the Subaru was displaced forward during the impact. She loaded the steering assembly and the knee bolster in two locations. The driver's knees struck the knee bolster which resulted in fracturing of the rigid plastic knee bolster cover and pocketing of the steel backer panel. The pocketing occurred to the left and right aspects of the backer panel. The center instrument panel exhibited damage; however, this appeared to be induced damage from the exterior crash force rather than occupant contact. The driver also contacted and loaded the steering wheel rim and column. The top section of steering wheel rim was deformed forward 11 cm (4.3"). The steering column loading resulted in compression of the shear capsules. The left shear was compressed 0.5 cm (0.2") and the right was compressed 1 cm (0.4"). **Figure 7** is an overall view of the driver's area.

Figure 7. Overall view of the driver's area and contact points.

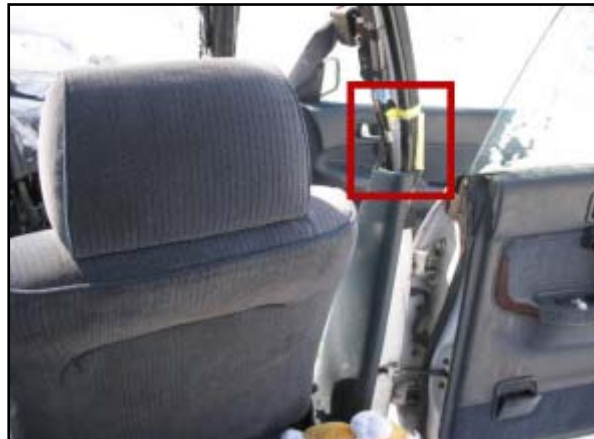
The child was displaced forward during the crash which resulted in his head contacting the right B-pillar (**Figure 8**). This contact was located 5 cm (2") above the belt line and was evidenced by hair, body fluid, and skin. No additional contact points were noted for this passenger. Belt loading evidence was observed during the inspection. This loading is described in the *Safety Belt* section of this report.

Figure 8. Rear right passengers B-pillar contact point.

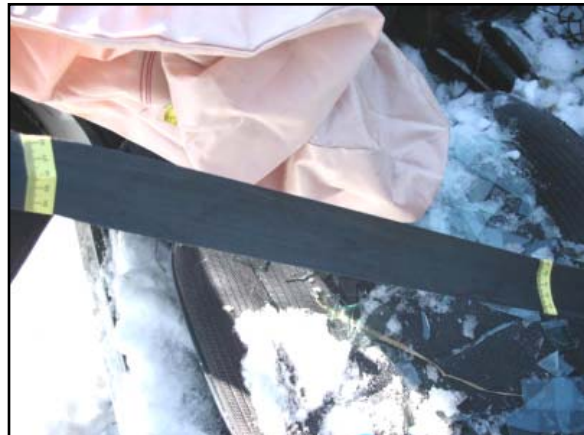
Figure 9: Driver's shoulder belt webbing.

At the time of the SCI inspection, the driver's lap belt webbing was stowed in the ELR retractor and encased in ice and snow. The roof was cut from the vehicle by the first responders, thus exposing the retractor to the elements. The lap belt could not be inspected. The driver's shoulder belt was stowed in the inboard retractor at initial inspection. Inspection of the webbing revealed a 43 cm (16.9") section that appeared loaded and stressed (**Figure 9**). The loading was attributed to the driver's torso during the frontal impact. With the shoulder belt spooled out, the loaded section was located 46 cm (18.1") to 89 cm (35") above the retractor. The mouse was located in the retracted position adjacent to the cut pillar.

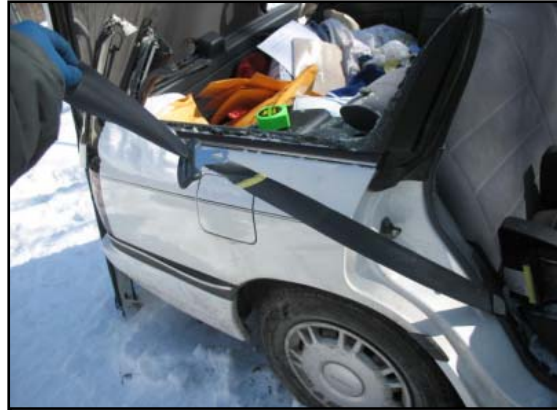
Figure 10: Rear right safety belt webbing.

The SCI inspection of the rear right restraint revealed signs of obvious use (**Figure 10**). The webbing was cut by the rescue personnel as they cut the roof from the vehicle. The safety belt was cut 16 cm (6.3") above the latch plate. The exposed webbing section measured 110 cm (43.3") in length from the outboard anchor to the cut end. The balance of the webbing had spooled back into the retractor and could not be inspected. The rear right webbing was gathered and jammed in the latch plate. The latch plate was located 94 cm (37") above the anchor. Examination of the webbing adjacent to the jammed latch plate revealed 9 cm (3.5") of heavily abraded webbing. The hardware on the latch plate exhibited corresponding abrasions. Refer to (**Figure 11**). As the child occupant loaded the lap belt, the belt folded over onto itself. The folded webbing section measured 22 cm (8.7"). Examination of the D-ring revealed minor frictional abrasions associated with use.

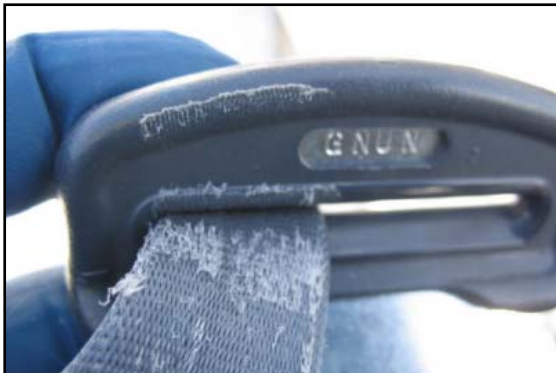
Figure 11. Frictional abrasions of the rear right latch plate.

Given the disparity in the nature (strength) of the abrasions between the D-ring and latch plate, it is probable that the child's loading force translated primarily to the lap belt. Inspection of the rear right restraint determined that excess slack developed in the lap belt due to the combined kinematic loading of the child, and the physical seat back loading produced by unsecured objects in the trunk. **Figure 12** is an overhead view of the booster seat and the lap belt slack. The longitudinal distance between the seat bight and the webbing measured 39 cm (15.3").

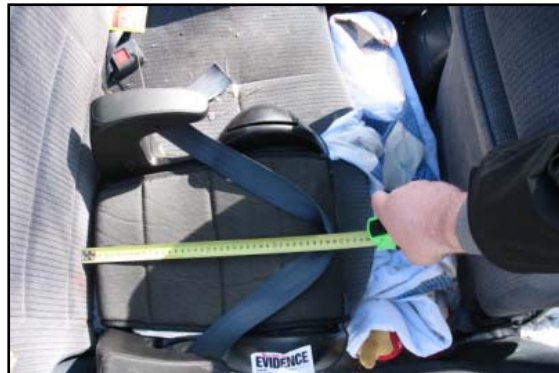
Figure 12. Loose fit of the lap belt webbing.

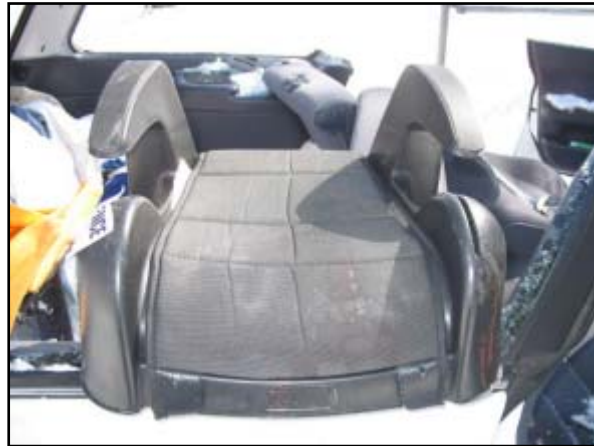
The 4-year-old male was positioned in a Cosco Highrise backless booster child safety seat and was restrained by the vehicle's manual three-point lap and shoulder belt in the rear right seating area (**Figure 13**). The safety seat was manufactured by Dorel Juvenile Group and contained model number 22-297-DSW. The manufacture date of the safety seat was 12-19-2007 and had a "do not use beyond date of December 2013." This safety seat was designed to be used with children that are over 1-year in age, weighing 13.6-45.4 kg (30-100 lbs), and whose height is 85-145 cm (34-57").

Figure 13. Overall view of the child safety seat.

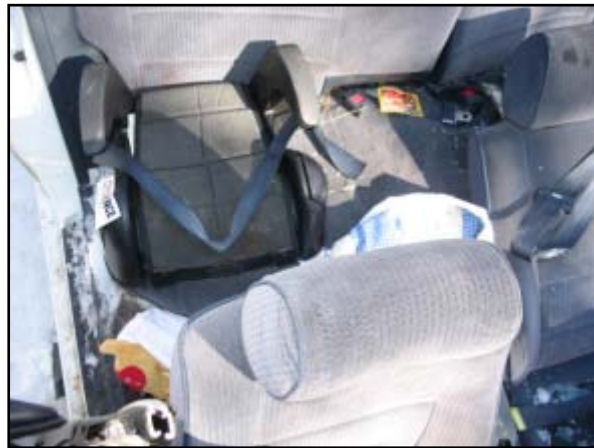
Figure 14. Overhead view of the booster seat.

safety seat to the forward edge (**Figure 14**) creating a large arc of webbing. During the crash, the child and the safety seat loaded the safety belt webbing resulting in frictional abrasions to the belt path. On the left side, these frictional abrasions were minor and measured 4 cm (1.6") in height and wrapped around the belt path 1 cm (0.4"). The

abrasions on the right belt path were more extensive and measured 8 cm in height and also wrapped around the belt path 1 cm (0.4”). The safety seat was not damaged during the crash.
