On-Site Side Air Bag Investigation
Dynamic Science, Inc. (DSI), Case Number DS09010
2007 BMW 335i Coupe
California
January 2009

1. Report No. DS09010		2. Government Accession No.		3. Recipient Catalog No.	
4. Title and Subtitle On-Site Side Air Bag Investigation				5. Report Date February 8, 2010

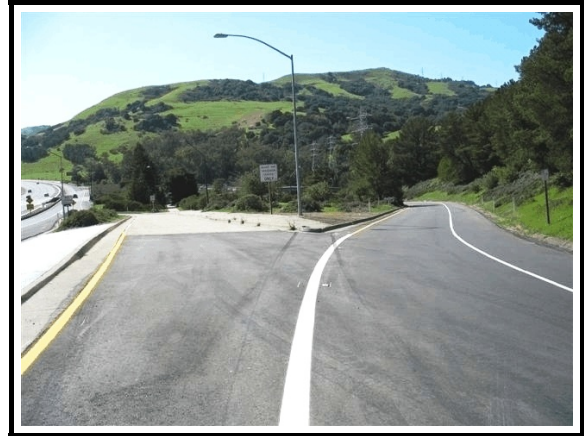
The crash site consisted of a raised median that separated a bus-only lane from a highway exit ramp. The exit ramp included two westbound lanes in its approach to the crash site. Approximately 22.9 m (75 ft) from the median, the exit ramp lanes split; the outboard lane curved right (west) and the inboard lane continued straight (south). The curve profile of the westbound lane decreased in radius as it approached the median. The median's eastern aspect marked the division of the exit ramp and the bus lane (**Figure 2**).

Figure 2. Crash site showing approach to impact and skid marks

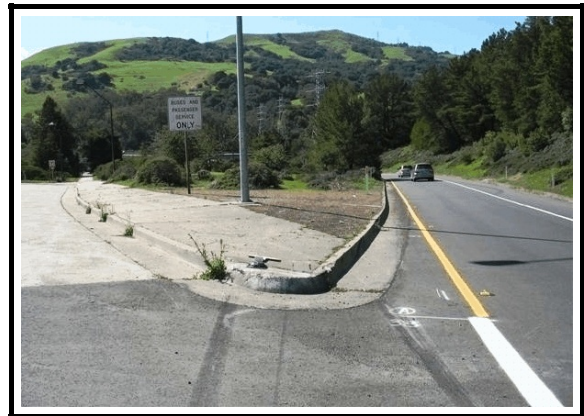
The subject vehicle was traveling west and the driver was negotiating a right curve. Approximately 15 m (49.2 ft) from the median the driver braked hard with lockup. Two skid marks were documented on the roadway: a skid mark from the front left tire measured 15.2 m (49.9 ft) and a skid mark from the right front tire measured 15.7 m (51.5 ft). The skid marks were straight and terminated at the raised concrete curb (**Figure 3**).

Figure 3. Area of impact, Events 1 - 3

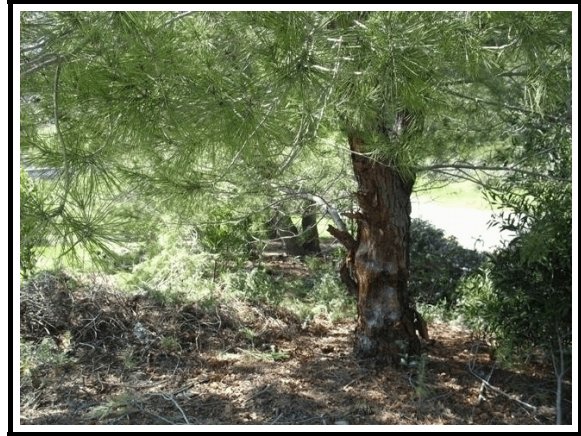
Figure 4. Impacted tree, Event 5

After contacting the shrubbery the vehicle traveled for an additional 5 m (16.4 ft) and its right side impacted a tree (Event 6) (**Figure 4**). The direct damage to the vehicle was located on the passenger and rear sections including the right rear tire. The tree trunk measured 30.5 cm (12 in) in diameter at the area of impact. The impacted area was determined based on stripped bark and gouges on the tree trunk. The vertical extent of the damaged area began at the ground and extended upward 134 cm (52.8 in). The tree trunk was not cracked or bent; however, three limbs were fractured and detached near the upper aspect of the impacted area.

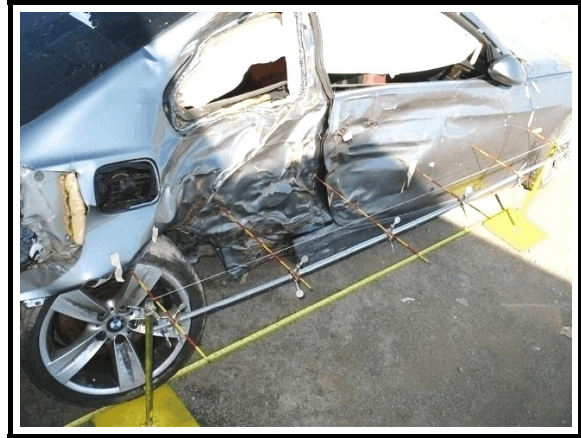
Figure 5. Right side crush profile measurement

The maximum lateral crush to the roof side rail measured 11 cm (4.3 in), and was located 88 cm (34.7 in) forward of the rear axle, just aft of the B-pillar. Six crush measurements were taken at mid-door level (**Figure 5**) as follows: $C_1 = 0$ cm, $C_2 = 20$ cm (7.9 in), $C_3 = 18$ cm (7.1 in), $C_4 = 13$ cm (5.1 in), $C_5 = 5$ cm (2.0 in), $C_6 = 0$ cm. Maximum lateral crush measured 20 cm (7.9 in) and was located 42 cm (16.5 in) forward of the rear axle at C2. The CDC for Event 6 was 01RZAW2.

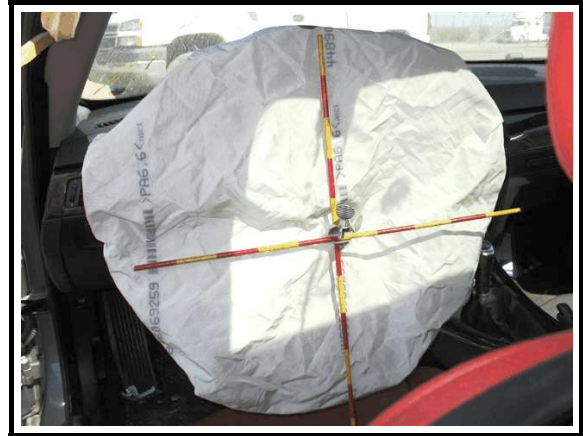
The BMW was a CAC vehicle equipped with advanced dual-stage frontal air bags. The driver's air bag deployed from the steering wheel hub (**Figure 6**) during the tree impact (Event 5), which resulted in the highest Delta-V of the six documented events. The module cover flaps opened at their tear points and were not damaged. The frontal air bag was round in shape and measured 60 cm (23.6 in) in diameter. It was configured with two vent ports measuring 2 cm (0.8 in) in diameter on

A 4 x 5 cm (1.6 x 2.0 in) area of dark-colored scuffs were located in the lower right quadrant near the seam. The source of the scuffs was probably from the driver's clothing when she loaded the air bag. The driver sustained a right forearm abrasion consistent with frontal air bag loading.

Figure 6. Deployed left frontal air bag

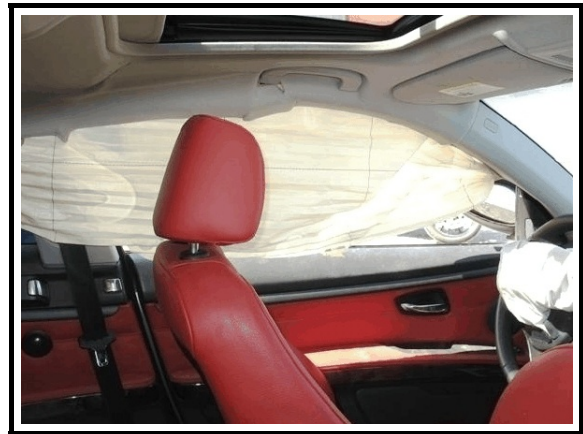
The vehicle's left and right IC air bags deployed from the roof side rails over the front doors and rear side panels at impact with the tree (**Figure 7**). The IC air bags measured 168 cm (66.1 in) in length and 36 cm (14.2 in) in height. They were configured without vent ports or tethers. The left IC air bag exhibited a horizontally oriented tear on its outboard panel measuring 15 cm (5.9 in) in length. The tear was located 20 cm (7.9 in) forward of the left B-pillar and 20 cm (7.9 in) above the bottom edge of the air bag, and the damage was confined to the outboard panel. The source of the tear was probably from the side glass during the tree impact. The glass from the left side window disintegrated and was displaced to the right in response to the direction of force. There was no evidence of occupant loading or other damage to the inboard panel. The right IC air bag was identical in size and configuration to the left IC air bag and was unremarkable.

Figure 7. Deployed left IC air bag
