## ON-SITE HYBRID VEHICLE INVESTIGATION

CASE NUMBER - IN09010

VEHICLE - 2008 FORD ESCAPE HYBRID

CRASH DATE - February 2009

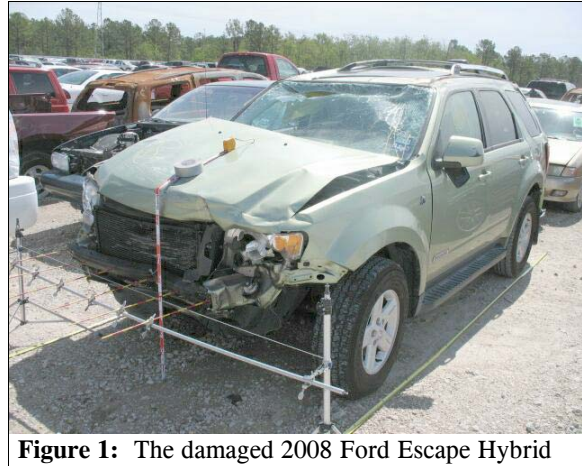
**Figure 1:** The damaged 2008 Ford Escape Hybrid

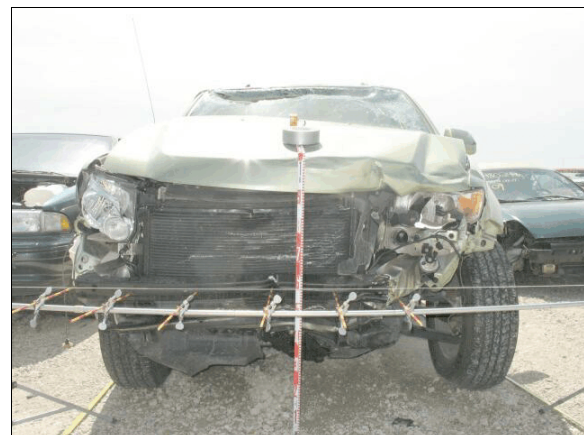
Figure 4: Damage to the Escape's front plane from the impact with the Taurus

**Exterior Damage:** The impact with the Taurus involved the Escape's front plane. The bumper, bumper fascia, grille, hood, both fenders, and both headlamp/turn signal assemblies were directly damaged. The direct damage began at the front left bumper corner and extended across the full width of the front plane. The front bumper fascia was not present at the vehicle inspection and the direct damage width of 112 cm (44.1 in) was measured on the bumper bar. The crush measurements were taken on the bumper bar and the residual maximum crush was 24 cm (9.5 in) occurring at C<sub>3</sub> (**Figure 6**). The induced damage involved the hood and both fenders. The table below shows the vehicle's front crush profile.

**Damage Classification:** The Collision Deformation Classification (CDC) for the Escape’s front plane damage was: **71-FDEW-2 (320 degrees)**. The force direction was incremented by 60 to account for the rightward shift of the Escape’s basic end structure (**Figure 4**), which exceeded the 10 cm (4 in) threshold. The CDC for the rollover was **00-TDDO-2**. The Damage algorithm of the WinSMASH program calculated the Escape’s Delta V for the front impact as 23 km/h (14.3 mph). The longitudinal and lateral velocity changes were -17.6 km/h (-10.9.0 mph) and 14.8 km/h (9.2 mph), respectively. The results appeared reasonable based on the damage on both vehicles. The severity of the rollover damage was minor based on the extent of the roof crush.

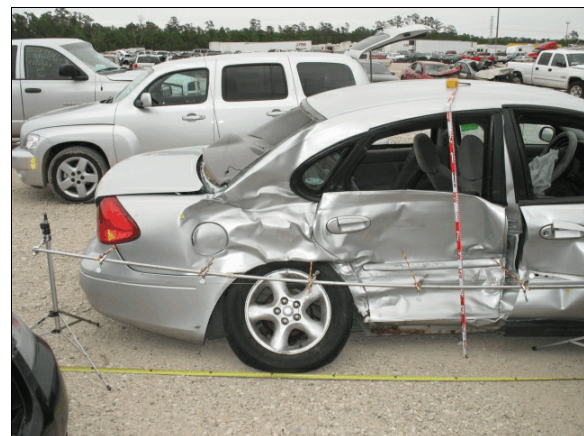
Figure 5: Damage to the Taurus' right side plane from the impact with the Escape

**Exterior Damage:** The impact with the Escape involved the Taurus' right side plane (**Figure 5**). The right front and rear doors, B-pillar, quarter panel, rear wheel, and C-pillar were all directly damaged. The direct damage began 137 cm (53.9 in) rear of the right front axle and extended 172 cm (67.7 in) rearward along the right side. The crush measurements were taken at the mid-door level and the residual maximum crush was 34 cm (13.4 in) occurring at C<sub>5</sub>. The induced damage

**Damage Classification:** The CDC for the Taurus’ right side plane impact with the Escape’s front plane was: **02-RZAW-3 (50 degrees)**. The CDC for left side plane impact with the traffic signal police was **09-LZAW-3 (280 degrees)**. The Damage algorithm of the WinSMASH program calculated the Taurus’ Delta V for the right side impact as 24 km/h (14.9 mph). The longitudinal and lateral velocity changes were -15.4 km/h (-9.6 mph) and -18.4 km/h (-11.4 mph), respectively. Based on the damage on both vehicles, the results appeared reasonable. The Barrier algorithm of the WinSMASH program calculated the Taurus’ Delta V for the left side impact as 15 km/h (9.3 mph). The longitudinal and lateral velocity changes were -2.6 km/h (-1.6 mph) and 14.8 km/h (9.2 mph), respectively. Based on the extent of the damage the results appeared reasonable.

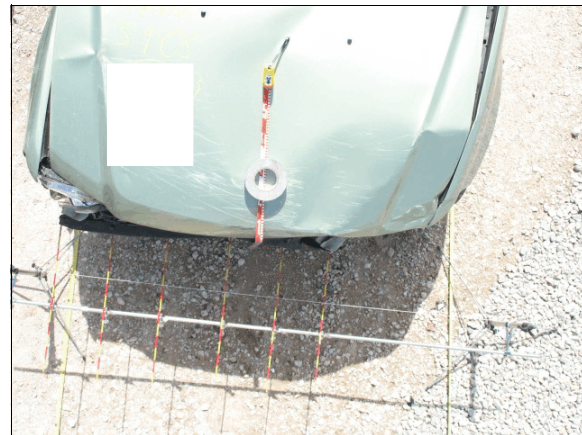
Figure 6: Top view of Escape’s front crush profile

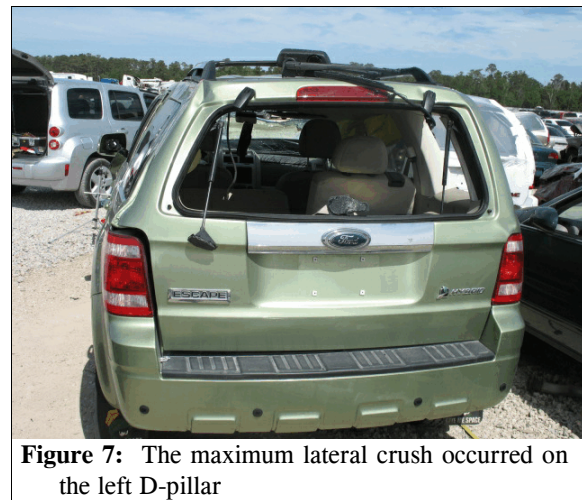
The damage from the rollover involved the Escape’s top, left, and right side planes. The direct damage on the left side plane began 92 cm (36.2 in) rear of the left front axle and extended 230 cm (90.5 in) rearward along the left side, mostly at the roof side rail and upper pillars. The maximum lateral crush was 6 cm (2.4 in) and occurred at the top of the left D-pillar (**Figure 7**).

Figure 7: The maximum lateral crush occurred on the left D-pillar

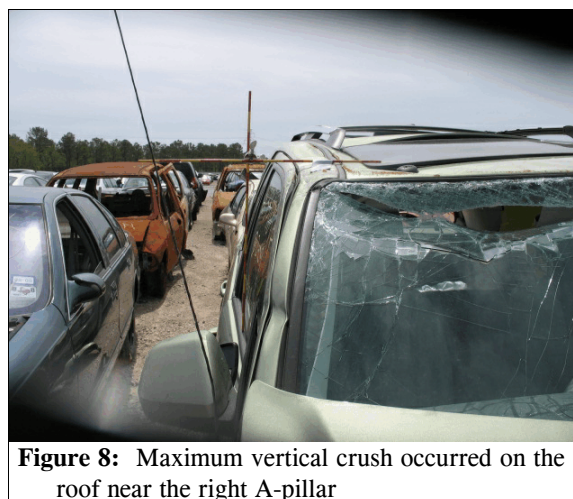
The Escape’s direct damage on the top plane began at the front of the hood and extended the entire length of the vehicle and the full width of the roof, 106 cm (41.7 in). The maximum vertical crush occurred on the roof (**Figure 8**) and was 6 cm (2.4 in). It was located 15 cm (5.9 in) inboard of the right A-pillar and 188 cm (46.5 in) rear of the right front axle. The induced damage from the rollover involved the roof and the rear hatch.

All the vehicle’s doors and the rear hatch remained closed and operational. The pre-crash status of all the glazings was either closed or fixed. The windshield was in place and cracked due to impact forces. At the time of the inspection, the windshield glazing was split open near the header (**Figure 8**), but this was probably due to weathering. The second right rear window glazing and the backlight glazing were disintegrated due to impact forces.

**Figure 8:** Maximum vertical crush occurred on the roof near the right A-pillar

The roof, windshield header, and right A-pillar intruded vertically 3 cm (1.2 in), 2 cm (1.2 in), and 1 cm (0.4 in), respectively into the front passenger occupant space. The roof intruded 1 cm into the driver’s occupant space.

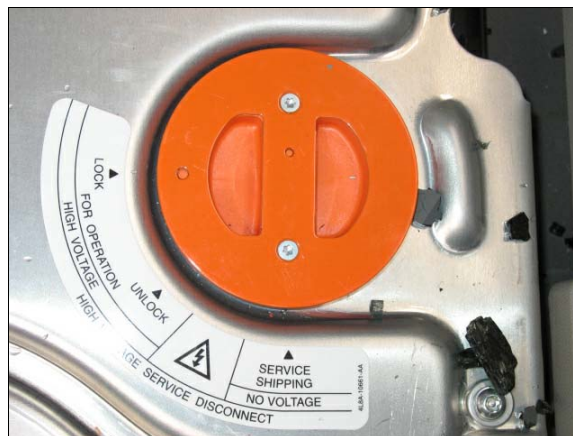
battery is crushed, it is possible for a small amount of electrolyte to leak<sup>3</sup>. Inspection of the propulsion battery revealed no evidence of movement and no damage. The battery was equipped with a high voltage service disconnect switch (Figure 9), which was located on the top right of the battery. At inspection, the switch was in the “Lock” position. It could be turned to the “Unlock” position but not to the “Service/Shipping” position. Since the switch could not be removed, no attempt to take a voltage measurement was made. The high voltage wiring connector was located on the front right of the battery (Figure 10). It was undamaged and exhibited no evidence of displacement within the socket. Examination of the DC/DC converter and the high voltage wiring and connectors that were in the engine compartment (Figure 11, exemplar) could not be made because the hood was jammed shut. The vehicle was equipped with an inertia activated high voltage shut off switch, which was located in the jack storage compartment within the passenger side cargo area (Figure 12). The switch button was pushed in an attempt to determine if the switch had opened during the crash, but it did not click or feel like it reset. While it is probable that the switch opened during the crash and disabled the high voltage system, this simple test was indeterminate. See the attachments<sup>3</sup> at the end of this report, which show the location and identification of the Escape’s hybrid components.

Figure 9: The high voltage service disconnect switch; switch in the locked position at inspection

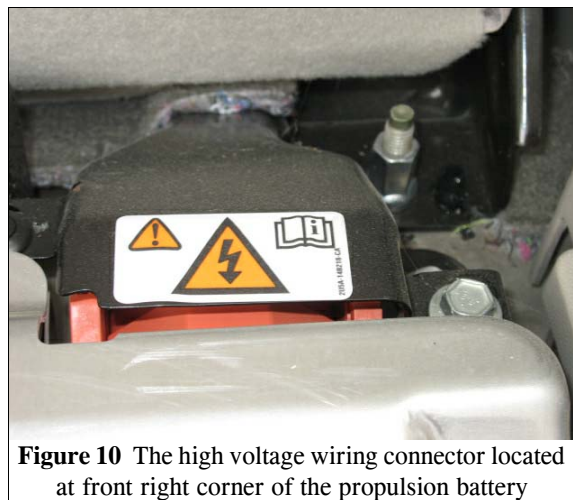
Figure 10 The high voltage wiring connector located at front right corner of the propulsion battery

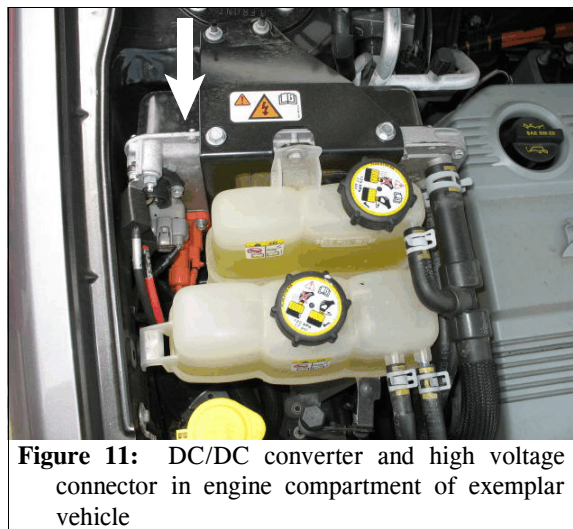
Figure 11: DC/DC converter and high voltage connector in engine compartment of exemplar vehicle

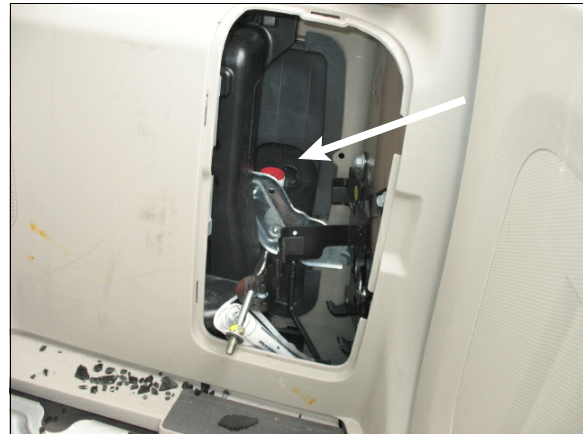
**Figure 12:** Inertia activated high voltage shut off switch in rear right side of Escape

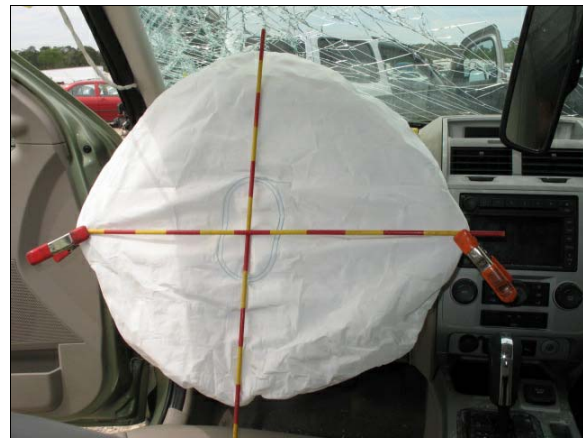
The driver's frontal air bag was located within the steering wheel hub and the module cover was a two flap configuration constructed of pliable vinyl. Each cover flap was 12 cm (4.7 in) in height and 6.5 cm (2.6 in) in width. The cover flaps opened at the designated tear seams and were not damaged. The deployed air bag (**Figure 13**) was round with a diameter of 58 cm (22.8 in) and was designed with two tethers and two vent ports. There was no discernable evidence of occupant contact on the air bag and no damage.

**Figure 13:** The driver's frontal air bag

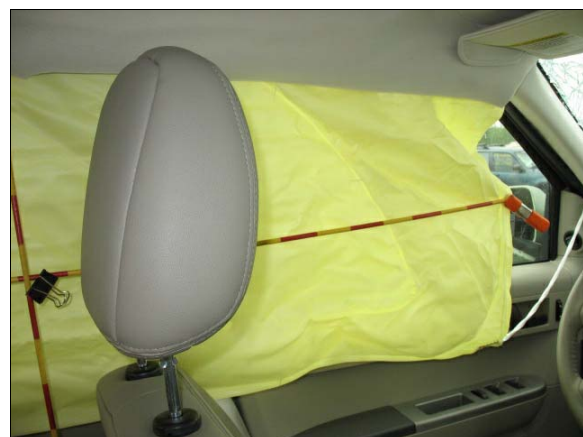
The Escape's IC air bags were located along the roof side rails inside the headliner (**Figure 14**) and extended from the A-pillar to the C-pillar. They were designed with inflation chambers adjacent to each outboard seat position and did not have external vent ports. The IC air bags were 146 cm (57.4 in) in length and 44 cm (17.3 in) in height. Each IC was anchored to the A-pillar by a cloth cord 38 cm (15 in) in length and to the C-pillar by a cloth cord 5 cm (2 inches) in length. There was a 30 cm (11.8 inches) wide gap between the bottom leading edge of each IC air bag and the A-pillar. The distance from the beltline to the bottom of the IC air bags was 14 cm (5.5 in). The inspection of the IC air bags revealed no discernable evidence of occupant contact and there was no damage.

**Figure 14:** Forward portion of left side curtain air bag

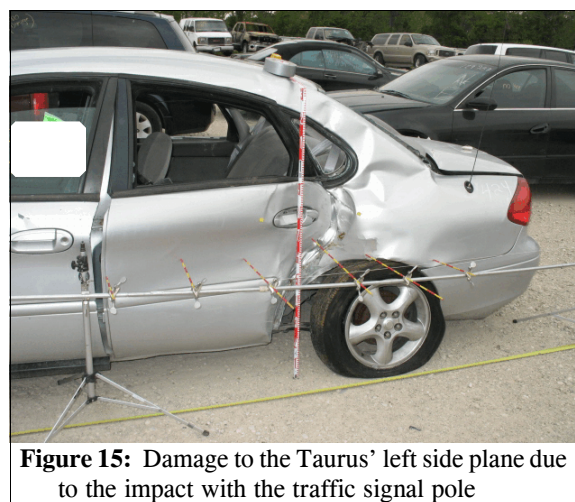
The Taurus’ impact with the traffic signal pole (event 3) involved the left side of the vehicle. The left rear door, left C-pillar, roof side rail, and quarter panel were all directly damaged (**Figure 15**). The direct damage began 228 cm (90 in) rear of the left front axle and extended 48 cm (19 in) rearward along the left rear door and quarter panel. The crush measurements were taken at the mid-door level and the residual maximum crush was 28 cm (11 in) at C<sub>3</sub>. There was induced damage on both left side doors, the left quarter panel, roof side rail, and C-pillar. The vehicle’s left side wheel base was extended 10 cm (3.9 in). The table below shows the Taurus’ left side crush profile.

**Figure 15:** Damage to the Taurus’ left side plane due to the impact with the traffic signal pole
