## REMOTE NOT IN TRAFFIC SURVEILLANCE FALLING VEHICLE INVESTIGATION

CASE NUMBER - IN09013  
LOCATION - NEW MEXICO  
VEHICLE - 2000 CHRYSLER CONCORDE LX  
INCIDENT DATE - February 2009

1. <i>Report No.</i> IN09013		2. <i>Government Accession No.</i>		3. <i>Recipient's Catalog No.</i>	
4. <i>Title and Subtitle</i> Remote Not In Traffic Surveillance Falling Vehicle Investigation Vehicle - 2000 Chrysler Concorde LX Location - New Mexico			5. <i>Report Date:</i> May 29, 2009

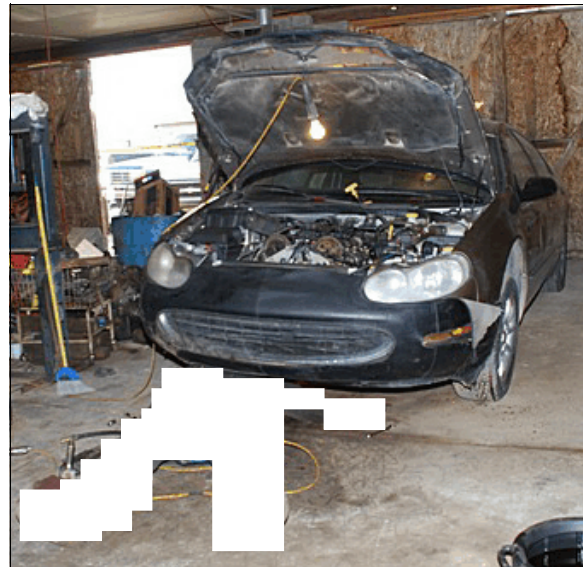
**Figure 1:** Police on-scene photograph showing the Chrysler Concorde and deceased victim (sanitized) under the front of the vehicle

under the front of the vehicle. He called out to the victim but received no response. The co-worker nudged the victim with his foot and called out to him again. When the victim did not respond, the co-worker knelt down and realized the front of the vehicle was resting on the victim's head and chest. The co-worker pumped the floor jack handle several times to raise the vehicle enough to see that the victim was not breathing. The co-worker left the victim under the vehicle and notified authorities. The victim was laying on his back on the crawler with his head under the engine and his lower chest under the front bumper. His right arm was curled upward between the right front wheel and the engine. He had impressions on his face consistent with the bottom of the engine and impressions on his chest area and clothing consistent with the bottom of the bumper fascia.

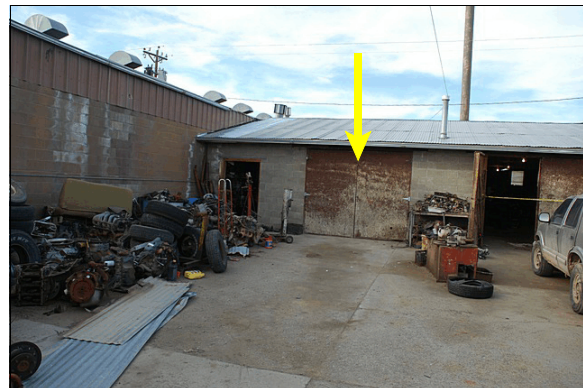
**Figure 2:** Police on-scene photograph of subject garage; arrow shows door to the bay where the Chrysler was located

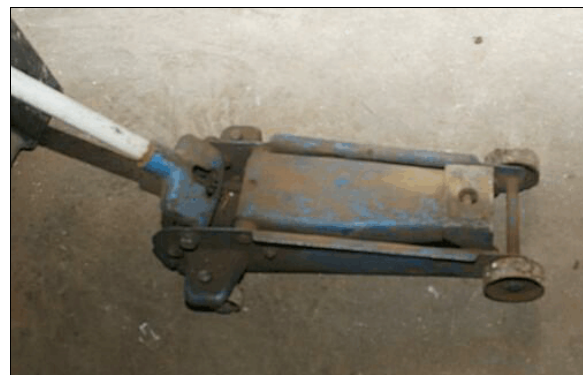
**Figure 3:** The floor jack used by the victim to raise the front of the Chrysler; the make and model could not be determined

by the victim to raise the front portion of the vehicle. The investigating detective reported that there were no identifiers on the floor jack that indicated the manufacturer or the model and serial number. The owner of the business stated during the SCI interview that he had purchased the floor jack new approximately two years ago. He did not know the make or model of the floor jack. Four jack stands were located in the immediate vicinity of the vehicle (**Figure 5**). They were not used by the victim to support the vehicle once it was raised with the floor jack.

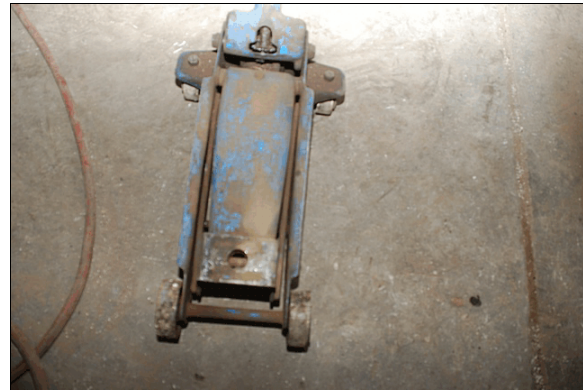
**Figure 4:** Another view of the floor jack

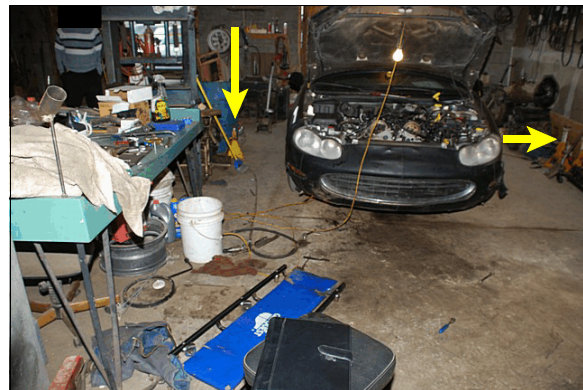
**Figure 5:** Arrows show three of the four jack stands that were in the immediate vicinity of the vehicle

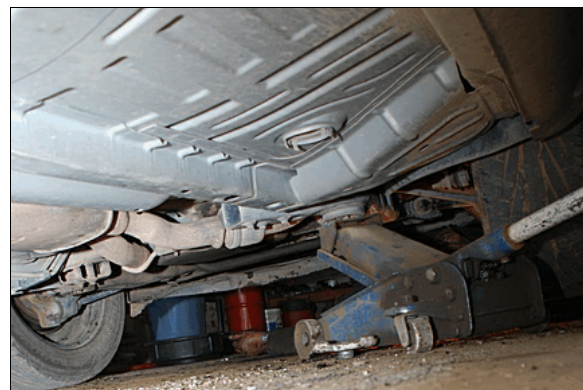
**Incident:** The victim used a mechanic's crawler to position himself under the front right area of the vehicle, near the right front wheel where he was performing mechanical work on the engine. The victim's activity and the length of time he was under the vehicle is unknown. The length of time the vehicle had been raised prior to the incident is also not known. Measurements were taken on an exemplar vehicle and the distance from the ground to the bottom of the front bumper fascia and the bottom of the right frame member, near the right front wheel were determined to be 18 cm (7.1 in) and 17 cm (6.7 in), respectively.

**Figure 6:** The floor jack was positioned under the right frame member, behind the right front wheel

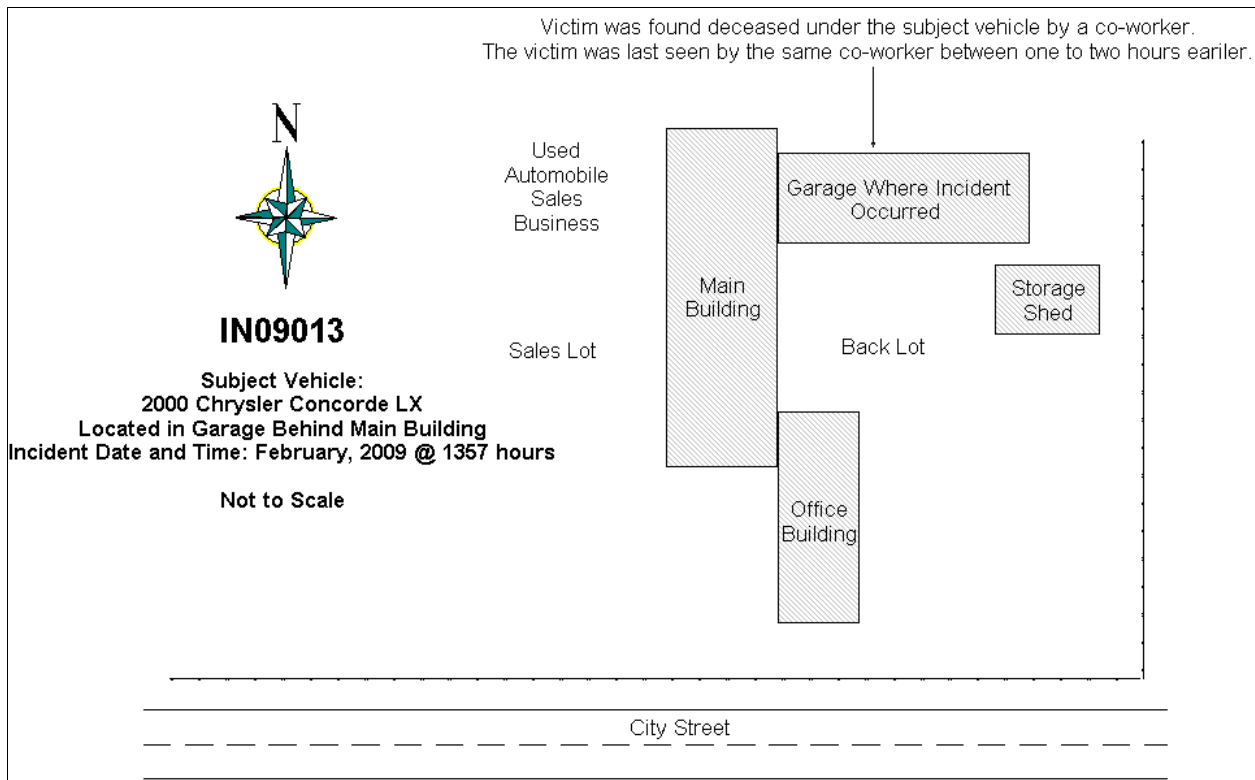
INCIDENT LOCATION DIAGRAM . . . . . 4

**Incident Environment:** This incident occurred within a garage of a used automobile sales business. The establishment consisted of four buildings located on a commercial lot in the industrial section of a city with a population of 20,209. Please see the incident location diagram on page 4 of this report. The Chrysler was parked within a two-vehicle garage (**Figure 2**) that was located on the northeast corner of the property in back of the business' main building. The garage floor consisted of level concrete. There were no vehicle lifts located in the garage. A hydraulic floor jack (**Figures 3 and 4**) was used
