## ON-SITE SIDE IMPACT INFLATABLE OCCUPANT PROTECTION INVESTIGATION

CASE NUMBER - IN09015

VEHICLE - 2003 BUICK RENDEZVOUS

CRASH DATE - March 2009

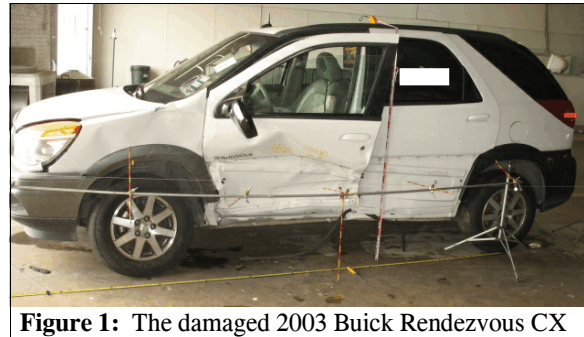
**Figure 1:** The damaged 2003 Buick Rendezvous CX

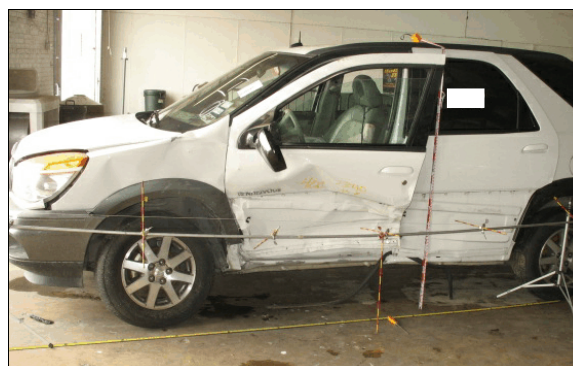
**Crash:** The front plane of the Century impacted the left side plane of the Rendezvous (**Figure 4**). The direction of force on the Rendezvous was within the 11 o'clock sector and the impact force was sufficient to trigger the deployment of the driver's seat-mounted side impact air bag and the driver's and front right passenger's frontal air bags. The impact caused both vehicles to rotate counterclockwise. The scene inspection revealed no evidence of the final rest positions of either vehicle. The police crash schematic did not depict the final rest position of the Rendezvous. The Rendezvous probably came to final rest within the intersection heading northwest. The police crash schematic showed the final rest position of the Century north of the intersection on the west side of the roadway. It is probable that the Century came to final rest within the intersection heading northeast, and the driver drove the vehicle to the position indicated on the police crash schematic following the crash.

**Figure 4:** Damage to the left side plane of the Rendezvous from the impact with the Century

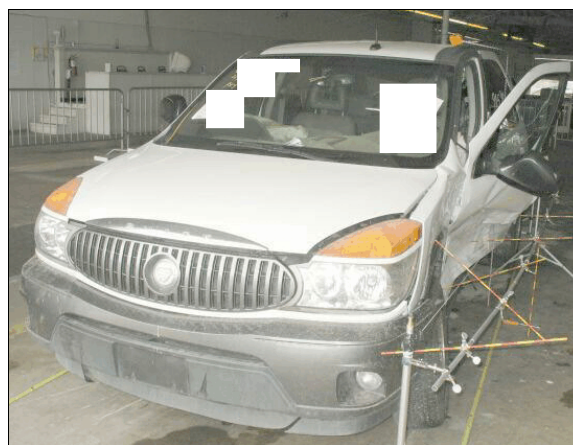
**Exterior Damage:** The impact with the Century involved the left side plane of the Rendezvous. The left fender, left front and left rear doors, the sill, and the front and back wheels were directly damaged. The direct damage began 290 cm (114 in) forward of the left rear axle and extended 270 cm (106 in) along the left side. The crush measurements were taken on the lower door level (**Figure 5**) and the residual maximum crush was 26 cm (10.2 in) occurring at C<sub>3</sub>. The height of the maximum door crush was 55 cm (21.6 in) and the Door Sill Differential was 9 cm (3.5 in). The table below shows the vehicle’s left side plane crush profile.

**Figure 5:** Damage to the left side plane of the Rendezvous from the impact with the Century

The vehicle’s left wheelbase was shortened 3 cm (1.2 in) and the right wheelbase was extended 1 cm (0.4 in). The induced damage involved the left fender, front bumper fascia, and both left side doors.

**Damage Classification:** The Collision Deformation Classification was **11-LDEW-3 (320 degrees)**. The Missing Vehicle algorithm of the WinSMASH program calculated the vehicle’s total Delta V for the left side impact as 23 km/h (14 mph). The longitudinal and lateral velocity changes were -17.6 km/h (-10.9 mph) and 14.8 km/h (9.2 mph), respectively. The results were based only on the crush profile of the Rendezvous and should be considered a borderline reconstruction of the vehicle’s Delta V.

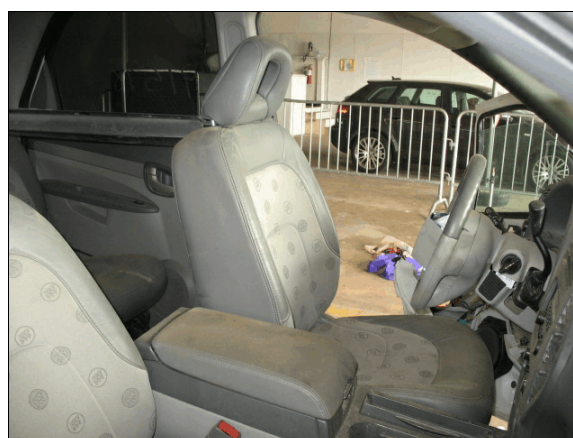
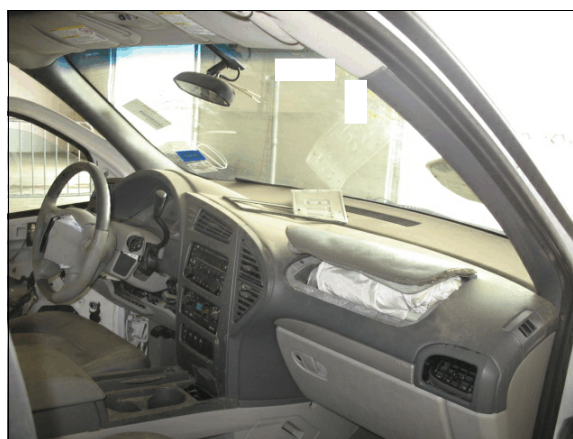
**Vehicle Interior:** The inspection of the interior (Figures 6 and 7) revealed no discernable occupant contact evidence and no evidence of steering rim deformation or compression of the energy absorbing steering column.

Figure 6: Driver's seating position

Figure 7: Instrument panel, steering wheel and windshield

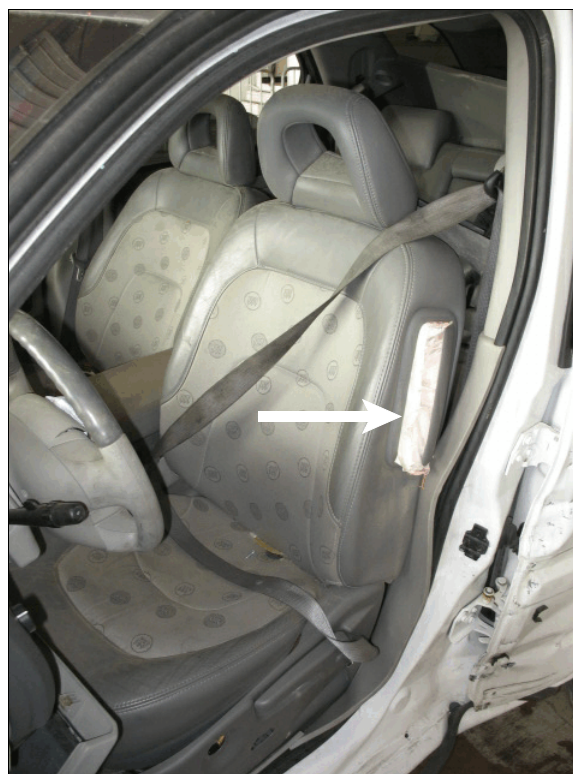
The driver's seat-mounted side impact air bag was located in the outboard side of the driver's seat back (**Figure 8**). The module cover was rectangular and constructed of pliable vinyl. It was 8 cm (3.1 in) in width and 21 cm (8.3 in) in height. Inspection of the cover flap revealed that it opened at the designated tear points. The deployed air bag (**Figure 9**) was 29 cm (11.4 in) in width at the bottom, 36 cm (14.2 in) in width at the top, and 70 cm (27.6 in) in height. There were no vent ports, but the inboard and outboard sides of the air bag fabric were sewn together in two locations. The sewn areas were 12 cm (4.7 in) in width and 1 cm (0.4 in) in height. They were located 15 cm (5.9 in) and 33 cm (13 in) from the top, respectively, and 13 cm (5.1 in) from the leading edge of the air bag. Inspection of the air bag revealed a possible occupant contact on the lower left quadrant on the inboard side located 17 cm (6.7 in) from the bottom and 17 cm (6.7 in) from the leading edge.

**Figure 8:** The driver's seat; arrow shows the packed seat-mounted side impact air bag and the module cover flap

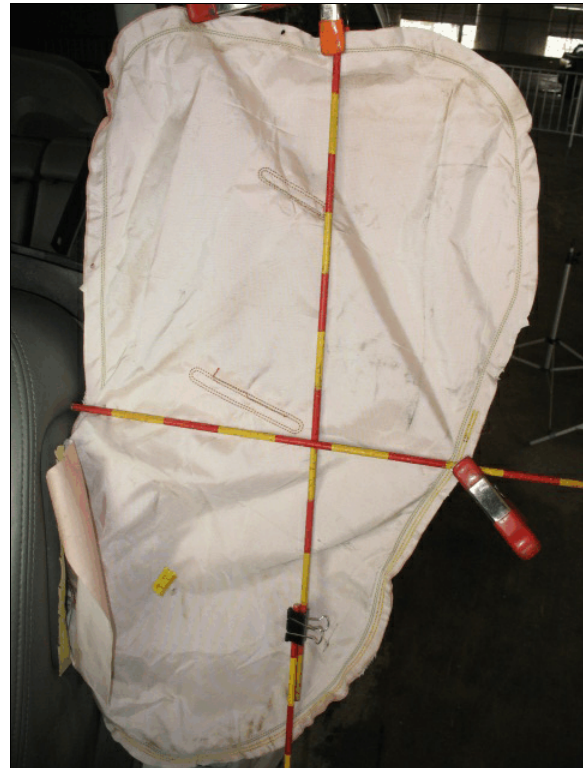
**Figure 9:** The deployed left front seat-mounted side impact air bag

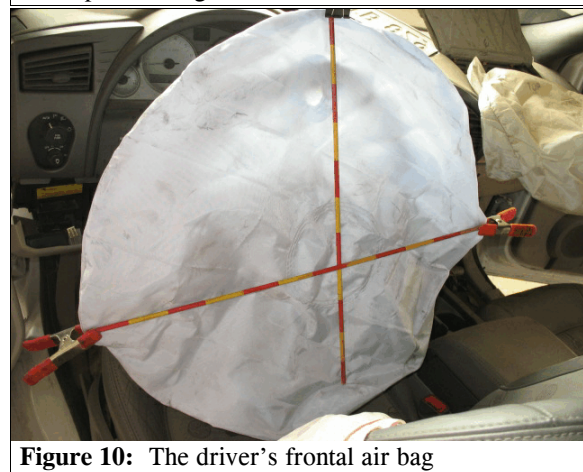
opened at the designated tear points. The deployed air bag (**Figure 10**) had a diameter of 64 cm (25.2 in) and was designed with four tethers and two vent ports. The vent ports were located on the back of the air bag at the 2 and 10 o'clock positions. Inspection of the air bag revealed no damage and no discernable evidence of occupant contact.

**Figure 10:** The driver's frontal air bag

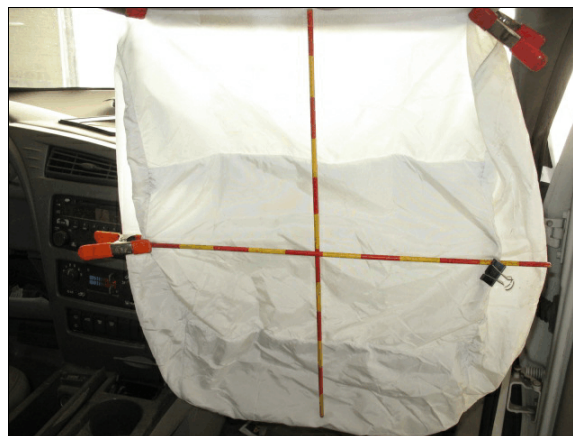
The front passenger's air bag was located within the top of the instrument panel. The air bag module cover consisted of a single flap constructed of pliable vinyl. The cover flap was 36 cm (14.2 in) in width and 24 cm (9.4 in) in height. It opened along the designated tear seam and was undamaged. The deployed air bag (**Figure 11**) was 48 cm (18.9 in) in width and 67 cm (26.4 in) in height. It was designed with two tethers and two vent ports located at the 10 and 2 o'clock positions. There were no discernable occupant contacts and no damage on the air bag.

Figure 11: The Rendezvous’ front right passenger’s frontal air bag
