On-Site Hybrid Vehicle Investigation
Dynamic Science, Inc. (DSI), Case Number DS09016
2008 Toyota Camry
California
September 2008

1. Report No. DS09016	2. Government Accession No.		3. Recipient Catalog No.	
4. Title and Subtitle On-Site Hybrid Vehicle Investigation			5. Report Date September 17, 2009

Dynamic Science, Inc.
Crash Investigation
Case Number: DS09016

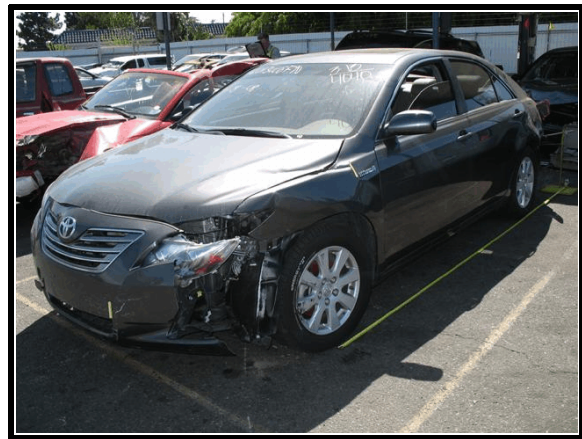
The Toyota sustained damage to the front, right, and rear planes. There were five impacts documented. The first was a frontal impact between the Toyota and the right side of the Ford (**Figure 3**). The direct damage began 35 cm (13.7 in) left of the centerline and extended 46 cm (18.1 in) to the left front bumper corner. The plastic fascia at the left bumper corner was broken away. The damage extended 119 cm (46.8 in) longitudinally along the left fender and vertically onto the left side of the hood. The damage height was 91 cm (35.8 in) above the ground. The Collision Deformation Classification (CDC) for the first event was 12FLEW1.

Figure 3. Left front damage (Impact 1)

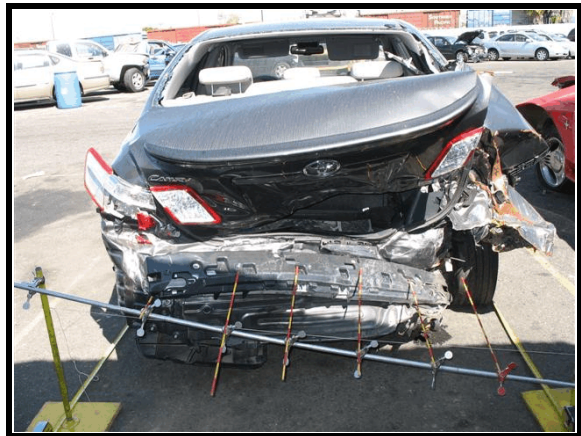
The second impact was between the rear of the Toyota and the front of the BMW (**Figure 4**). The direct damage began 11 cm (4.3 in) left of the centerline and extended 80 cm (31.5 in) to the right rear bumper corner. The right rear tire was damaged and restricted during this impact. There was a 36 cm (14.2 in) tear in the sidewall located 5 cm (1.9 in) from the bead, a 20 cm (7.9 in) tear at the area of restriction, and a 53 cm (20.9 in) tear to the inner sidewall. Six crush measurements were documented along the bumper as follows: C1 = 0 cm, C2 = 7 cm (2.8 in), C3 = 24 cm (9.4 in), C4 = 37 cm (14.6 in), C5 = 43 cm (16.9 in), C6 = 45 cm (17.7 in). The maximum crush was located at C6 and the CDC for the second event was 06BZEW4.

Figure 4. Rear damage (Impact 2)

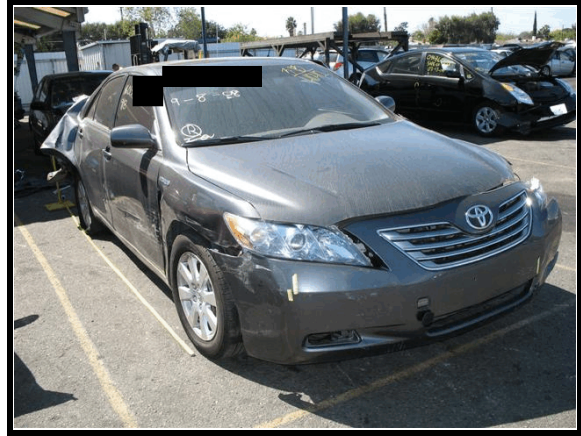
The third impact was between the front of the Toyota and the left side of the Saab (**Figure 5**). The direct damage began at the right front bumper corner and extended 3 cm (1.2 in) to the left and 246 cm (96.8 in) longitudinally down the right side. The CDC for the third event was 12FRES9.

Figure 5. Front right damage (Impact 3)

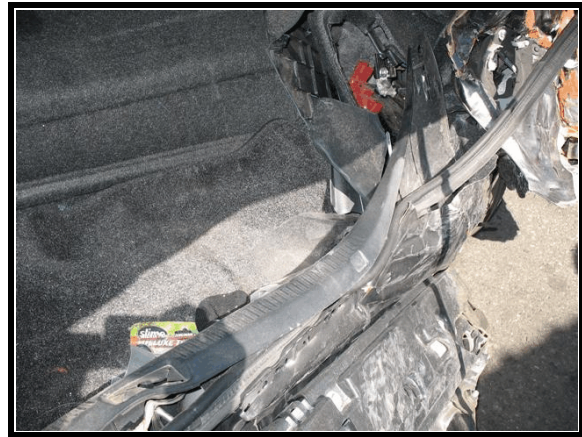
There was damage to the cargo area aft of the rear seat and the traction battery (**Figure 6**). The rear portion of the cargo area was deformed forward. The longitudinal distance from the traction battery to the rear portion of the cargo area measured 44 cm (17.3 in) on the left and 26 cm (10.2 in) on the right. Since the left was largely undamaged, the depth of crush was 18 cm (7.0 in). The vehicle's lead-acid service battery was located in the right rear of the cargo compartment. It was fractured during the crash and the battery had leaked the acid/water solution.

Figure 6. Trunk and service battery damage

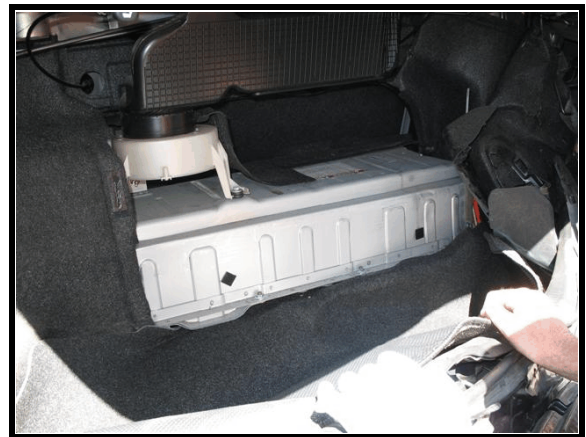
Figure 7. Traction battery

The battery system was a 244-volt Nickel Metal-Hydride (NiMH) battery that was mounted in the rear cargo floor, aft of the second row seat (**Figure 7**). This high-voltage (HV) battery system was mounted laterally in the vehicle and was concealed and protected by an aluminum cover that was bolted to the rear floor of the vehicle. An air intake vent was located on the right side of rear deck for the purpose of cooling the traction battery. Orange colored power cables carry high voltage direct current between the HV battery pack and the inverter/converter. The cables extended along the center of the vehicle, under the vehicle floor pan, from the cargo area to the engine compartment.

- There were no indications of electrolyte spillage from the propulsion battery.
- There was no movement of the battery module.
- The isolation test was not conducted; there was no power to the vehicle or to the traction battery.
- There were no indications of any arcing, fire or component meltdown.

This moderate severity crash was isolated to the right rear of the vehicle. There was no damage to the battery pack area and the battery had not moved. The engine compartment was not damaged. There was no evidence of damage by the first responders to the crash site.
