**CALSPAN ON-SITE INFLATABLE OCCUPANT PROTECTION SYSTEM
CRASH INVESTIGATION**

SCI CASE NO.: CA09016

VEHICLE: 2008 CHEVROLET COBALT LS SEDAN

CRASH DATE: JANUARY 2009

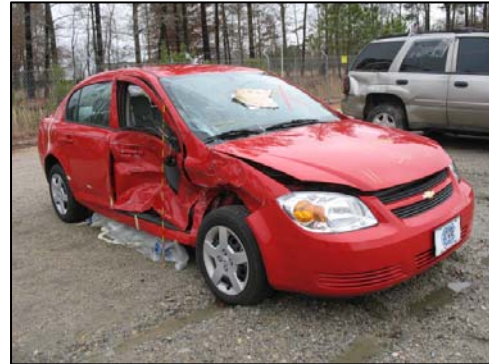
This on-site investigation focused on the deployment of the side air bag system of a 2008 Chevrolet Cobalt LS sedan (**Figure 1**). The vehicle was equipped with a Certified Advanced 208-Compliant (CAC) frontal air bag system, and Inflatable Curtain (IC) air bags. The manufacturer of the Chevrolet has certified that the vehicle is compliant with the advanced air bag portion of Federal Motor Vehicle Safety Standard (FMVSS) No. 208. The CAC system includes dual-stage frontal air bags for the driver and front right passenger positions, seat track positioning sensors, retractor pretensioners, and a front right occupant presence sensor. The Chevrolet was occupied by an 18-year-old female driver and 17-year-old female front right passenger. The vehicle was turning left at a signal-controlled intersection when impacted on the right side by a 2001 Ford Explorer. The right side IC air bag in the Chevrolet deployed. Both occupants were transported to a local hospital where they were treated in the emergency department and released.

Figure 1. 2008 Chevrolet Cobalt case vehicle

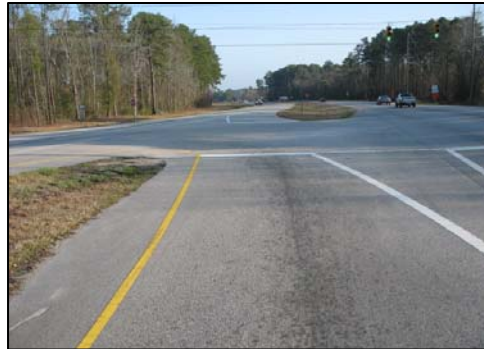
The Chevrolet was occupied by a restrained 18-year-old female driver and a restrained 17-year-old female front right passenger. The driver of the Chevrolet was operating the vehicle northbound towards the intersection in lane three of a three-lane divided roadway, negotiating a curve to the left (**Figure 2**). The driver was slowing on her initial approach to the intersection and traveling at an EDR recorded speed of 11 km/h (7 mph) at 5 seconds prior to Algorithm Enable (AE). The Ford was traveling southbound toward the intersection in lane three of the four-lane divided roadway, negotiating a curve to the right. As the Chevrolet approached the intersection, the overhead signal was in a green phase, and the driver accelerated. The driver of the Chevrolet stated that she did not see oncoming traffic and initiated a left turn across the intersection. This was confirmed by the EDR output which recorded the pre-crash speed of 27 km/h (17 mph). The driver of the Chevrolet did not initiate avoidance action.

Figure 3. Chevrolet's pre-crash trajectory

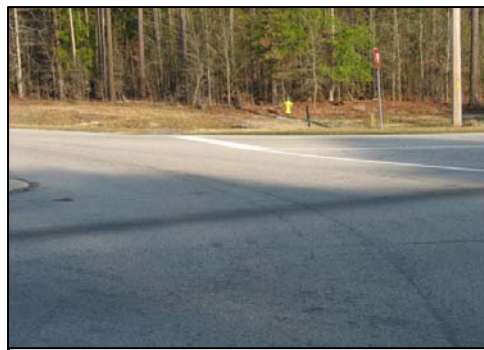
Figure 2. Area of initial impact from the travel direction of the Chevrolet.

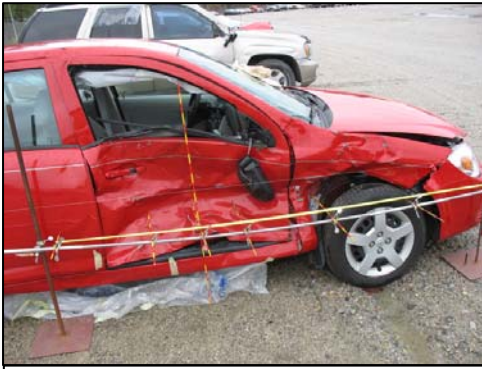
The exterior of the Chevrolet sustained moderate severity damage to the right side as a result of the multiple impact crash. The initial impact (Event 1) occurred to the front aspect of the right side. The direct contact damage began 120 cm (47.2 in) forward of the right rear axle and extended 145 cm (57.1 in) forward. The combined direct and induced damage (Field L) began 95 cm (37.4 in) forward of the right rear axle and extended 227 cm (89.4 in) forward. The maximum crush measured 26 cm (10.2 in) and was located 165 cm (64.9 in) forward of the right rear axle. The crush profile was as follows: C1 = 0 cm, C2 = 18 cm (7.1 in), C3 = 23 cm (9.1 in), C4 = 22 cm (8.7 in), C5 = 8 cm (3.1 in), C6 = 0 cm. The height of the maximum crush was 54 cm (21.3 in), consistent with the 56

cm (22 in) front bumper height of the Ford. The Door Sill Differential (DSD) of the maximum crush to the Chevrolet was 21 cm (8.3 in). The Collision Deformation Classification (CDC) assigned for this impact was 02-RYEW-2.

Figure 4. Initial impact damage to the Chevrolet.

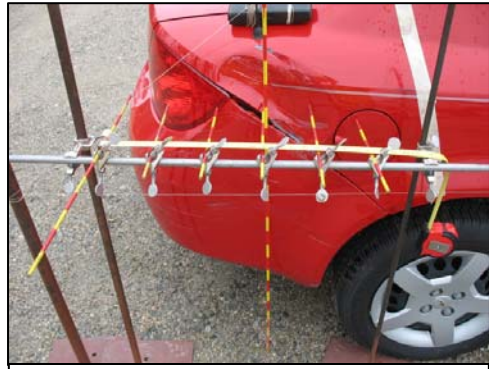
The sideslap impact involved the right rear aspect (Event 2) of the Chevrolet. The direct contact damage began 28 cm (11 in) rearward of the right rear axle and extended rearward 54 cm (21.3 in). The Field L was the same as the direct damage location. The maximum crush measured 3 cm (1.2 in) and was located at C4, 49 cm (19.3 in) rear of the right rear axle. The crush profile was as follows: C1 = 0 cm, C2 = 0 cm, C3 = 1 cm (0.4 in), C4 = 3 cm (1.2 in), C5 = 2 cm (0.8 in), C6 = 0 cm. The maximum crush height for Event 2 was 90 cm (35.4 in), consistent with the height of the left front corner of the Ford. The CDC assigned for this impact was 03-RBEW-1. **Figures 4 and 5** depict the right side damage sustained by the Chevrolet in Events 1 and 2.

Figure 5. Secondary impact damage (Event 2) to the Chevrolet.

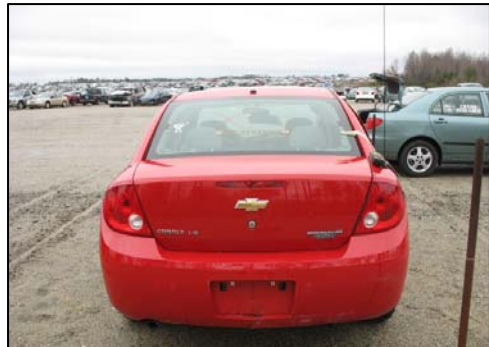
There was minor scratching to the rear bumper fascia of the Chevrolet extending from the left rear bumper corner to the right rear bumper corner (**Figure 6**). This damage occurred in a previous crash and was unrelated to the side impact crash. The imaged EDR data also showed a non-deployment event stored from thirteen ignition cycles prior to the deployment event.

Figure 6. Previous minor rear-end damage to the Chevrolet.

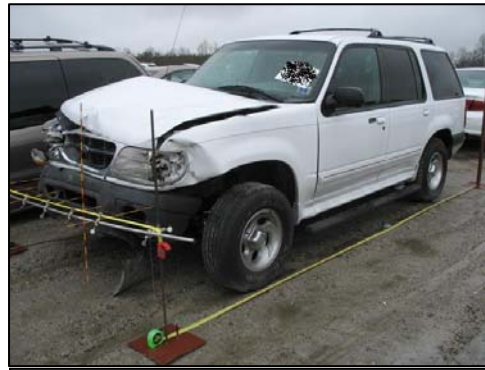
The full frontal area of the Ford sustained moderate severity damage as a result of the initial impact with the Chevrolet (**Figure 7**). The direct contact damage measured 152 cm (59.8 in) and extended the full width of the bumper. The maximum crush measured 21 cm (8.3 in) and was located at C6 at the front right bumper corner. The crush profile at bumper level was as follows: C1 = 18 cm (7.1 in), C2 = 19 cm (7.5 in), C3 = 16 cm (6.3 in), C4 = 16 cm (6.3 in), C5 = 16 cm (6.3 in), C6 = 21 cm (8.3 in). The right lateral displacement of the frame rails measured 19 cm (7.5 in). The CDC assigned for this event was 71-FDEW-1. The 11 o'clock impact force was incremented by 60 to accommodate the lateral displacement

Figure 7. Frontal damage to the Ford.

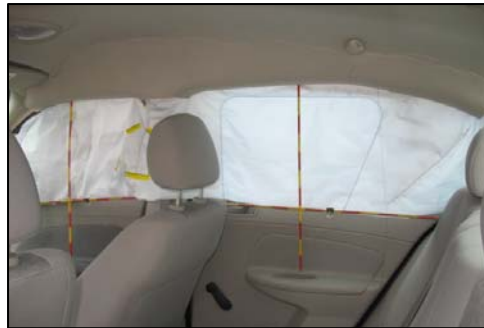
The right side IC air bag deployed from the roof side rail (**Figure 8**). The air bag measured 152 cm (59.8 in) in length and 39 cm (15.4 in) in height.

Figure 8. Right IC air bag

The air bag was tethered to the A-pillar. A triangular-shaped gap of 17 cm (6.7 in) in height was located at the front of the IC. Vertically, the air bag extended below the belt line at both right outboard positions. The air bag provided head protection from aft of the A-pillar to the C-pillar of the vehicle. There was a vertical scuff mark on the inboard side of the air bag at the forward aspect of the B-pillar from contact with the headliner during deployment. This scuff mark began at the top of the IC and extended downward 21 cm (8.3 in). There was a scuff mark attributed to contact with the right side of the front right passenger's head. This scuff mark was located 53–64 cm (20.9–25.2 in) aft of the front edge of the IC and 8–21 cm (3.1–8.3 in) above the bottom edge.

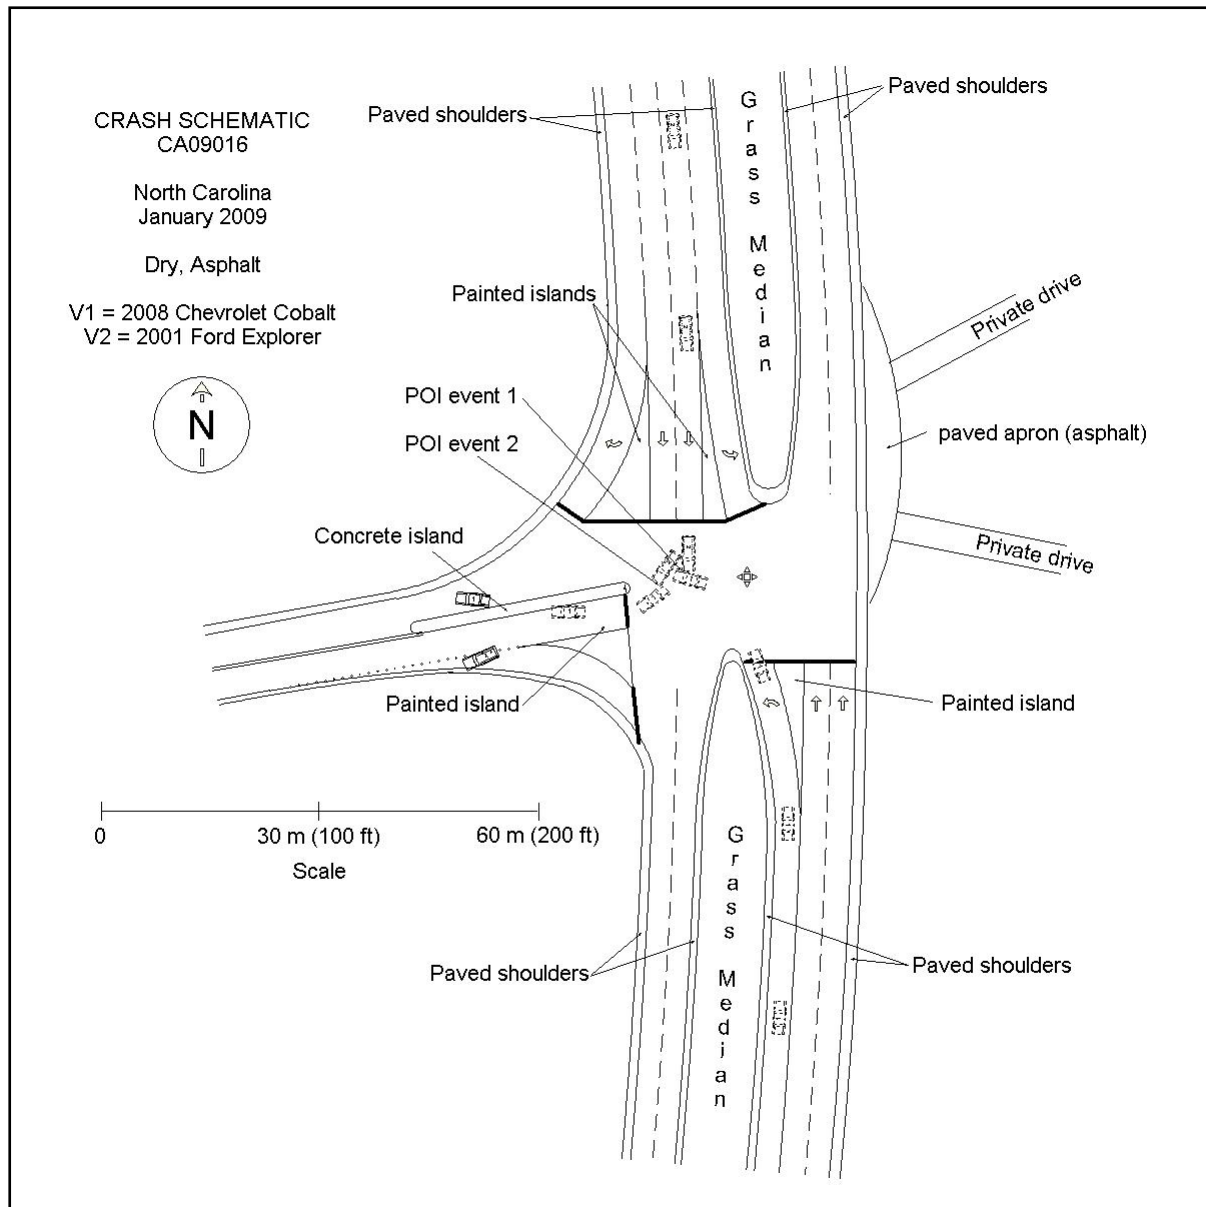
Figure 9. Crash Schematic

direction of travel consisted of four travel lanes that were 3.7 m (12.1 ft) in width. The southbound lanes were bordered on both sides by asphalt shoulders, 1.2 m (3.9 ft) in width on the west side and 0.5 m (1.6 ft) on the east. On the west side of the intersection was a two-lane roadway that increased to three lanes divided by a concrete median and a painted island near the intersection. The intersection was controlled by overhead three-phase traffic signals. The crash schematic is included as **Figures 9 and 10** at the end of this report.
