CALSPAN ON-SITE ROLLOVER CRASH INVESTIGATION

SCI CASE NO: CA09017

VEHICLE: 2007 NISSAN ARMADA

CRASH DATE: FEBRUARY 2009

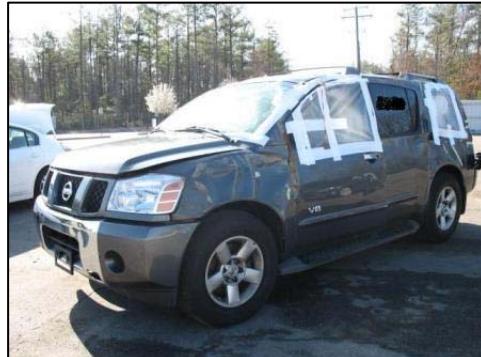
Figure 1. Front left view of the 2007 Nissan Armada.

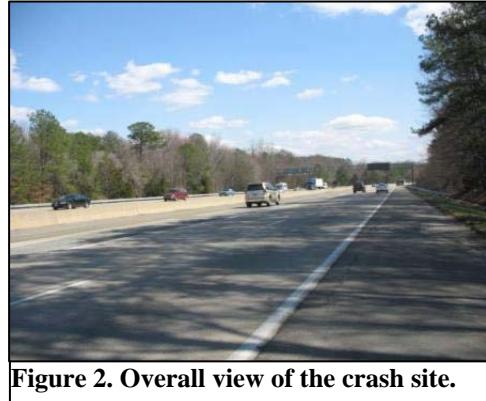
This crash occurred during the dusk hours of February 2009, on a divided interstate roadway (**Figure 2**). In the area of the crash site, the interstate consisted of three lanes in each direction that was physically divided by a concrete median barrier. In the vicinity of the crash site, the concrete road surface was straight and level. The conditions were clear and the environmental surfaces were dry. The eastbound travel lanes measured 3.7 m (12.1 ft) wide and were bordered by asphalt shoulders. The south side shoulder measured 3.5 m (11.5 ft) wide while the north side shoulder was 3.2 m (10.5 ft) wide. The posted speed limit was 97 km/h (60 mph). The approximate area of the rollover event was identified by surface scratches and gouge marks in the south asphalt shoulder. The Crash Schematic is included as **Figure 9** of this report.

Figure 2. Overall view of the crash site.

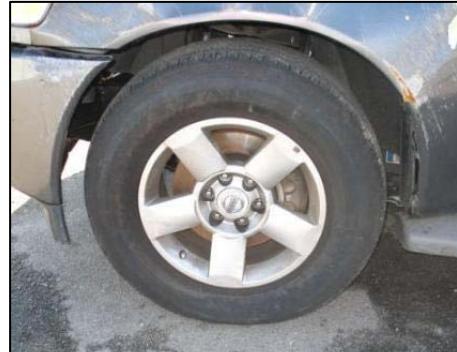
As the Nissan yawed in a CW direction, the roll moment at the CG exceeded the lateral forces exerted on the left side tires and caused the high-CG vehicle to initiate a lateral rollover to the left. There were no air outs of the left side tires and no gouging of the alloy wheels (**Figure 3**) into the concrete road surface or asphalt shoulder. Therefore, the rollover was classified as an untripped, turn-over event. The EDR recorded a roll angle of -20 degrees at time zero. This was the deployment command for the IC air bags and the actuation of the buckle and retractor pretensioners. The roll angle continued to -88 degrees at the 1-2 second interval post-deployment. The roll rate was recorded at 47 degrees/second to the right at the -1 second interval, followed by -100 degrees/second to the left at time zero (deployment). The Nissan rolled onto its left side and slid for a distance of approximately 8 m (26 ft) before coming to final rest straddling the south edge line. At rest, the vehicle was facing in a southerly direction.

Figure 3. Left front tire and wheel of the Nissan.

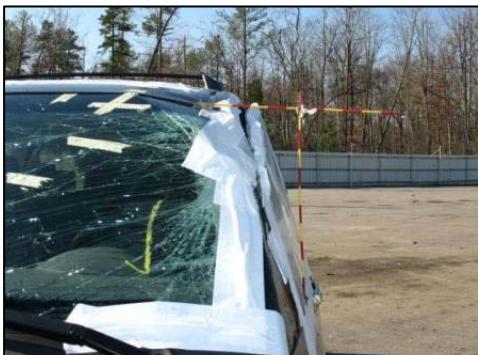
The exterior of the Nissan sustained damage that was distributed vertically and longitudinally on the left side as a result of the rollover sequence. The damage consisted of abrasions that were vertically oriented with superficial dents of the sheet metal and lateral displacement of the left A- and C-pillars. The direct contact damage measured 489 cm (192.5 in) in length and extended from the left front bumper corner to the left rear bumper corner. The vertical aspect of the direct damage extended from the sill to the roof side rail area and included the exposed portion of the alloy wheels. The left upper A-pillar was displaced 3.8 cm (1.5 in) laterally that resulted in fracturing of the left aspect of the windshield. The lateral displacement of the upper A-pillar resulted in 3 cm (1.2 in) of induced vertical deformation to the windshield header/A-pillar juncture (**Figure 4**). The left upper B-pillar was displaced 3.8 cm (1.5 in) laterally with equal displacement of the left roof side rail at the area of the pillar (**Figure 5**). All four doors remained closed and were found to be operational at the time of the SCI inspection. The left front door glazing, left rear quarter window glazing and sunroof glazing were all disintegrated from impact forces. The Collision Deformation Classification for this left side rollover event was 00LDAO3.

Figure 4. Lateral displacement of the left upper A-pillar with vertical displacement of the windshield header.

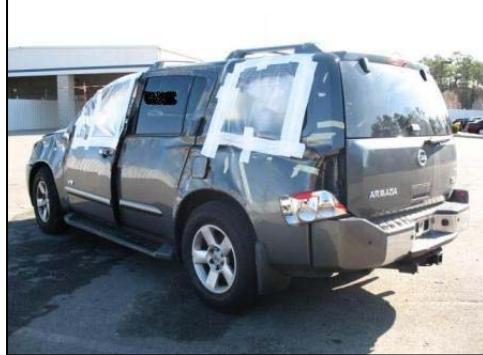
Figure 5. Lateral displacement of the left upper C-pillar and adjacent side rail.

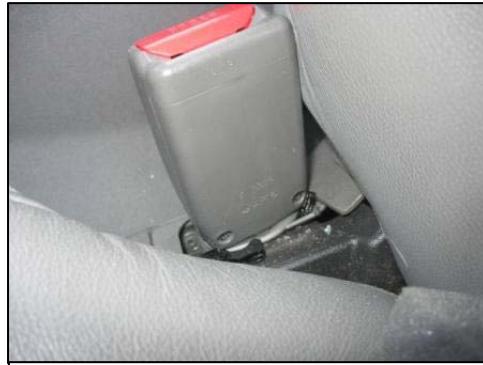
Figure 6. Actuation of the front left buckle pretensioner of the Nissan.

The plastic surface of the latch plate exhibited frictional abrasions to its full width that resulted from loading by the driver. There was no related loading evidence on the belt webbing. The belt buckle was engaged against the plastic trim panels due to the actuation of the buckle pretensioner (**Figure 6**).

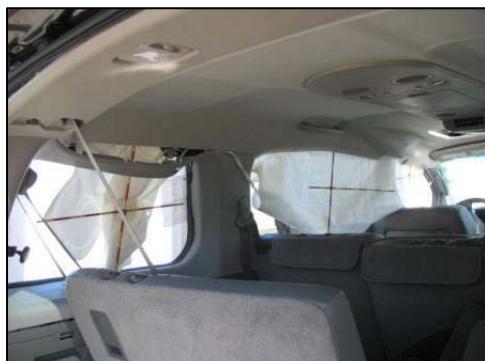
Figure 7. Overall view of the deployed left IC air bags in the Nissan.

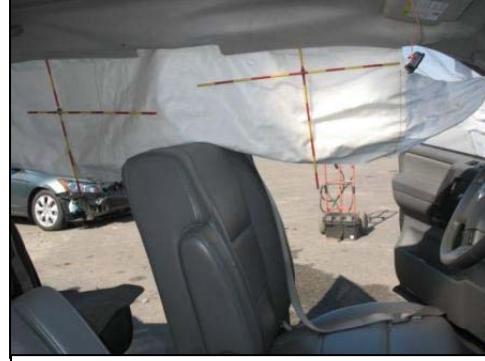
Figure 8. Deployed IC air bag in the driver's position of the Nissan.
