On-Site Certified Advanced 208-Compliant Air Bag Investigation
Dynamic Science, Inc. (DSI), Case Number DS09017
2005 Honda Odyssey
California
January 2009

Dynamic Science, Inc.
Crash Investigation
Case Number: DS09017

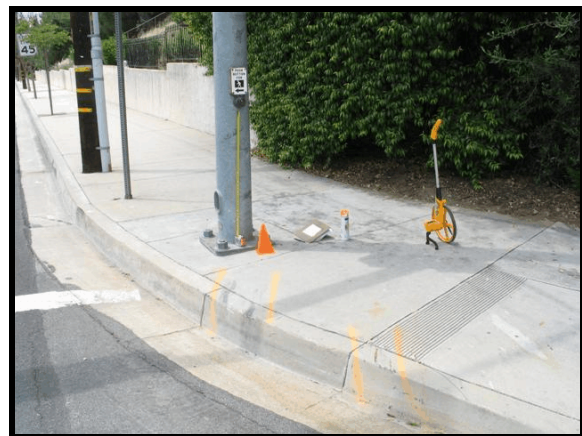
The front of the Mazda impacted the left front of the Honda. The driver's air bag in the Honda deployed during the impact. The Mazda was displaced in a southwest direction. The Honda was redirected clockwise and continued forward in a southwest direction. The Honda traveled southwest until impacting a 21 cm (8.3 in) high concrete curb and a 28 cm (11.0 in) diameter metal light pole with its front end (**Figure 4**). Left front tire marks were located on the curb and sidewalk. The marks began at the curb edge and extended approximately 40 cm (15.7 in) toward the pole. To the right of the tire marks, there was an area of scraping that was probably caused by the vehicle undercarriage. A right side tire mark was located 73 cm (28.7 in) to the right of the area of scraping. The pole was located 104 cm (40.9 in) from the curb edge, as measured along the path the vehicle traveled. The damage to the pole measured 100 cm (39.3 in) from the base of the pole upward. For the Honda's initial impact, the Missing Vehicle algorithm of the WinSMASH program computed a Total Delta-V of 18 km/h (11.2 mph) based on the final appearance of the damage. The longitudinal and lateral components were -18 km/h (-11.0 mph) and 3 km/h (1.9 mph), respectively. For the Mazda, the program computed a Total Delta-V of 26 km/h (16.2 mph). The longitudinal and lateral components were -24 km/h (-15.2 mph) and -9 m/h

Figure 4. Points of impact with curb and pole

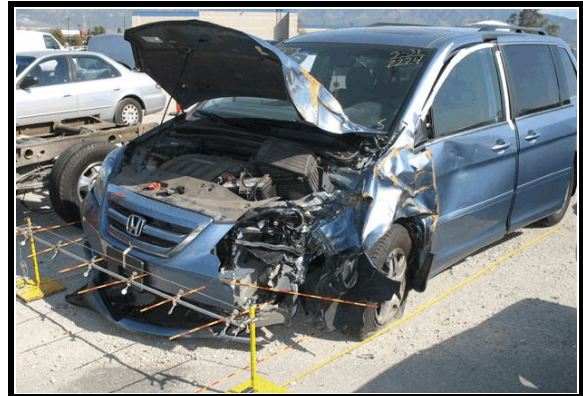
The Honda sustained moderate damage due to the impact with the Mazda and the subsequent impact with the metal pole (**Figure 5**). The direct damage began at the left front bumper corner and extended 45 cm (17.7 in) to the right. The damage between the two impacts overlapped. The pole damage included direct contact along the outboard edge of the hood and the pocketing in the left fender. The left bumper fascia was broken away and the damage bypassed the bumper backing bar. There was 195 cm (76.8 in) of direct contact along the left side of the vehicle that extended to the front row door and vertically to the A-pillar. The wheelbase on the left side was shortened by 17 cm (6.7 in). Six crush measurements were documented at bumper level; the C1 measurement was a projected point and was averaged with the above bumper crush. The crush measurements were as follows: C1 = 30 cm (11.8 in), C2 = 2 cm (0.8 in), C3 = 2 cm (0.8 in), C4 = 3 cm (1.2 in), C5 = 5 cm (2.0 in), C6 = 0 cm.

Figure 5. Left front corner damage

The Collision Deformation Classification (CDC) for the impact with Mazda was 12FLEW4, the CDC for the pole impact was 12FLEE4, and the CDC for the wheel to curb impact was 12FLWN3.

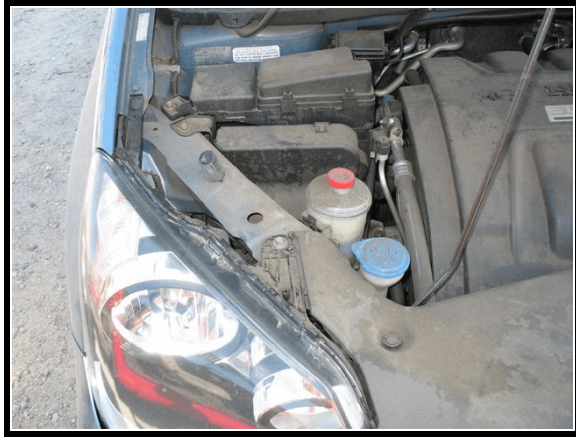
Measurements were taken to compare the damaged upper bulkhead frame on the left to the relatively undamaged upper bulkhead frame on the right (**Figures 7-8**). The frame was displaced 6 cm (2.4 in) laterally to the right at the forward aspect and 11 cm (4.3 in) at the midpoint and 17 cm (6.7 in) rearward.

Figure 7. Right upper frame

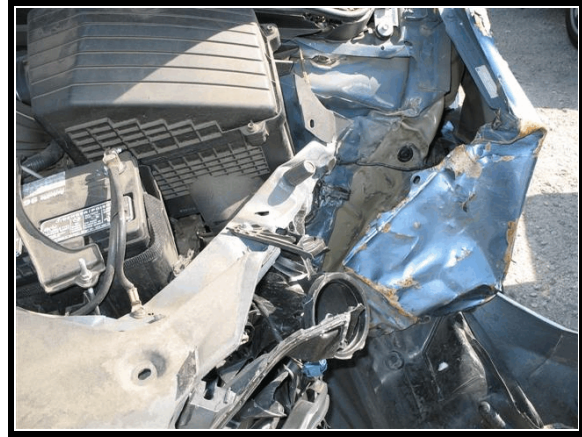
Figure 8. Left upper frame

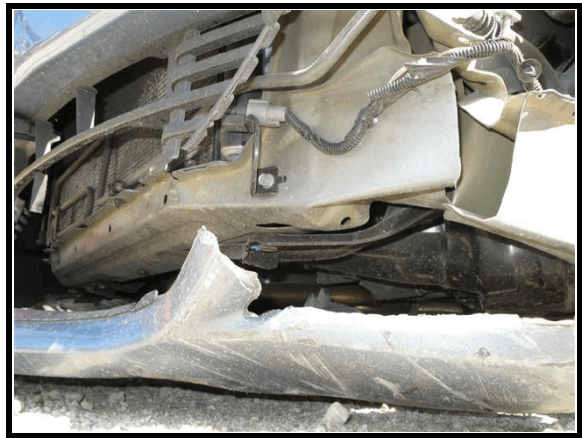
Measurements were taken to the lower frame. The left edge of the frame was fractured and displaced 14 cm (5.5 in) rearward and 12 cm (4.7 in) laterally to the right (**Figure 9**).

Figure 9. Lower frame

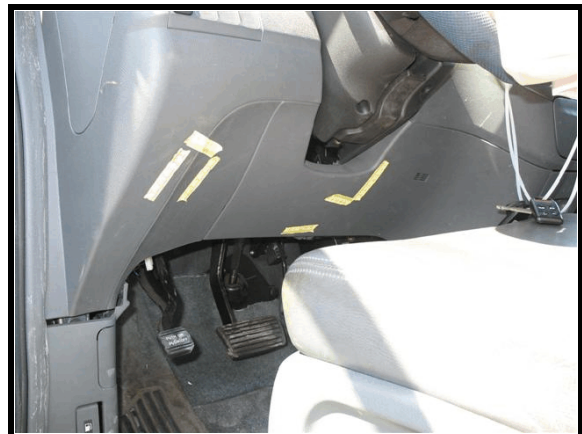
The Honda sustained minor interior damage due to intrusion and occupant contacts (**Figure 10**). There was 2 cm (0.8 in) of longitudinal intrusion to the left lower kick panel. A 4 x 6 cm (1.6 x 2.4) scuff was located 9 cm (3.5 in) left of the left instrument panel (IP) and 11 cm (4.3 in) above the bottom of the IP, a 3 x 2 cm (1.2 x 0.8 in) scuff was located right of the steering wheel column, and a 2 x 1 cm (0.8 x 0.4 in) scuff was located along the bottom edge of the IP. There was also a 2 x 4 cm (0.8 x 1.6 in) scuff located on the glove box and a 5 x 2 cm (1.9 x 0.8 in) scuff on the forward aspect of the right seat cushion.

Figure 10. Contacts to lower instrument panel

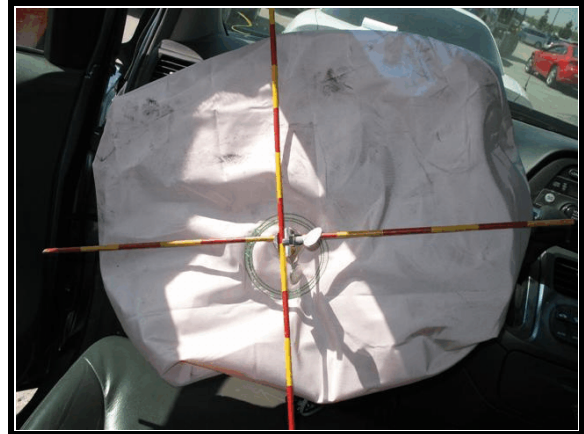
The driver's air bag deployed from the center of the steering wheel hub through H-configuration module cover flaps (**Figure 11**). The top flap measured 15 cm (6.7 in) in width and 8 cm (3.1 in) in height; the lower flap measured 15 cm (6.7 in) in width and 7 cm (2.8 in) in height. The deployed air bag measured 52 cm (20.4 in) in width in its deflated state. The air bag was tethered by two internal straps. The tethers were attached to a stitched 10 cm (3.9 in) diameter circle in the center of the air bag face. Two vent ports that measured 4 cm (1.6 in) in diameter were located at the 11 and 1 o'clock aspects on the rear of the air bag. There were areas of grease smears and scuffs over the entire upper half the air bag. There was a 33 x 9 cm (12.9 x 3.5 in) area of light scuffing on the bottom of the air bag face that was probably a result of occupant contact.

Figure 11. Driver's air bag

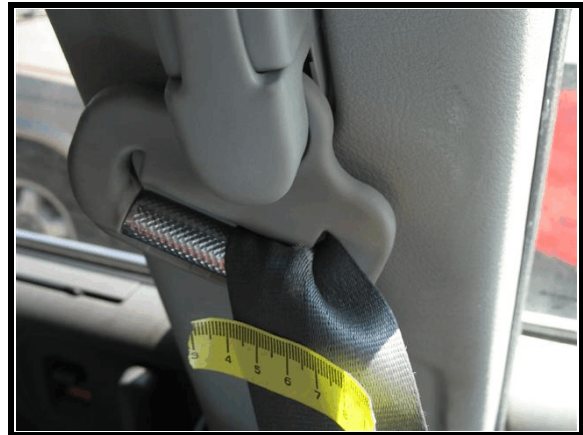
The Honda was configured with 3-point manual lap and shoulder belts for all seven seating positions. The Honda was equipped with driver and front right passenger safety belt retractor pretensions. The safety belt anchorage for the driver’s seat belt, front right passenger’s seat belt, and second row right passenger’s seat belt were in the full-down position. The anchorage for the second row left safety belt was in the mid-position. The driver’s safety belt was configured with a sliding latch plate and an Emergency Locking Retractor (ELR). The belt was locked in the used position at the time of the vehicle inspection (**Figure 12**). A scuff measuring 4 x 1 cm (1.6 x 0.4 in) was located on the belt webbing where it contacted the D-ring. Based on the evidence found during the vehicle inspection, it was determined that the safety belt was in use during the crash.

Figure 12. Driver safety belt
