ON-SITE CHILD SAFETY SEAT INVESTIGATION

CASE NUMBER - IN09018

VEHICLE - 1996 LEXUS LS 400

CRASH DATE - April 2009

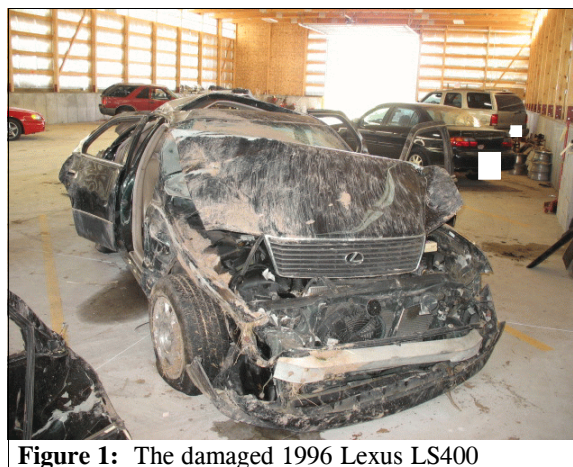
Figure 1: The damaged 1996 Lexus LS400

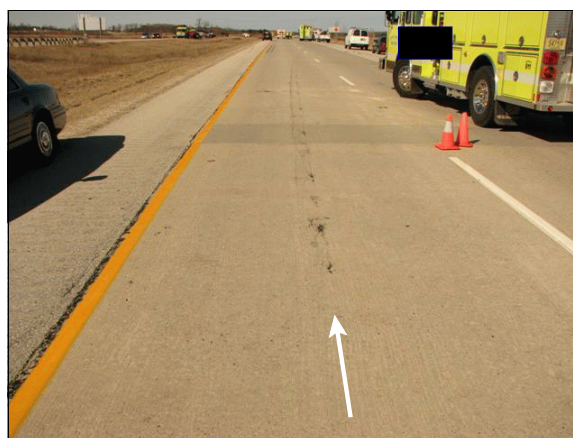
Figure 2: Police on-scene photo showing the travel lane of the Lexus and the beginning of tire marks from the left rear tire

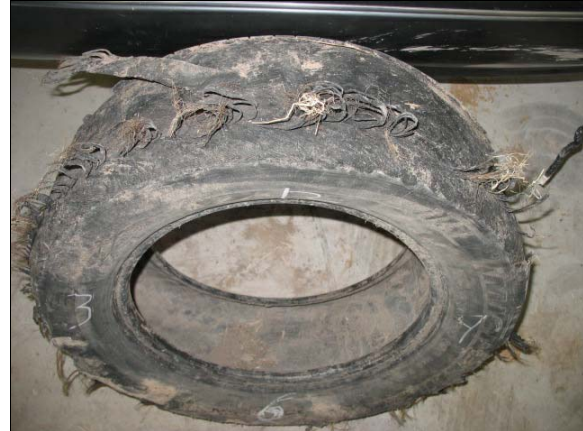
Figure 3: The tread separated from the left rear tire

Left Rear Tire Failure Discussion: The left rear tire was a Michelin Destiny (**Figure 9**) size P225/60R16. The Tire Identification Number (TIN) was M33V F7LX 2403. The left rear wheel had been removed from the vehicle by the police and they also removed the tire from the rim. The inspection of the tire revealed that the entire tread had separated from the carcass and was separated into numerous pieces. There was also a 4 cm (1.5 in) by 8 cm (3.1 in) hole in the tire carcass (**Figure 10**) located adjacent to the sidewall on the inboard side of the tire between the 12 and 3 o’clock positions. The clock positions 12, 3, 6, and 9 were written on each side of the tire as reference locations with the 12 o’clock position corresponding to the TIN (**Figure 9**). The sidewall of the tire was very weathered and cracked as were the side walls of the other tires on the vehicle. The police crash report contained information indicating that the tire may have become overheated. The police interviewed numerous witnesses who had been passed by the Lexus prior

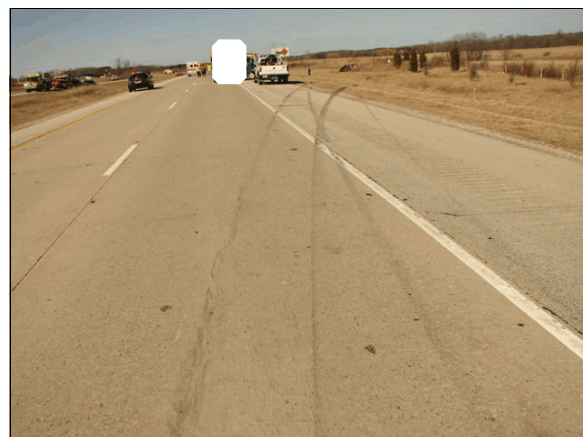
Figure 4: Police on-scene photo showing yaw marks from the Lexus as it approaches the departure point from the road; yaw marks from left to right are: left rear, left front, right rear, and right front

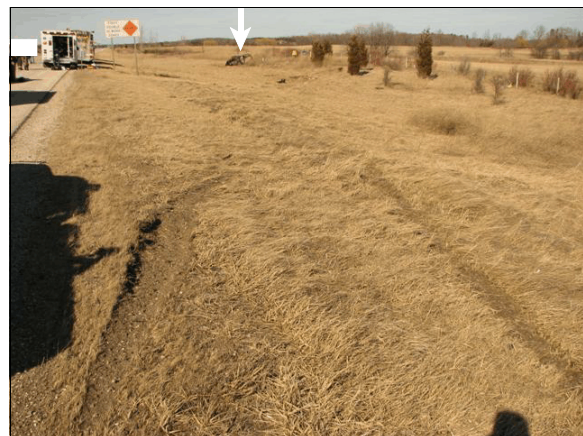
Figure 5: Police on-scene photo showing area of rollover initiation; furrow on left is from the left rear wheel; furrow on right is from the left front wheel; arrow shows the final rest position of the Lexus

The Lexus was in a clockwise rotation as it departed the east shoulder. The vehicle traveled 20 m (65.6 ft) on dry grass down a negative 10% grade to the point of rollover initiation. The vehicle had rotated 95 degrees clockwise from its initial northerly heading on the roadway when the left side wheels furrowed into the ground and the vehicle tripped and rolled over left side leading. The damage on the vehicle indicated that the end planes and both side planes impacted the ground during the rollover. The vehicle traversed a distance of 73 m (239.4 ft) from the area of rollover initiation to the final rest position. Based on the distance traversed during the rollover and the damage to the vehicle, it was estimated that the Lexus rolled over 16 quarter turns. The vehicle came to final rest on its wheels heading northeast and was located 28 m (91.8 ft) east of the outside edge of the east shoulder.

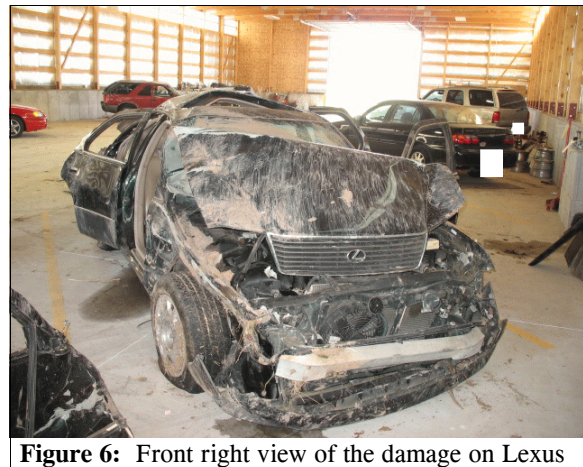
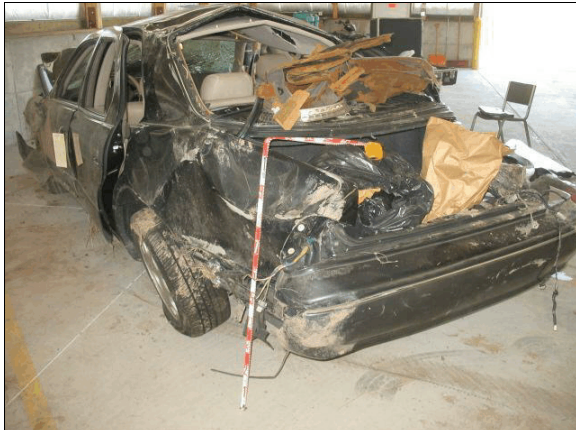
Exterior Damage: The damage from the rollover involved the entire vehicle (Figures 6 and 7). The maximum vertical crush was 11 cm (4.3 in) and occurred on the backlight header adjacent to the right C-pillar (Figure 8). The maximum lateral crush was 12 cm (4.7 in) and occurred on the right C-pillar. Both positions were located 16 cm (6.3 in) forward of the right rear axle. The direct damage width on the top plane was 117 cm (46.1 in), which involved the full width of the top plane. The right side wheelbase was reduced 2 cm (0.8 in), while the left side wheelbase was reduced 3 cm (1.2 in).

Figure 6: Front right view of the damage on Lexus

Damage Classification: The Collision Deformation Classification was **00-TDDO-3**. The WinSMASH program could not be used on this crash since rollovers are out of scope for the

program. Based on the extent of the crush on the roof, the severity of damage from the rollover was moderate.

Figure 7: Back left view of the damage on the Lexus

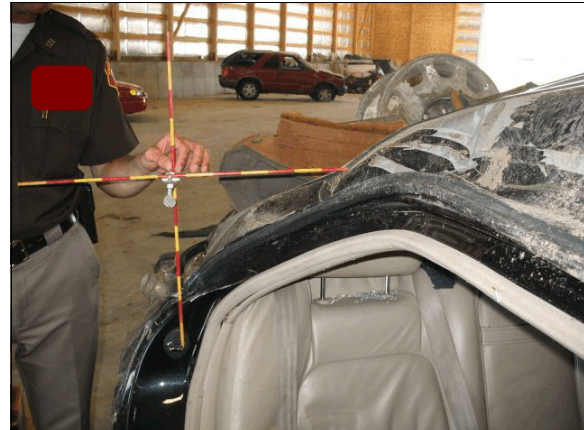
Figure 8: The maximum vertical crush occurred adjacent to the right C-pillar; the maximum lateral crush occurred on the right C-pillar

The passenger compartment sustained 10 intrusions due to the rollover. The most severe of these involved the right C-pillar, which intruded laterally 18 cm (7.1 in). The backlight header and roof at the second row right seating position both intruded vertically 12 cm (4.7 in) and 9 cm (11 in), respectively).

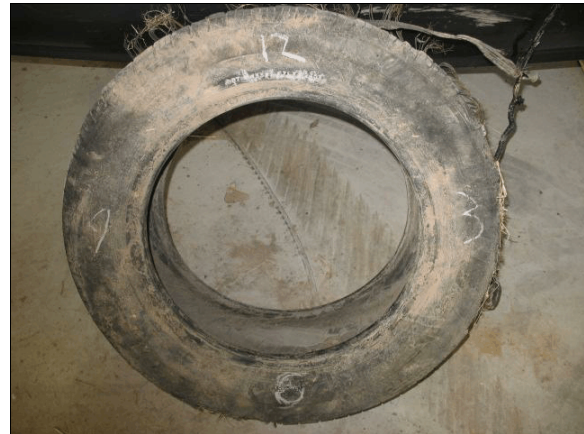
| Tire | Measured Pressure | | Vehicle Manufacturer’s Recommended Cold Tire Pressure | | Tread Depth | | Damage | Restricted | Deflated |
|---|---|---|---|---|---|---|---|---|---|
| LR | Flat | Flat | 207 | 30 | 3 | 4 | Tread separation from tire | No | Yes |

Figure 9: The left rear tire, a Michelin Destiny

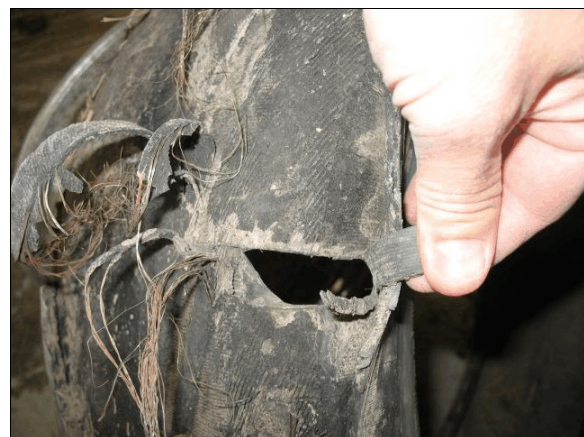
Figure 10: A hole in the tire carcass adjacent to the inside sidewall

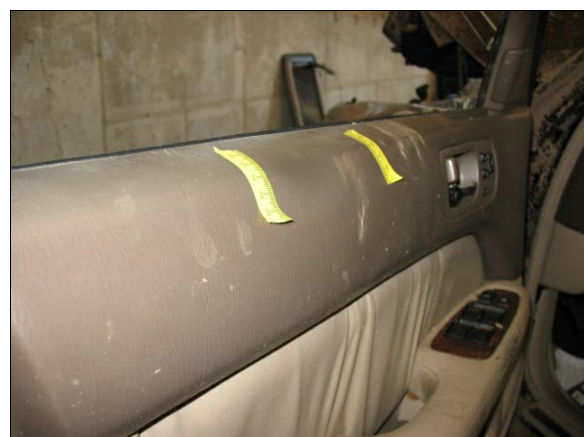
Vehicle Interior: The interior inspection revealed evidence of multiple occupant contacts in the front and second row. The left front door was slightly deformed at the beltline (**Figure 11**) and a scuff was found on the roof above the driver's seat. Scratches and scuff marks were present on the right A-pillar, the right front door just below the beltline (**Figure 12**), the right B-pillar, and the roof over the front passenger seat. Scratches were present on the window frame and the roof panel was deformed and scuffed in the second row right passenger area (**Figure 13**). Scuff marks were also present on the seat that were probably related to contact by the FSS (**Figure 14**). Scuff marks were also present on the door and roof in the second row left passenger area.

Figure 11: Area of slight deformation on the left front door

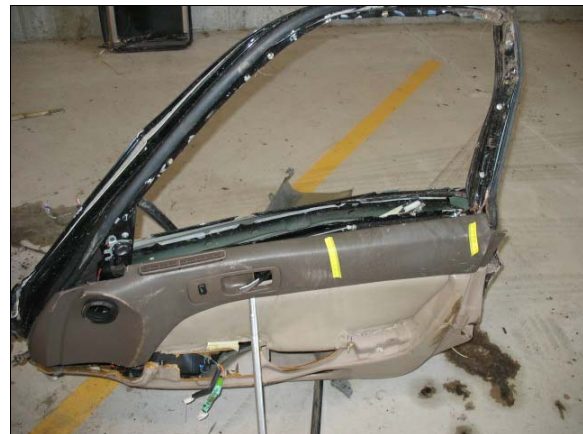
Figure 12: Yellow tape outlines scuff marks on the right front door from contact by the front passenger

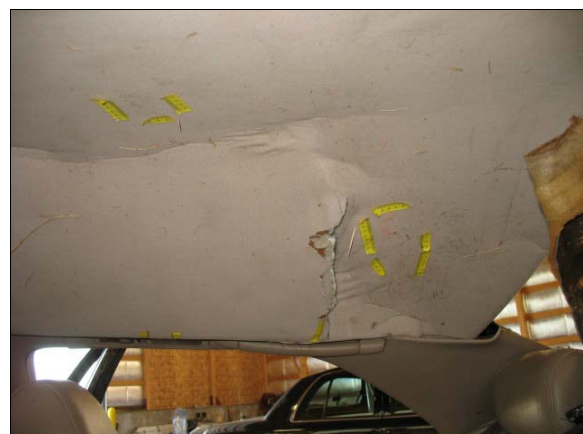
Figure 13: Scuff marks and damage on the roof at the second row right seat position

As the Lexus rotated clockwise prior to the rollover, the second row left passenger was probably displaced to the left due to the vehicle’s deceleration. The evidence within the second row seating area (**Figures 13 and 14**) indicated that the FSS probably contacted the roof and second row right seat during the rollover. The right rear window glazing was disintegrated during the rollover and the passenger was ejected through the window opening. He was found by rescue personnel still restrained in the FSS approximately 30 m (98 ft) south of the vehicle’s final rest position. He sustained critical injuries and was transported by helicopter to a children’s hospital where he expired six hours post-crash.

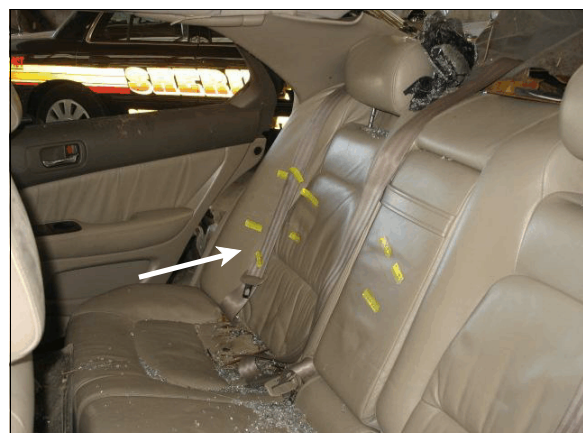
Figure 14: Arrow shows area of scuff marks on the second row right seat that were probably caused by contact with the FSS

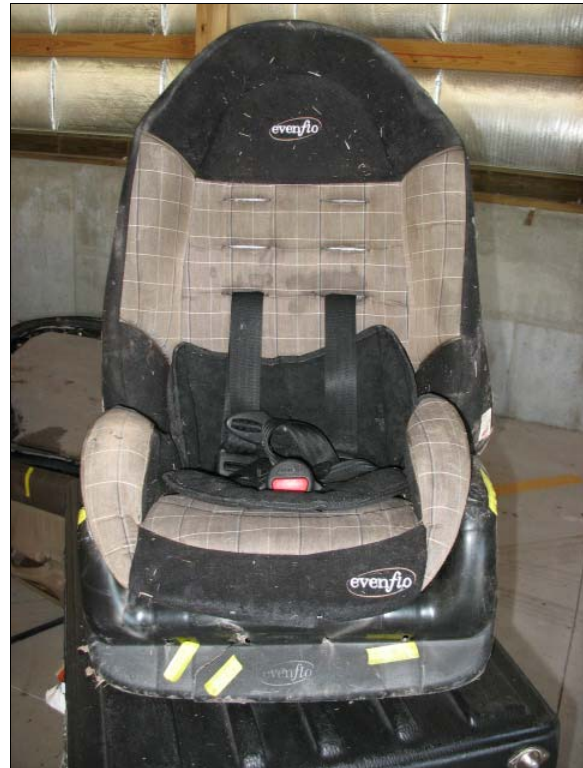
The second row right passenger [23-month-old, male (unknown height and weight)] was seated in an Evenflo Chase DLX Booster FSS that was equipped with a 5-point harness (**Figure 15**). The child's height and weight could not be determined since access to the child's medical records was denied and no autopsy was performed. The FSS was manufactured on April 22, 2008 and the model number was 3291620 L2. When the FSS was used with the 5-point harness, it was designed for children who weighed 9-18 kg (20-40 lb) and were 74-109 cm (29-43 in) in height. When used without the 5-point harness (as a belt positioning booster seat), the FSS was designed for children who weighed 13.6-45.3 kg (30-100 pounds) and who were 137 cm (54 in) or less in height and whose ears were below the top of the FSS.

Figure 15: The Evenflo Chase DLX Booster FSS

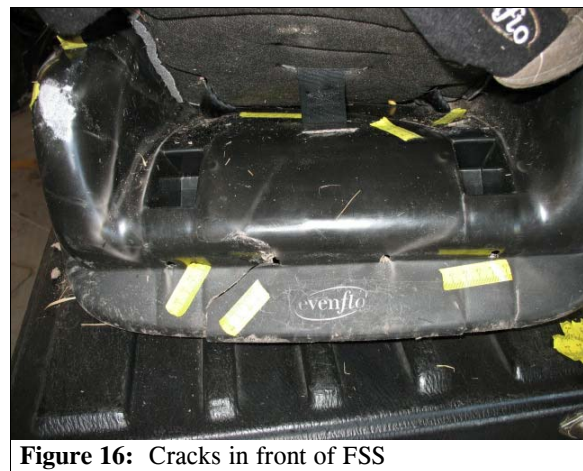
Inspection of the FSS revealed a 9 cm (3.5 in) long crack on the front (**Figure 16**). It was located 10 cm (3.9 in) to the right of the center of the FSS. A 3 cm (1.2 in) long crack was also located on the front at 10 cm (3.9 in) to the left of the center of the FSS. Load marks where the plastic had been bent were present on the seat bottom. A 6 cm (2.4 in) long crack was also

Figure 16: Cracks in front of FSS

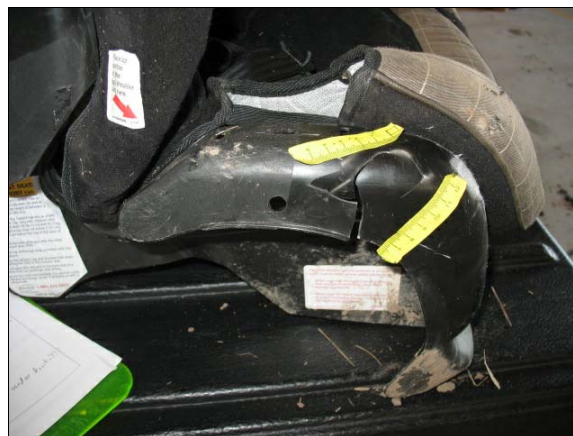
present on the seat bottom located 9 cm (3.5 in) left of the center. A 9 cm (3.5 in) long crack was present on the right arm rest (**Figure 17**). On the back side of the FSS, there was a 16 cm (6.3 in) crack on the right side, behind the seat belt guide (**Figure 18**). A small abrasion was present on the left armrest. The damage on the FSS was the result of loading that occurred during the ejection of the seat and child from the vehicle. There was no evidence that the FSS had been secured by the safety belt of the Lexus.

Figure 17: Cracks in the plastic on the right arm rest

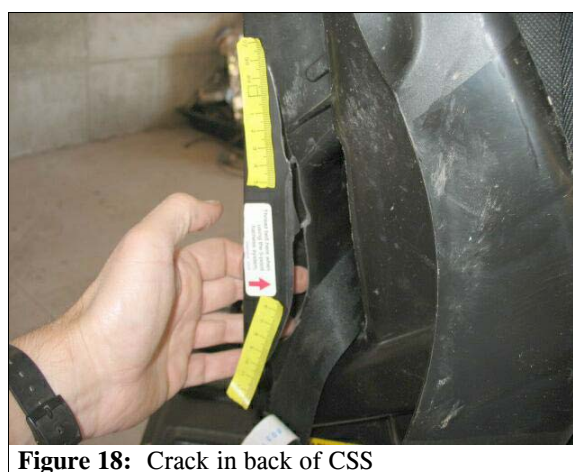
Figure 18: Crack in back of CSS
