## ON-SITE ROLLOVER INVESTIGATION

CASE NUMBER - IN09019

VEHICLE - 2006 CADILLAC SRX

CRASH DATE - April 2009

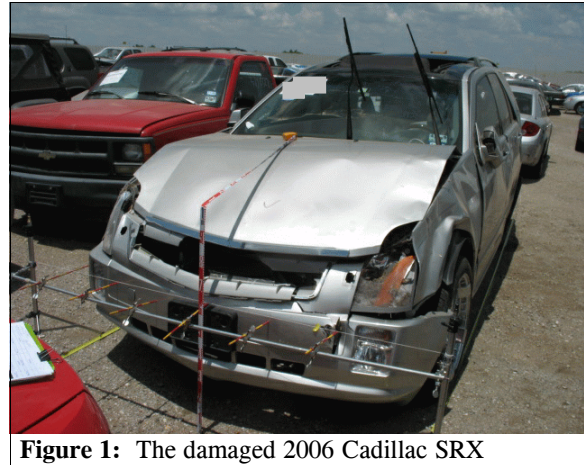
**Figure 1:** The damaged 2006 Cadillac SRX

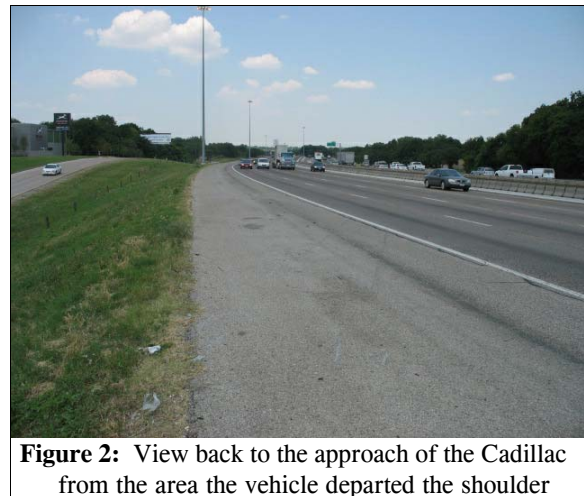
**Pre-Crash:** The Cadillac's unrestrained 61-year-old male driver was traveling east in the inside lane. According to the police crash report, the driver dropped his cellular telephone and reached down to pick it up. As a result, the driver lost directional control of the vehicle and it traveled across all the eastbound lanes of traffic toward the outside shoulder. The vehicle was equipped with Electronic Stability Control (ESC), but the driver did not regain directional control and the vehicle departed the south side of the roadway in a clockwise yaw (**Figure 2**).

**Figure 2:** View back to the approach of the Cadillac from the area the vehicle departed the shoulder

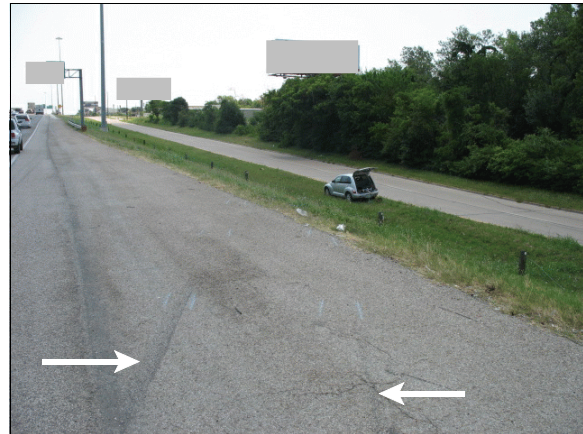
The tire mark evidence on the bituminous shoulder (**Figure 3**) indicated that the Cadillac was in a clockwise yaw as it departed the south shoulder. It probably became airborne as it traveled off the edge of the embankment and began to rollover (event 1). The damage pattern indicated that the vehicle touched down on the front plane and hood (**Figure 4**) as it rolled over in a primarily left side leading configuration. The damage on the vehicle did not support an end-over-end type of rollover since the back plane was not damaged. During the rollover the right side plane (**Figure 5**) impacted a wood post (event 2, **Figure 6**) of a single cable guardrail located adjacent to a service roadway at the bottom of the embankment. Based on the damage on the Cadillac, it was estimated that the vehicle rolled over at least 5 quarter turns. However, there was insufficient information and physical evidence to determine the specific rollover dynamics, specific

**Figure 3:** Yaw marks from the Cadillac on the shoulder and path of travel off the roadside; arrow on left shows left rear yaw mark; arrow on right shows left front yaw mark

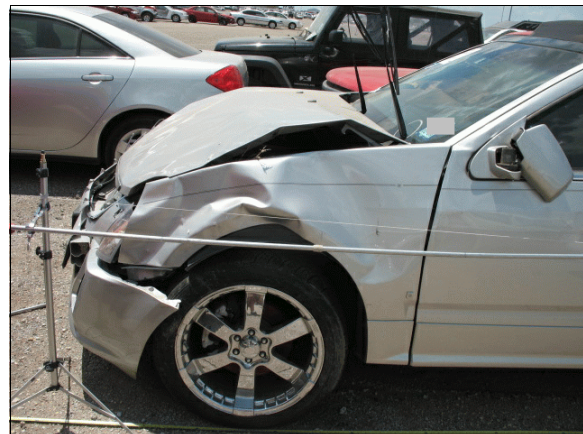
**Figure 4:** Damage on the grille, hood, and fender of the Cadillac

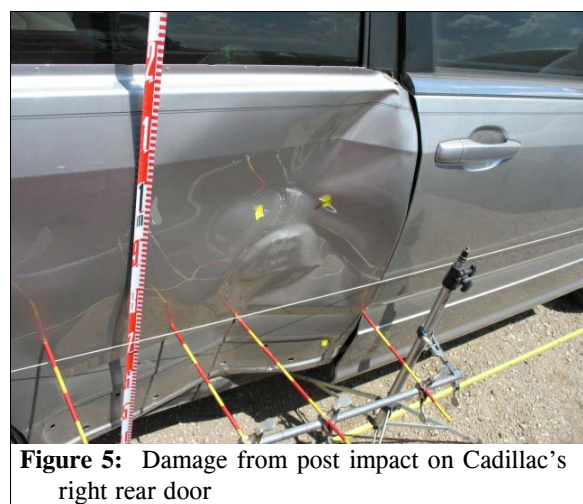
**Figure 5:** Damage from post impact on Cadillac's right rear door

Diagonal scratches that began 292 cm (115 in) rear of the left front axle extended from the roof side rail to the tail light. The direct damage on the right side plane due to the impact with the wood post began 187 cm (74 in) rear of the right front axle and extended 13 cm (5.1 in) rearward on the rear door. The maximum residual crush was 9 cm (3.5 in) occurring at C<sub>5</sub>. The table below shows the right side crush profile.

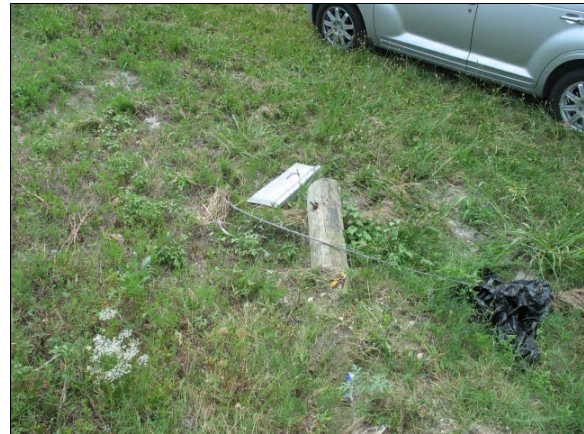
**Figure 6:** Damaged wood post

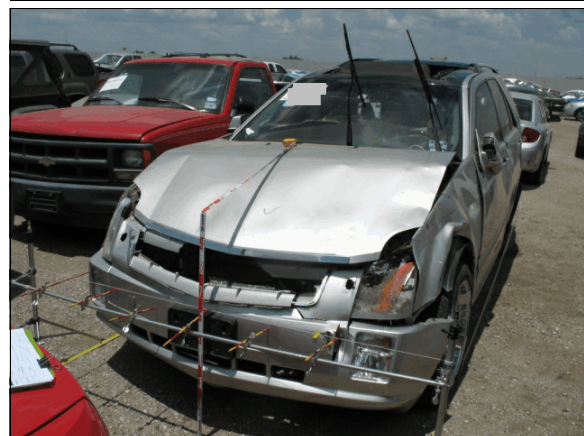
**Exterior Damage:** The damage from the rollover involved the front plane, top of the hood, and the left side plane of the vehicle (**Figures 7 and 8**). The direct damage was distributed across the entire frontal plane and hood. There was no evidence of direct damage on the roof or back plane of the vehicle. On the front bumper and grille, the direct damage began at the front left bumper corner and extended 139 cm (54.7 in). The front bumper sustained 11 cm (4.3 in) of crush at the left bumper corner. The direct damage on the left side plane (**Figure 8**) began 249 cm (98 in) rear of the left front axle and extended 141 cm (55.5 in) rearward to the back bumper corner.

**Figure 7:** Damage on the front plane, hood, and left side of the Cadillac

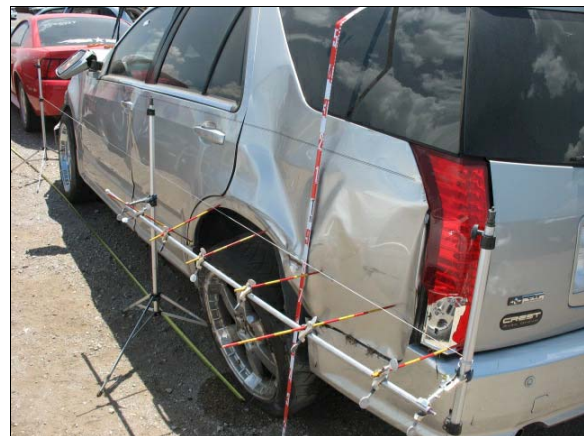
**Figure 8:** Left side damage from the rollover on the left side plane of the Cadillac

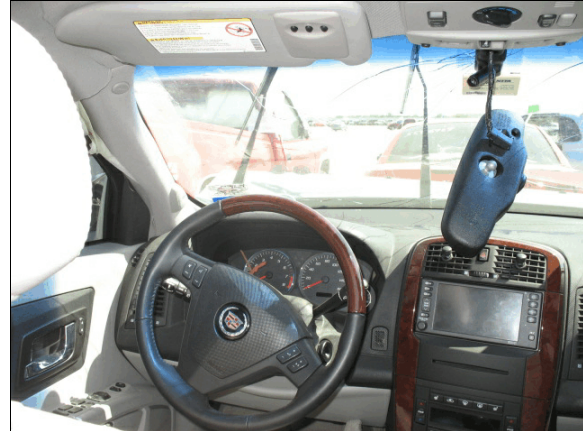
**Vehicle Interior:** The inspection of the Cadillac's interior (**Figures 9** and **10**) revealed no discernable evidence of occupant contact. There was no deformation of the steering wheel and no compression of the energy absorbing steering column.

Figure 9: The Cadillac's steering wheel, instrument panel, and windshield

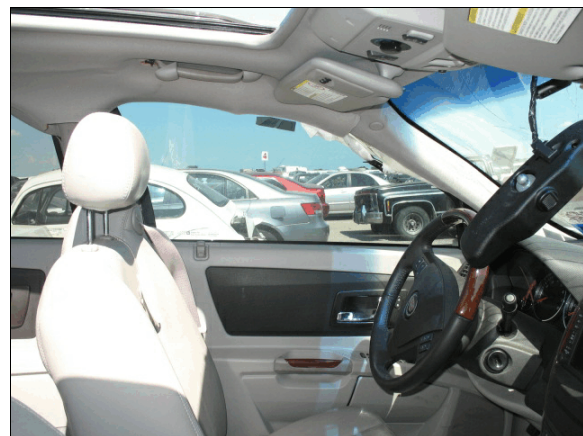
Figure 10: Cadillac driver's seating area

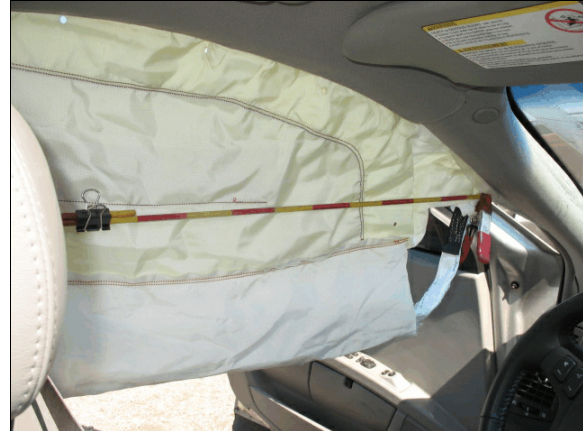
The deployed left IC air bag (**Figure 11**) was located along the left roof side rail inside the headliner and extended from the A-pillar to the C-pillar. It was designed with inflation chambers adjacent to the driver and second row left seat positions. There was also an inflatable tube at the bottom of the air bag that was 15 cm (5.9 in) in height. The ends of the tube were attached to the A and C-pillars. A cloth tether (**Figure 12**) that was 17 cm (6.7 in) in length was attached to the tube and the A-pillar. There was also a triangular shaped fabric 17 cm (6.7 in) in width and 13 cm (5.1 in) in height that attached the front of the IC air bag to the A-pillar. The deployed IC air bag was 140 cm (55.1 in) in width and 37 cm (14.6 inches) in height. There was no gap between the air bag and the A-pillar or C-pillar. The IC air bag extended 8 cm (3.1 in) below the beltline. There were no discernable evidence of occupant contact on the air bag and it did not sustain any damage. The right IC air bag was of the same dimensions and features and had no discernable evidence of occupant contact and was undamaged.

**Figure 11:** The front left portion of the Cadillac's deployed left IC air bag

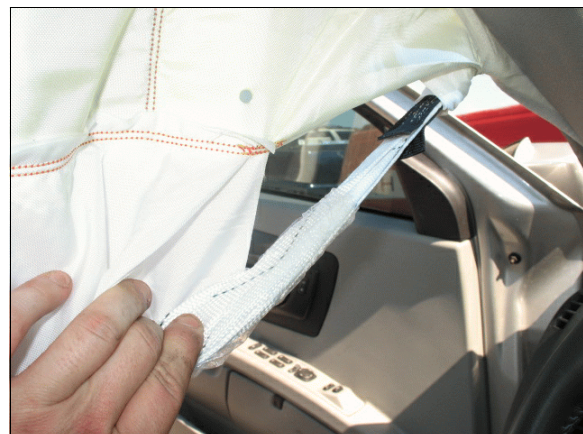
**Figure 12:** Front tether/air tube of the Cadillac's left IC air bag
