CALSPAN ON-SITE ROLLOVER CRASH INVESTIGATION

SCI CASE NO.: CA09020

VEHICLE: 2009 MITSUBISHI GALANT ES

CRASH DATE: MARCH 2009

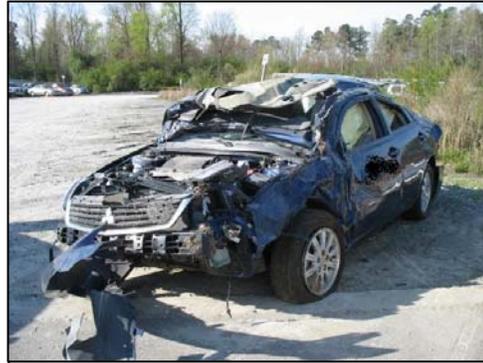
Figure 1. 2009 Mitsubishi Galant case vehicle

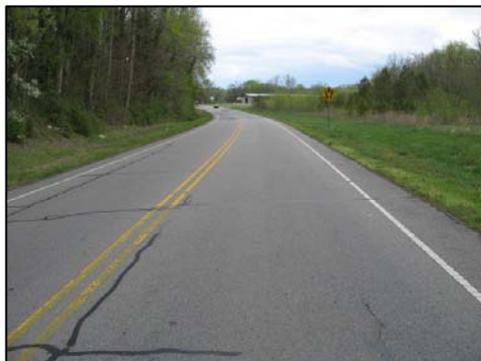
The restrained 20-year-old female driver of the Mitsubishi was traveling in a northeast direction on the two-lane roadway and entered a curve to the left (**Figure 2**). The

Mitsubishi was traveling at a police estimated speed of 145 km/h (90 mph). The vehicle departed the right side of the roadway at a shallow departure angle. The Mitsubishi traveled for approximately 155 m (508.5 ft) on the roadside, gradually entering the ditch and yawing approximately 10 degrees counterclockwise as it approached a culvert for the commercial driveway.

Figure 2: Mitsubishi's pre-crash trajectory

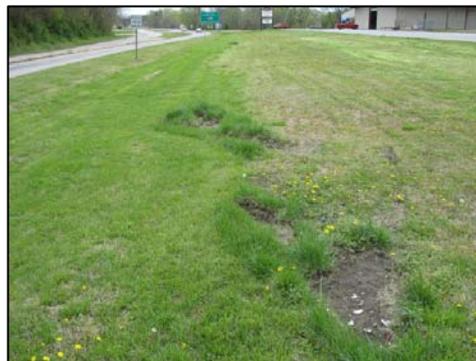
Figure 3: Start of rollover evidence on ground

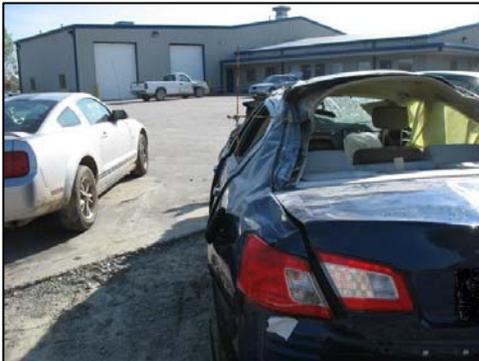
The rollover damage consisted of scratches to the roof and sides that were oriented in multiple directions, indicating that the vehicle had rotated during the rollover. The maximum crush locations for lateral and vertical crush were located at the same point on the greenhouse area, the junction of the left C-pillar and backlight header. The maximum vertical crush to the roof was 10 cm (3.9 in). The maximum lateral deformation was 6 cm (2.8 in). The direct contact damage across the roof was 112 cm (44.1 in), extending from side rail to side rail. The longitudinal contact damage extended from the front right corner to the rear right corner, a distance of 445 cm (175.2 in). **Figures 4 and 5** depict the rollover damage sustained by the Mitsubishi. The CDC assigned for this impact was 00-TDDO-3.

Figure 4: Maximum rollover crush to greenhouse

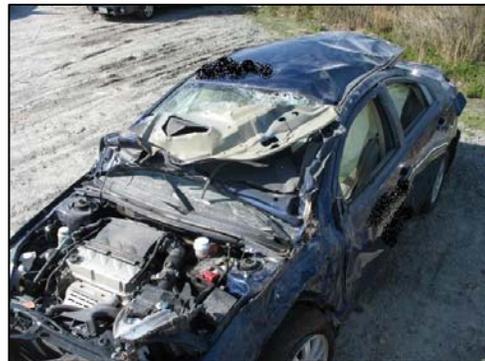
Figure 5: Rollover damage from top left

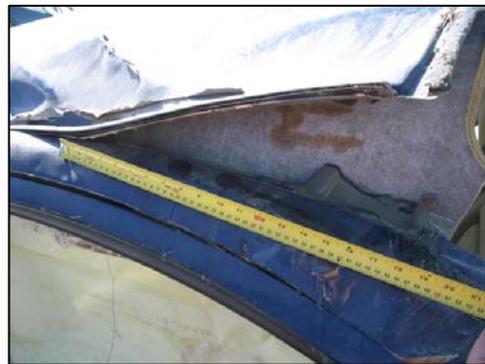
Other exterior damage occurred to the hood and top body panel. The hood latch released and the frame of the hood was displaced longitudinally into the windshield during the rollover resulting in a 10 cm by 4 cm (3.9 in by 1.6 in) hole in the windshield. The outer sheet metal skin of the hood separated from the vehicle and was unavailable for inspection. The spot welds at the rear aspect of the roof panel at the side rail separated. This resulted in a 43 cm (16.9 in) separation of the metal roof body panel from the roof side rail (**Figure 6**).

Figure 6: Partial separation of roof body panel

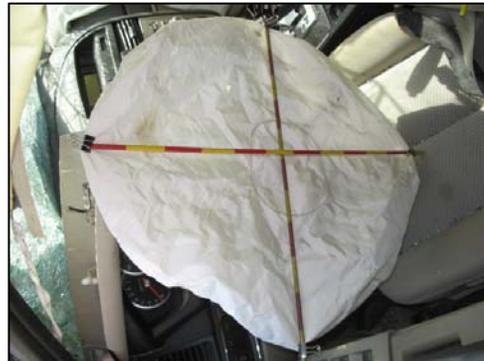
Figure 7: Deployed driver's frontal air bag

13 cm (5.1 in) in width at the horizontal tear seam and 8 cm (3.1 in) in height. The lower flap measured 13 cm (5.1 in) in width at the horizontal tear seam and 6 cm (2.4 in) in height. The air bag membrane (**Figure 7**) measured 56 cm (22 in) in diameter in its deflated state. The air bag was vented by two vent ports located at the 11 and 1 o'clock positions. The air bag was tethered by two tethers located at the 9 and 3 o'clock positions of a 13 cm (5.1 in) diameter tether seam located at the center of the face of the membrane. There were no occupant contact on the air bag; however there was a vertically oriented plastic-type deployment transfer that was 9 cm (3.5 in) in width located on the upper rear of the membrane, 6 to 11 cm (2.4 to 4.3 in) above the top cover flap.

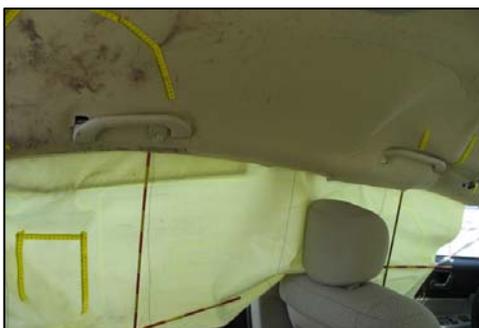
There was a scuff mark on the left IC air bag located 14 to 23 cm (5.5 to 9.1 in) above the lower edge of the membrane and 23 to 36 cm (9.1 to 14.2 in) from the rear edge of the membrane. There was a scuff on the right IC air bag located 12 to 22 cm (4.7 to 8.7 in) above the lower edge of the membrane and 19 to 27 cm (7.5 to 10.6 in) from the rear edge of the membrane. There was no damage to the IC air bags. It was probable that the deployed IC air bags prevented the potential partial ejection of an occupant's head and/or upper extremity. **Figures 8 and 9** depict the IC air bags.

Figure 8: Left IC air bag

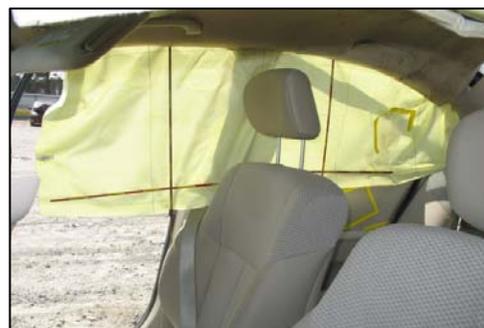
Figure 9: Right IC air bag

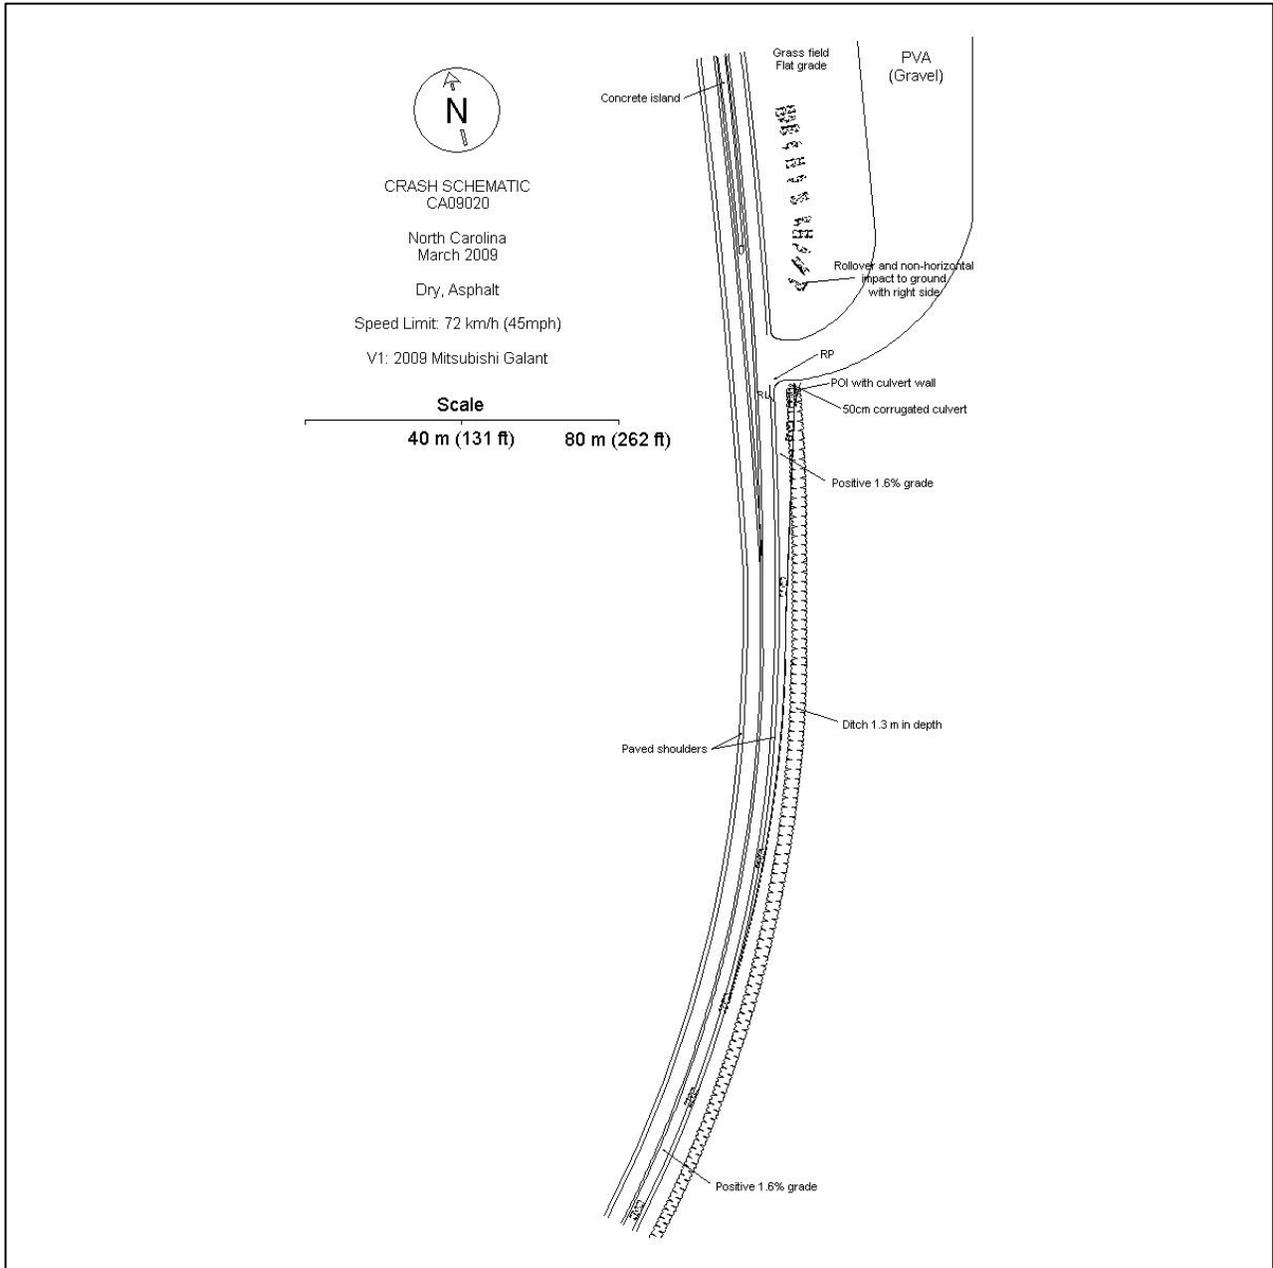
Figure 10: Crash Schematic

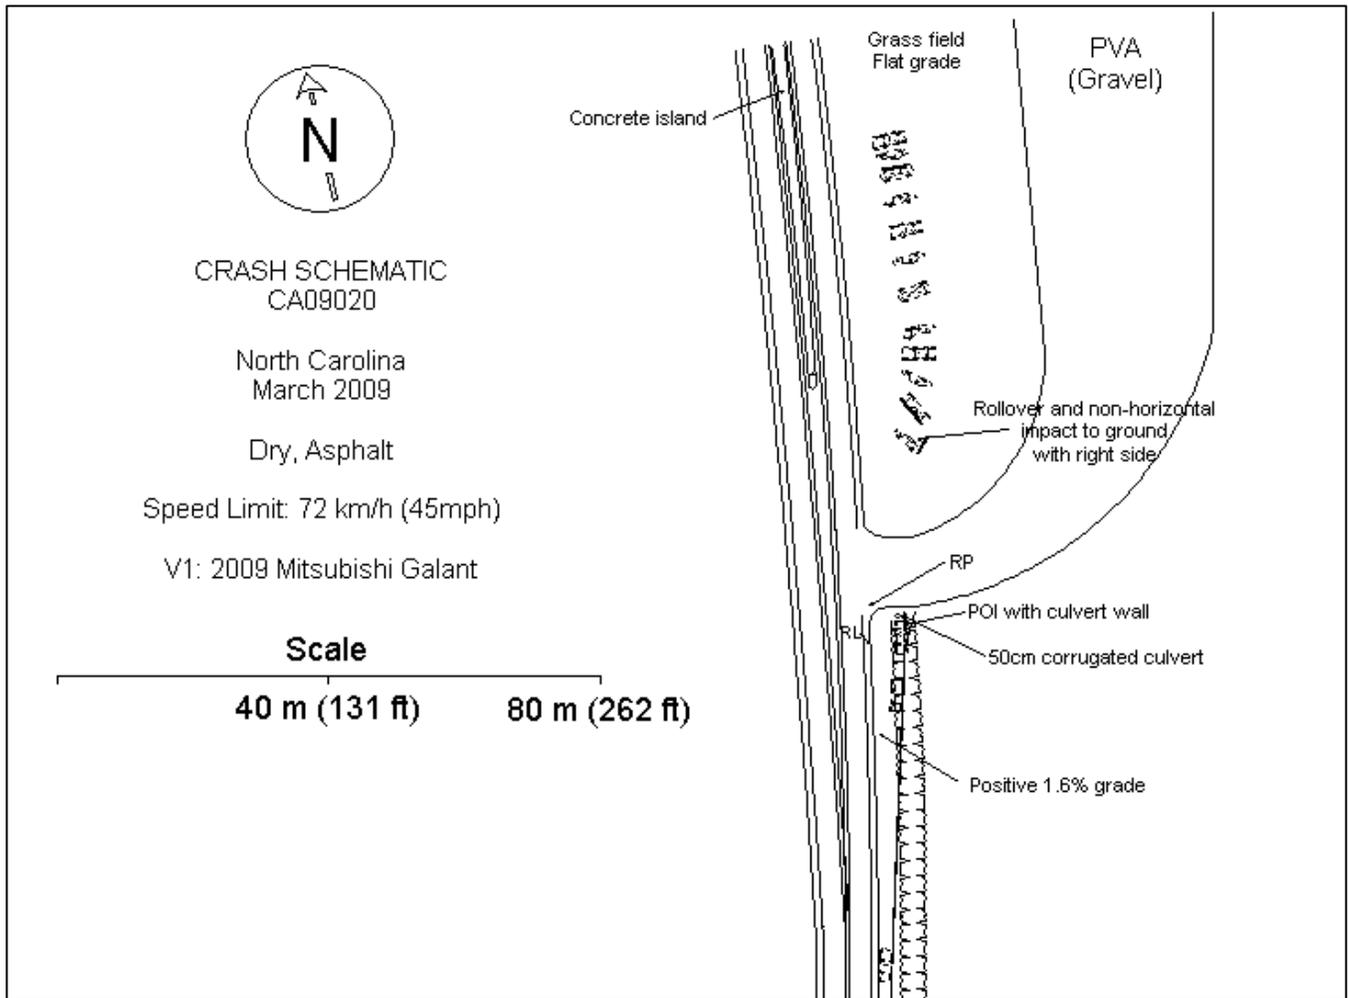
Figure 11. Crash Schematic of the Rollover Site
