CRASH DATA RESEARCH CENTER

**OFFICE OF DEFECTS INVESTIGATION
CALSPAN ON-SITE AIR BAG NON-DEPLOYMENT FATAL CRASH INVESTIGATION
SCI CASE NO: CA09022**

**VEHICLE: 2005 CHEVROLET COBALT
LOCATION: PENNSYLVANIA
CRASH DATE: APRIL, 2009**

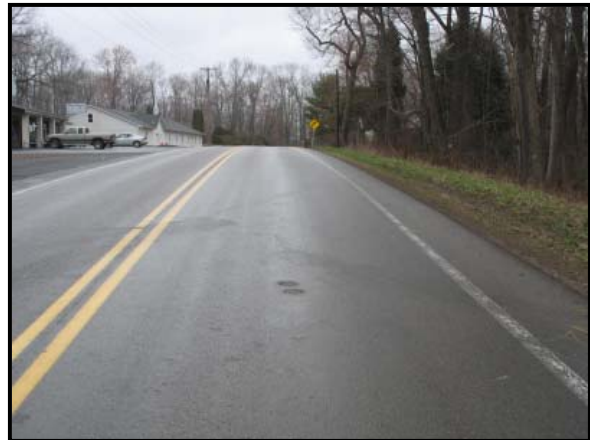
Figure 2: Eastbound trajectory view at the point of impact.

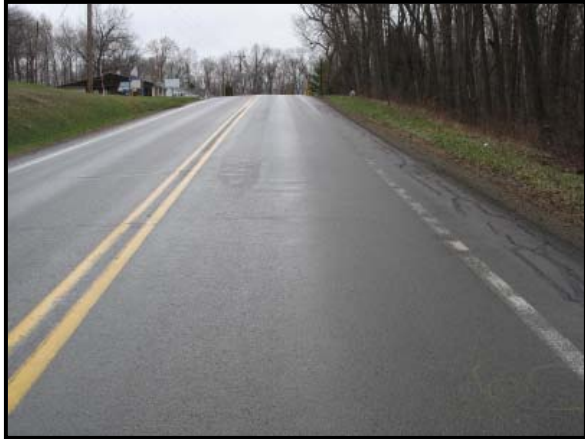
Figure 3: Eastbound approach view 90 m (300 ft) from the point of impact.

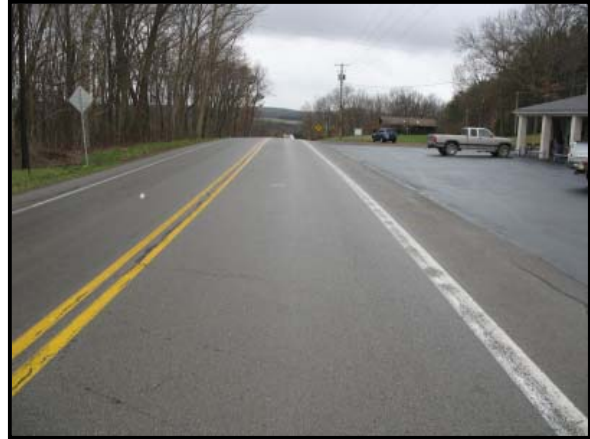
Figure 4: Westbound approach view 60 m (200 ft) from the point of impact.

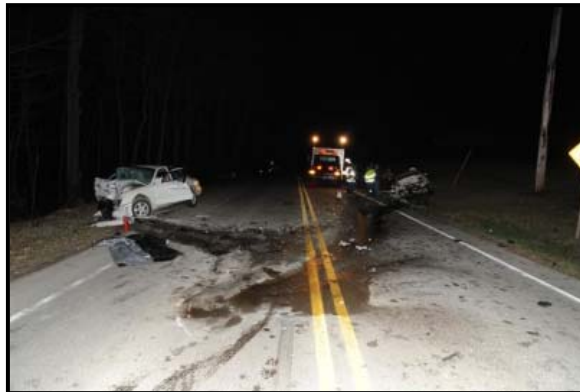
clockwise (CW) as they separated. The Hyundai rotated approximately 200 degrees clockwise and slid to rest on the south road edge. The Hyundai came to rest facing southeast 9.6 m (31 ft) from the impact. The Chevrolet rotated approximately 30 degrees CW and slid to rest on the north roadside. The vehicle slid through the road side ditch and came to rest on the back slope 17.5 m (57 ft) from the impact. **Figure 5** is an on-scene police image of the point of impact and final rest positions of the vehicles.

Figure 5: On-scene police image of the crash site.

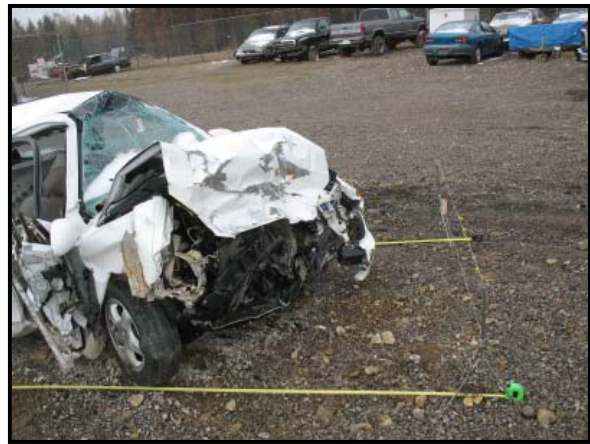
The 2001 Hyundai Sonata sustained severe frontal damage as a result of the impact with the Chevrolet (**Figures 12 and 13**). The width of the direct damage extended across the entire 147 cm (58 in) frontal end width of the Sonata. The right bias of the impact and extent of crush deformed the left front corner 23 cm (9 in) to the right. The bumper reinforcement and forward components deformed into the engine compartment. The front right wheel assembly crushed rearward into the lower A-pillar. The upper aspect of the A-pillar deformed and was near vertical. The rake angle measured 80 degrees from horizontal. The roof was buckled vertically above the front right position. The rake angle of the undeformed left upper A-pillar measured 35 degrees. The rearward displacement of the right upper shock absorber tower measured 65 cm (25.6 in). The left upper shock tower was displaced 10 cm (4.1 in). The residual frontal crush documented along the bumper reinforcement was as follows: C1 = 46 cm (18.1 in), C2 = 86 cm (33.9 in), C3 = 94 cm (37.0 in), C4 = 104 cm (40.9 in), C5 = 117 cm (46.1 in), C6 = 110 cm (43.3 in). The maximum crush was 117 cm (46.1 in) at C5. The right wheelbase was reduced 86 cm (33.8 in). The left wheelbase was reduced 12 cm (4.7 in). The front right door crushed 48 cm (19 in), bowed outboard and was jammed closed. The right rear door and the left doors remained closed during the impact. These were opened by the first responders and could not be relatched due to body deformation. The windshield was fractured. The front left and front right glazings disintegrated. The rear left, backlight and rear right glazings were intact. The CDC of the Hyundai was 12-FDEW5.

Figure 13: Right lateral view of the frontal deformation.

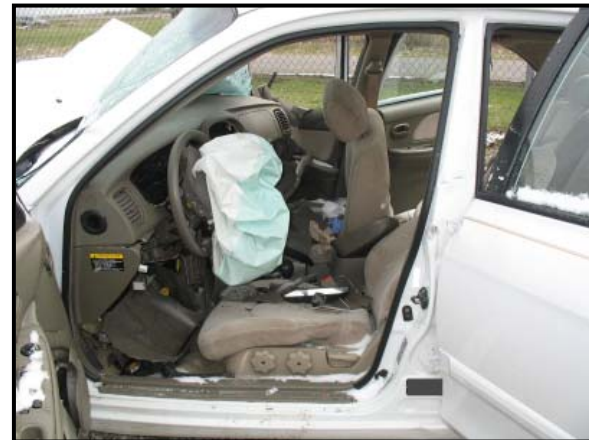
Figure 16 is a left lateral view of the driver compartment. The driver seat was adjusted to a full rear track position. The seat cushion was deformed vertically downward from driver loading. The seat back was reclined 45 degrees at the time of the SCI inspection and appeared to have been moved to that position by the first responders. The center aspect of the toe pan intruded to the brake pedal, an estimated 10 cm (4 in). There was no left instrument panel intrusion.

Figure 16: Left lateral view of the Hyundai's intrusion.

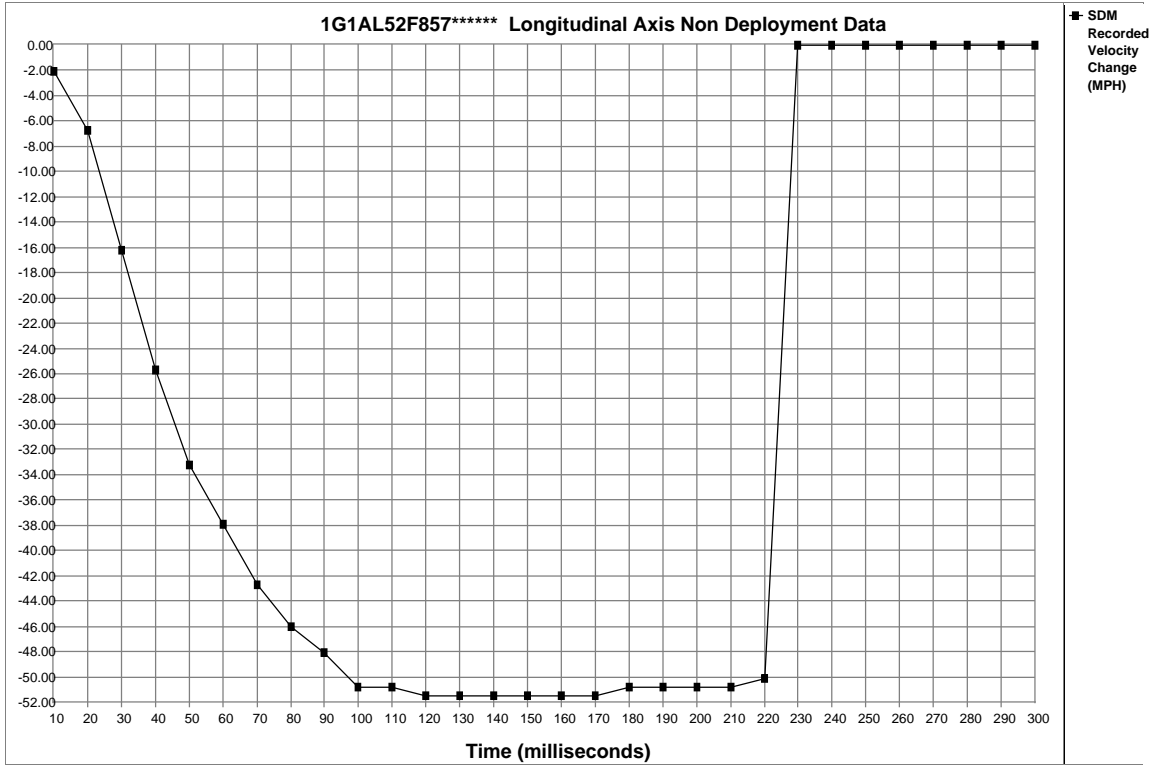
Time (milliseconds)	10	20	30	40	50	60	70	80	90	100	110	120	130	140	150
SDM Longitudinal Axis Recorded Velocity Change (MPH)	-2.03	-6.78	-16.26	-25.75	-33.21	-37.95	-42.69	-46.08	-48.12	-50.83	-50.83	-51.50	-51.50	-51.50	-51.50
Time (milliseconds)	160	170	180	190	200	210	220	230	240	250	260	270	280	290	300
SDM Longitudinal Axis Recorded Velocity Change (MPH)	-51.50	-51.50	-50.83	-50.83	-50.83	-50.83	-50.15	0.00	0.00	0.00	0.00	0.00	0.00	0.00	0.00

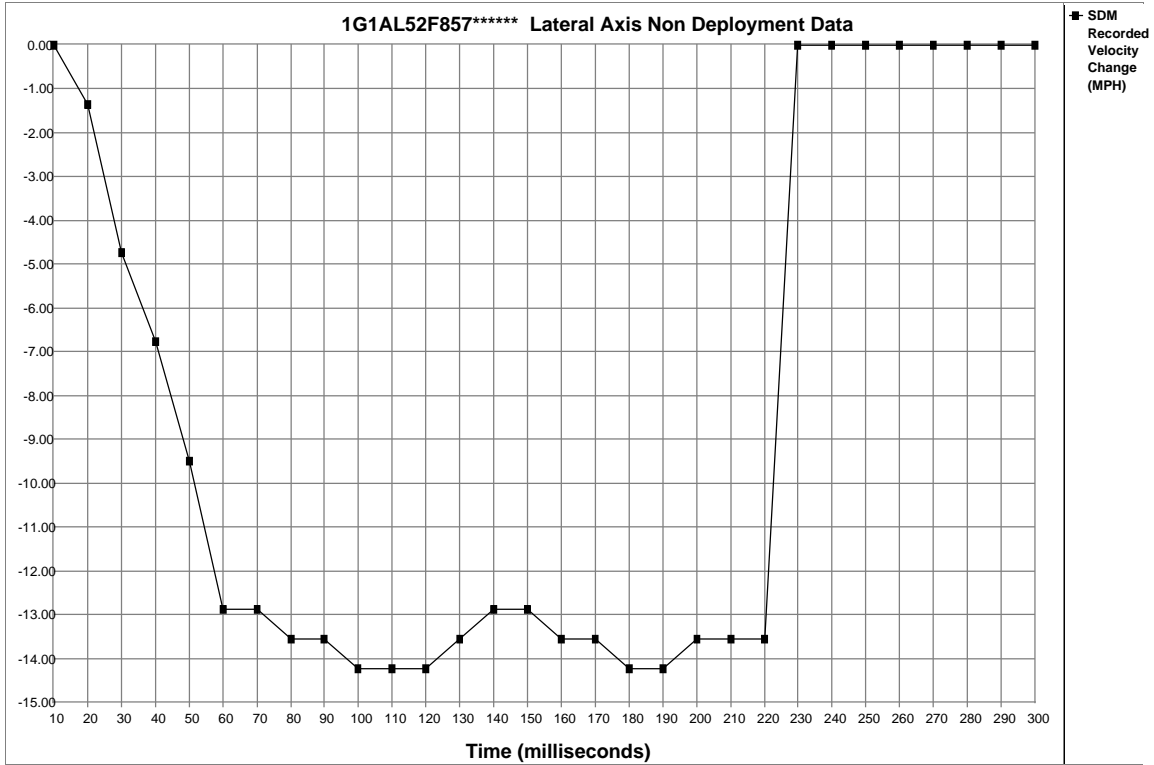
Time (milliseconds)	10	20	30	40	50	60	70	80	90	100	110	120	130	140	150
SDM Lateral Axis Recorded Velocity Change (MPH)	0.00	-1.36	-4.74	-6.78	-9.49	-12.88	-12.88	-13.55	-13.55	-14.23	-14.23	-14.23	-13.55	-12.88	-12.88
Time (milliseconds)	160	170	180	190	200	210	220	230	240	250	260	270	280	290	300
SDM Lateral Axis Recorded Velocity Change (MPH)	-13.55	-13.55	-14.23	-14.23	-13.55	-13.55	-13.55	0.00	0.00	0.00	0.00	0.00	0.00	0.00	0.00
