ON-SITE CHILD SAFETY SEAT INVESTIGATION

CASE NUMBER - IN09022

VEHICLE - 2009 KIA SPECTRA EX

CRASH DATE - July 2009

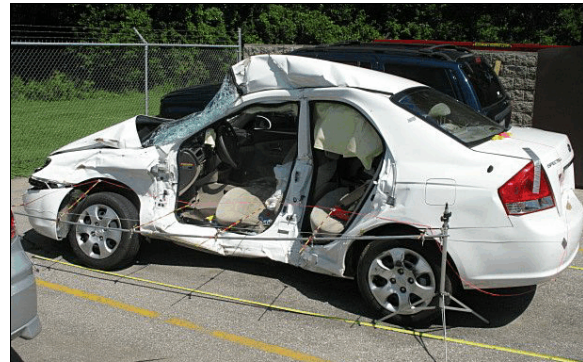
Figure 1: The damaged 2009 Kia Spectra EX

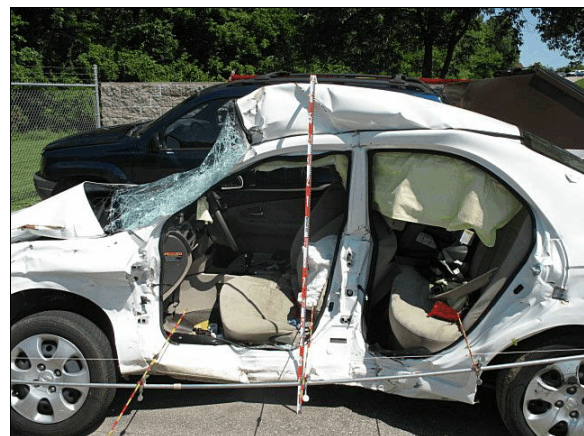
Crash: The two vehicles entered the intersection and the front plane of the Peterbilt impacted the left side plane (**Figure 4**) of the Kia. The Kia's direction of force was within the 9 o'clock sector and the impact force was sufficient to trigger deployment the driver's seat-mounted side impact air bag and the left side impact inflatable curtain (IC) air bag. Both vehicles remained engaged as they traveled approximately 26 m (85.3 ft) southwest to their final rest positions. The Kia came to final rest on the median heading northeast. The Peterbilt came to final rest with the tractor on the median heading southwest and the semi-trailer on the inside southwest lane.

Figure 4: Damage to the left side plane of the Kia from the impact with the Peterbilt; left side doors had been removed by rescue and were discarded

Exterior Damage: The impact with the Peterbilt involved the left side plane of the Kia. The left fender and both left side doors were directly damaged. The direct damage began 26 cm (10.2 in) forward of the left rear axle and extended forward 244 cm (96.1 in). The Kia's left side doors had been removed by rescue personnel and discarded. It was necessary to estimate the crush profile at C₂, C₃, and C₄ based on the remaining damaged components and experience documenting similar impacts. The crush values at C₂, C₃, and C₄ were represented against the left side door openings using a string line and the measurements rods (Figures 5 and 6). The crush measurements were taken at the mid-door level and the maximum residual crush was 67 cm (23.2 in) occurring at C₃. The induced damage involved the left fender, hood, roof, left quarter panel, trunk lid, and right side plane. The table below shows the left side crush profile.

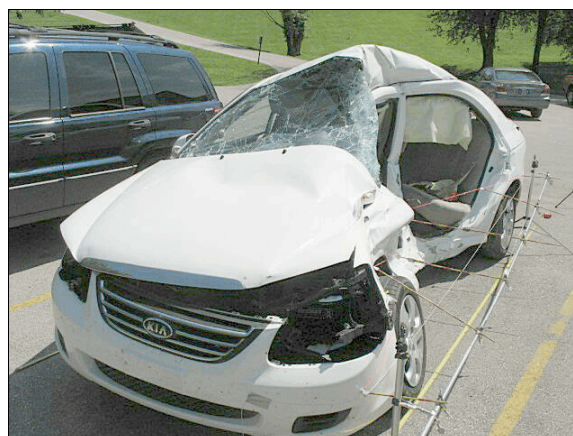
Figure 5: Front left view of Kia's left side crush profile

Damage Classification: The Collision Deformation Classification was **09-LYAW-5 (270 degrees)**. The WinSMASH program could not be used to calculate the Kia's Delta V because an impact with a heavy truck is out of scope for program. The Damage Algorithm of WinSMASH

was used to calculate a Barrier Equivalent Speed (BES). The calculated BES was 68 km/h (42.3 mph).

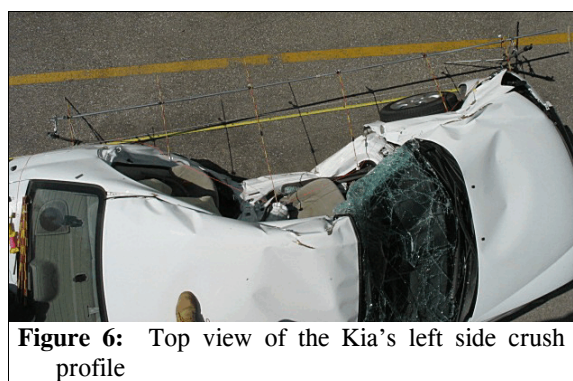
Figure 6: Top view of the Kia's left side crush profile

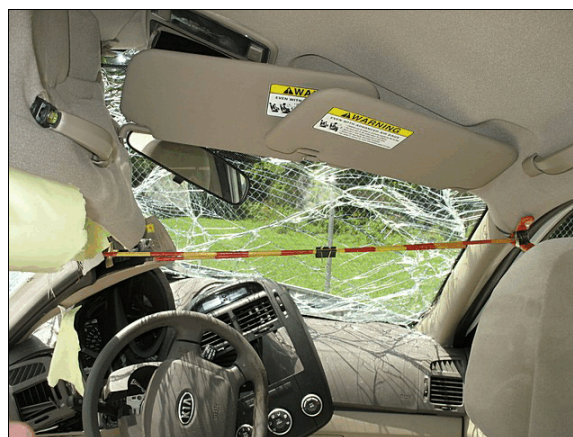
The vehicle’s passenger compartment sustained 21 intrusions due to the left side plane impact. The most severe intrusions into the driver’s space involved the lower rear quadrant of the left front door, left B-pillar, left A-pillar, and the left roof side rail (**Figure 7**). The extent of the left front door’s lateral intrusion was estimated to be approximately 45 cm (17.7 in), while the left B-pillar, A-pillar, and left roof side rail intruded laterally 45 cm, (17.7 in), 31 cm (12.2 in), and 26 cm (10.2 in), respectively. The most severe

Figure 7: Left A-pillar and roof side rail intrusion into the driver’s occupant space

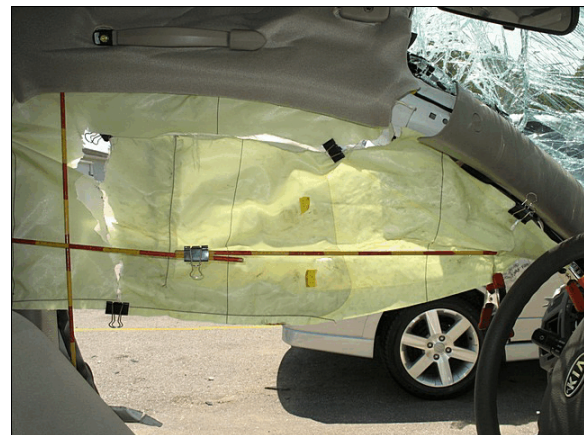
The left IC air bag was located along the left roof side rail (**Figures 8 and 9**) inside the headliner and extended from the A-pillar to the C-pillar. The IC air bag was designed with inflation chambers adjacent to the driver and second row left seat positions. There were no external vent ports. The deployed IC air bag was 170 cm (66.9 in) in width, 34 cm (13.4 inches) in height, and extended approximately 9 cm (3.5 in) below the beltline. It was attached at the A-pillar by a 4 cm (1.6 in) cloth tether. There was no visible tether at the C-pillar. There was no gap between the front of the IC air bag and the A-pillar. The fold creases on the air bag indicated that it had been folded accordion fashion within the headliner. Inspection of the deployed air bag revealed that an approximate 70 x 25 cm (27.6 x 9.8 in) section adjacent to the left front seat had been cut out of the air bag, probably during extrication of the driver. There was no evidence of crash related damage on the inside surface of the air bag. A hole and a tear were located on the lower outside surface of the IC air bag (**Figure 10**) located 33 cm (13 in) and 50 cm (19.7 in) rearward of the front of IC air bag. This damage was probably the result of contact by the front of the Peterbilt.

Figure 8: Front portion of the Kia's left IC air bag

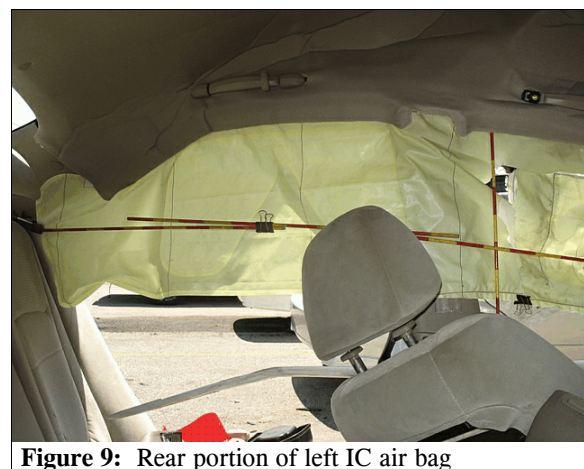
Figure 9: Rear portion of left IC air bag

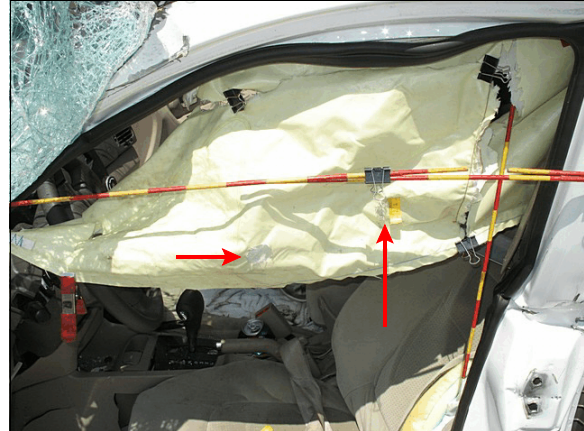
Figure 10: Arrows show a hole and tear in the IC air bag, probably due to contact by the front grille of the Peterbilt

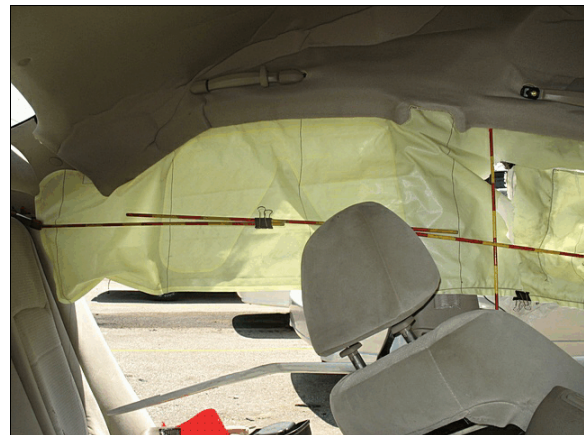
Two possible occupant contact scuffs were located adjacent to the left front seat position 30 cm (11.8 in) rear of the front of IC air bag and 15 cm (5.9 in) and 25 cm (9.8 in) below the top of the air bag. There was no discernable occupant contact evidence on the air bag adjacent to the second row left seat position (**Figure 11**).

Figure 11: Rear portion of left side curtain air bag

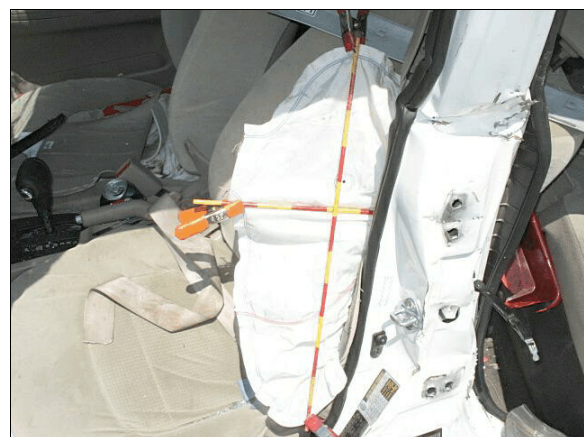
The driver's seat-mounted side impact air bag was located in the outboard side of the seat back and deployed through a tear-seam. The deployed air bag (**Figure 12**) was 22 cm (8.7 in) in width and 56 cm (22 in) in height and was designed with one vent port located on the front edge. There was a single circular tether where both sides of the air bag were sewn together located 20 cm (7.9 in) below the top of the air bag. A line of stitching located 20 cm (7.9) above the bottom of the air bag extended across the width of the air bag. There was no discernable evidence of occupant contact on the air bag. A small area of damage was present on its outboard surface. The damage consisted of small holes and was probably the result of contact by flying glass fragments from the disintegrated left front window. The area of damage was located 10 cm (3.9 in) from the top of the air bag.

Figure 12: The left front seat back-mounted side impact air bag

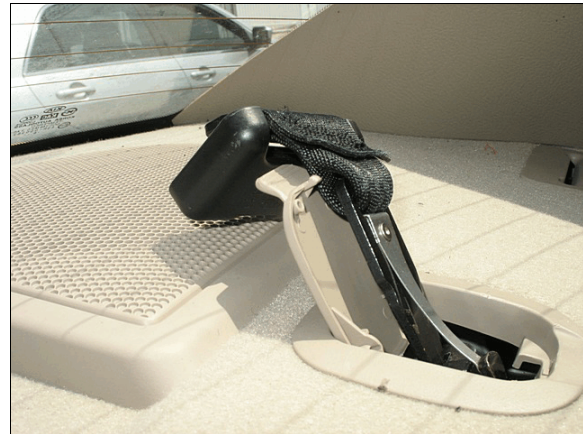
The inspection of the second row left safety belt assembly revealed that the belt webbing had been cut in two places. The latch plate was in the buckle and the cut piece of belt webbing was in the latch plate belt guide. The CSS's top tether strap had been cut and the tether clip was latched to the vehicle's upper tether anchor (**Figure 13**). Based on this evidence and the SCI interview with the driver's husband, the second row left passenger's CSS was secured in the vehicle by the tether strap and the vehicle's lap-and-shoulder belt, which was routed through the forward-facing belt path on the back of the CSS. The interviewee reported that the seat belt retractor was switched to ALR mode to secure the CSS in the vehicle and the passenger was restrained by the 5-point harness. The CSS's lower LATCH straps were not used.

Figure 13: The second row left CSS tether clip was found latched to the upper tether anchor

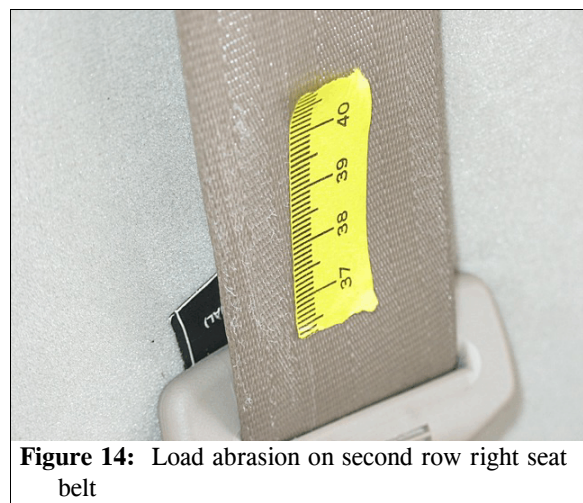
Figure 14: Load abrasion on second row right seat belt

The inspection of the second row right safety belt assembly revealed a load abrasion 5 cm (2 in) in length on the belt webbing (**Figure 14**). The abrasion was located 13 cm (5.1 in) above the seat cushion with the safety belt in the retracted position. Based on this evidence and the SCI interview with the driver's husband, the second row right passenger's CSS was secured in the vehicle by the lap-and-shoulder belt. The safety belt retractor was switched to ALR mode to secure the CSS in the vehicle and the passenger was restrained by the 5-point harness. The interviewee did not know if the CSS was equipped with a LATCH system.

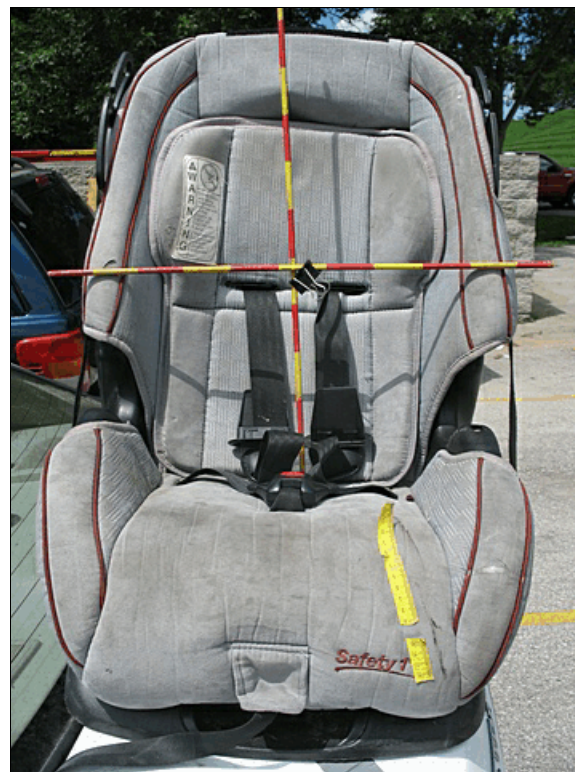
The Kia's second row left passenger [16-month-old, male; 81 cm (32 in) and 13 kg (29 lbs)] was seated in a Safety 1st All-in-One convertible CSS (**Figure 15**). It was located in the second row of the vehicle at the time of the inspection. The CSS was manufactured on March 19, 2007 and the model number was 22-152-BVL. The CSS was equipped with a LATCH system and a 5-point harness. There was no harness retainer clip present at the time of the inspection. Based on the SCI interview, a harness retainer clip was in use at the time of the crash, but its position on the child is not known. The CSS was used in the forward facing position. When used in this

Figure 15: The second row left CSS: Safety 1st All-in-One

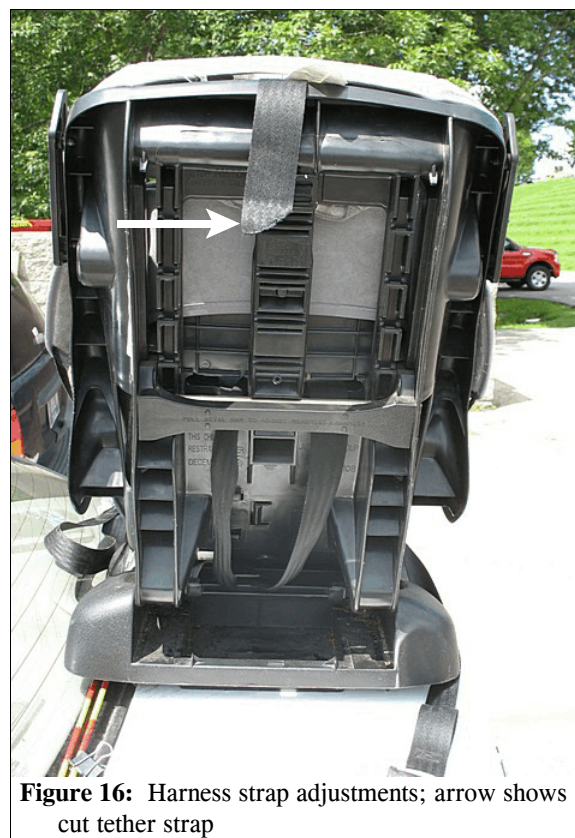
The CSS was constructed of a one-piece plastic shell with a non-detachable base and had a 1 cm (0.4 in) thick padded fabric cover and a reclining seat back. The seat back was adjusted to the upright position. The CSS was equipped with a sliding harness strap adjustment with 5 settings. The harness straps were adjusted to the lowest position (**Figure 16**).

Inspection of the CSS revealed a few stress marks on the left side and front left corner of the shell from contacting the left rear door during the crash. The plastic belt guides for the harness straps were also detached. The top tether strap had been cut (**Figure 16**) and the tether clip was found latched to the vehicle's upper tether anchor (**Figure 13**). There were no discernable occupant contact marks on the CSS.

Figure 16: Harness strap adjustments; arrow shows cut tether strap
