Rollover Investigation
Dynamic Science, Inc. (DSI), Case Number DS09023
2008 Smart Fortwo Coupe
California
February 2009

Dynamic Science, Inc.
Crash Investigation
Case Number: DS09023

This on-site investigation focused on the dynamics of a 2008 Smart Fortwo coupe that was involved in a rollover crash (**Figure 1**). The crash occurred on February 2009 at 0130 hours in California. The crash occurred on a six-lane divided state highway. On the right side of the roadway there was a set of traffic barrels protecting a concrete traffic barrier. North of the barriers was a 2000 Smart Monitoring Awareness Radar Trailer (SMART). The device is a self-contained speed display that is towed to sites to promote compliance with the speed limit.

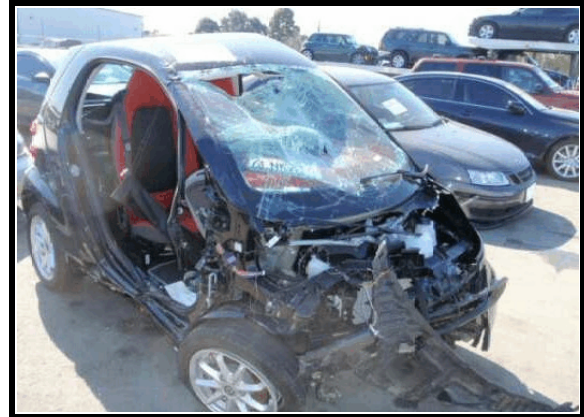
Figure 1. Right front, Smart Fortwo

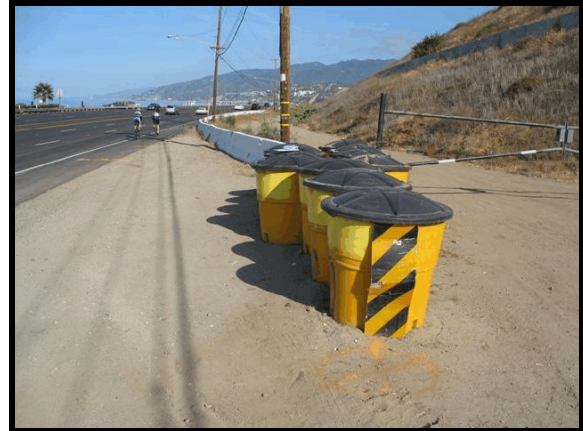
The right front of the Fortwo impacted the first and probably the second barrel (**Figure 4**). The Damage algorithm of the WinSMASH program computed a Total Delta-V of 23 km/h (14.3 mph). The longitudinal and lateral components were -23 km/h (-14.3 mph) and 0 km/h, respectively. The results were borderline because of the yielding nature of the traffic barrels. The driver's frontal air bag deployed during the impact. The Fortwo began a clockwise rotation and, after rotating approximately 45 degrees, it impacted the radar trailer. The driver's seat-mounted side air bag deployed during this impact. The trailer was displaced forward and the Fortwo continued the rotation until reaching a 90 degree angle relative to its original path of travel where it tripped and began a left side leading rollover. The Fortwo rolled two quarter-turns and struck the radar trailer with its right side. The vehicle rolled one additional quarter-turn before coming to rest on its right side.

Figure 4. Area of impact with barrels and rollover

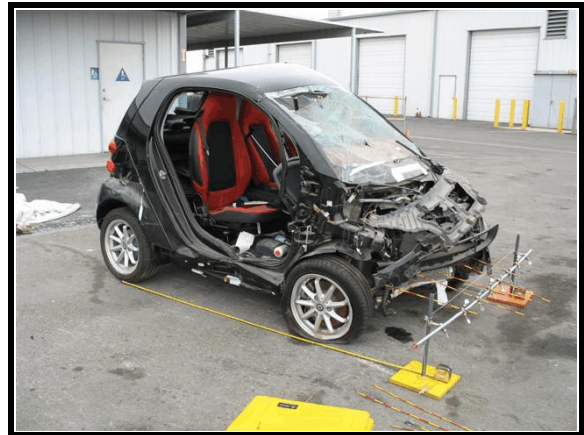
The Fortwo sustained moderate front end damage as a result of the initial impact with the traffic barrels (Event 1). The damage began at the right front bumper corner and extended 70 cm (27.5 in) to the left (**Figure 5**). The right side wheelbase was shortened by 14 cm (5.5 in). The right front wheel was damaged; 7 of the 9 spokes on the aluminum wheel were fractured. Six crush measurements were taken at the bumper level as follows: $C_1 = 0$ cm, $C_2 = 1$ cm (0.4 in), $C_3 = 4$ cm (1.6 in), $C_4 = 10$ cm (3.9 in), $C_5 = 20$ cm (7.9 in), $C_6 = 29$ cm (11.4 in). The Collision Deformation Classification (CDC) for the impact with the barrels was 12FZEW4.

Figure 5. Frontal damage and crush measurement

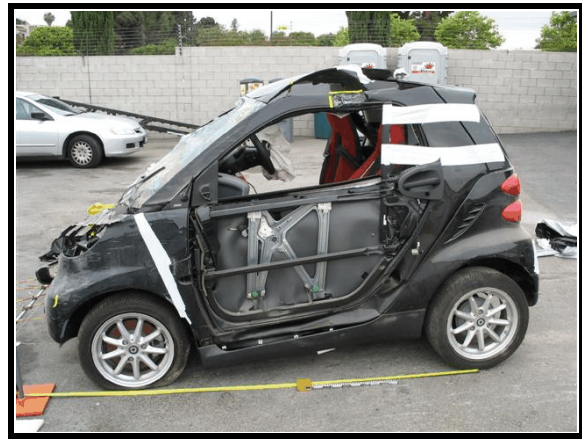
rollover (Event 3). The direct contact to the left side of the vehicle began at the front bumper corner and extended 71 cm (27.9 in) rearward to the door opening (**Figure 6**). There was 90 cm (35.4 in) of direct contact that extended from the A-pillar into the roof side rail. On the right side of the vehicle, there were scratches that began 23 cm (9.0 in) forward of the rear bumper corner and extended 37 cm (14.6 in) forward. The scratches extended to a height 89 cm (35.0 in) above the ground. There was also 51 cm (20.0 in) of direct contact along the right A-pillar. The roof damage began at the right windshield header and measured 51 cm (20.0 in) in width by 21 cm (8.3 in) rearward (**Figure 7**). The transparent polycarbonate roof was cracked. The crack was L-shaped and measured 85 cm (33.5 in) along the left roof side rail and 68 cm (26.8 in) laterally from left to right. The crack formed an opening 56 cm (22.0 in) in length and 9 cm (3.5 in) in height. The maximum vertical crush was located at the right A-pillar and measured 2 cm (0.8 in). The CDC for the rollover was 00TPZO1.

Figure 6. Left side damage

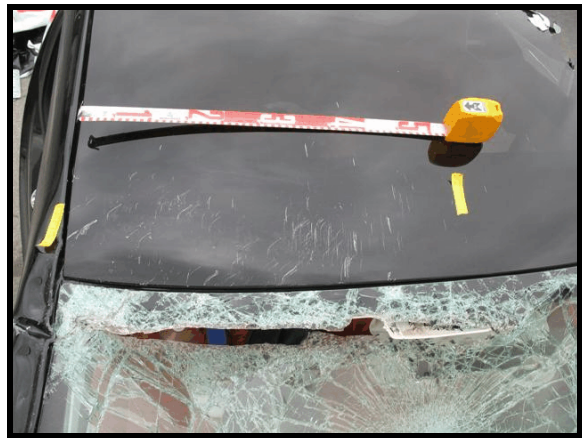
The vehicle sustained direct and induced damage to the left and right sides and the roof during the

Figure 7. Top rollover damage

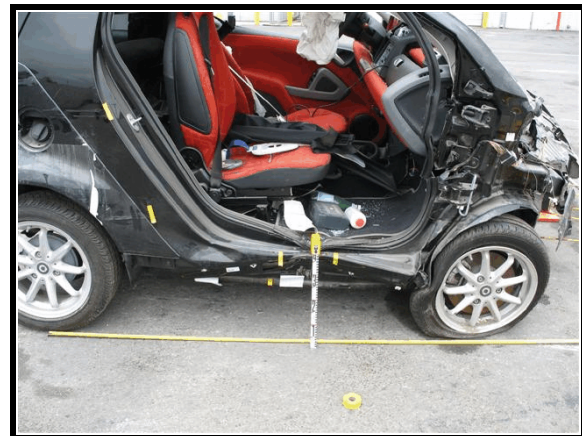
The right side of the vehicle also sustained direct damage from the second impact with the radar trailer (Event 4). The damage began 92 cm (36.2 in) forward of the rear axle and extended 22 cm (8.7 in) forward along the sill (**Figure 8**). The damage was located 36 cm (14.2 in) above the ground and was deformed upwards. The direct damage probably also extended into the right door but this could not be verified. The CDC for the impact with the trailer was 00RPLN1.

Figure 8. Right side damage

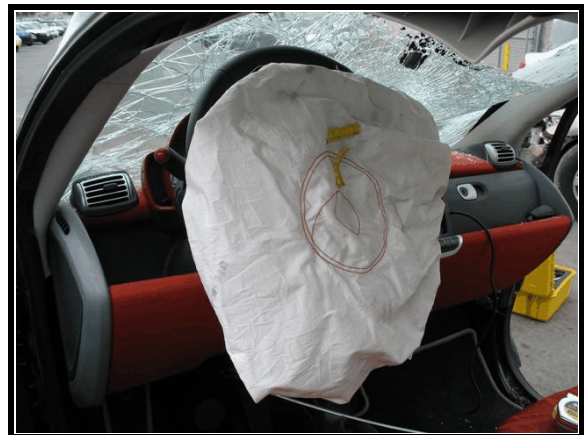
The driver's frontal air bag deployed from the center of the steering wheel hub through asymmetrical I-configuration module cover flaps (**Figure 9**). The left flap measured 8 cm (3.1 in) along the top and 8 cm (3.1 in) vertically to a 4 cm (1.6 in) offset. The right flap measured 3 cm (1.2 in) along the top and 8 cm (3.1 in) vertically to a 4 cm (1.6 in) offset. The air bag measured 45 cm (17.7 in) in diameter in its deflated state. The air bag was tethered by a single internal strap. Circular stitching on the face of the air bag measured 15 cm (5.9 in) in diameter.

Figure 9. Driver's air bag

A single 3 cm (1.2 in) circular vent port was located at the 12 o'clock aspect on the rear of the air bag. A black 3 x 2 cm (1.2 x 0.8 in) scuff was located 6 cm (2.4 in) to the right of bag centerline and 8 cm (3.1 in) above the bag centerline.

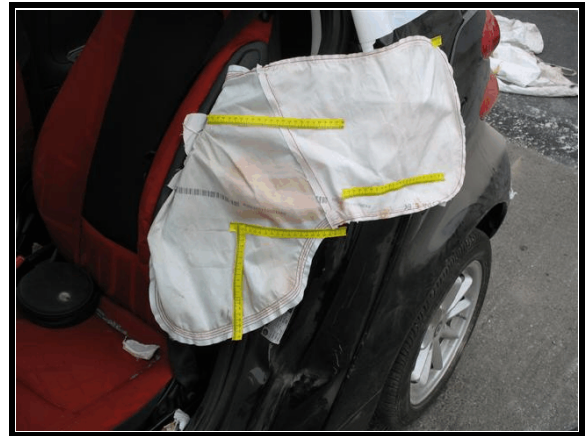
The driver's seat-mounted side air bag deployed forward from a triangular-shaped cover flap (**Figure 10**). The flap measured 33 cm (12.9 in) along the rear seat back, 37 cm (14.5 in) along the forward seat back, and 11 cm (4.3 in) along the base. The air bag extended forward 52 cm (20.5 in) and was 34 cm (13.3 in) in height at the rear and 31 cm (12.2 in) at the front. On the inboard panel of the air bag, there was a 19 x 13 cm (7.5 x 5.1) red transfer on the rear aspect and a 21 cm (8.3 in) long red transfer along the lower forward edge. The transfer was probably related to contact between the door panel and the air bag as the air bag unfolded during deployment. On the outboard panel of the air bag, there was a 21 x 13 cm (8.3 x 5.1 in) area of scuffing on the rearward portion of the bag.

Figure 10. Seat-mounted side air bag

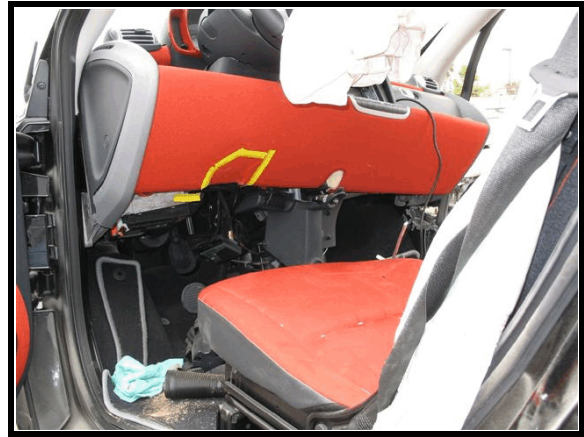
Figure 11. Lower instrument panel knee contact

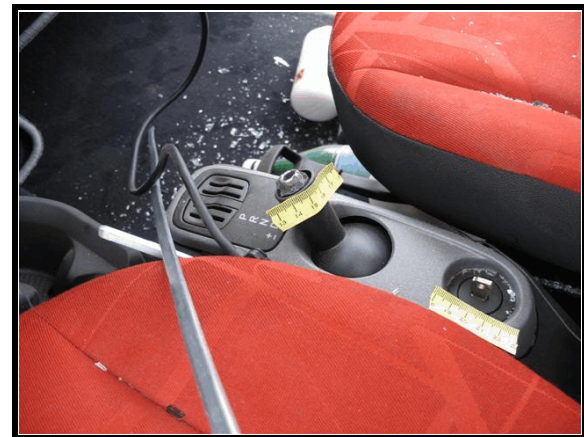
Figure 12. Shifter and key contacts
