ON-SITE SIDE IMPACT INFLATABLE OCCUPANT PROTECTION INVESTIGATION

CASE NUMBER - IN09026

LOCATION - TEXAS

VEHICLE - 2003 FORD EXPEDITION EDDIE BAUER

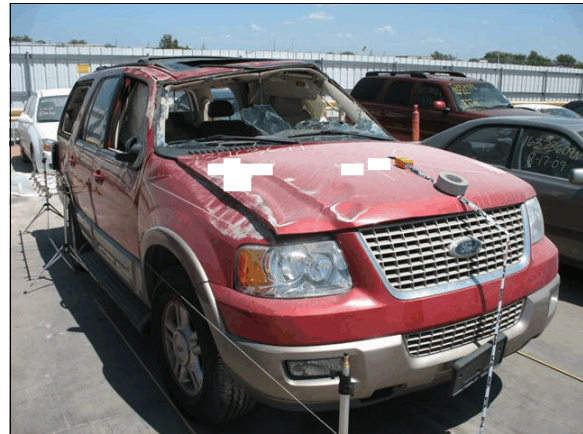
Figure 1: The damaged 2003 Ford Expedition Eddie Bauer

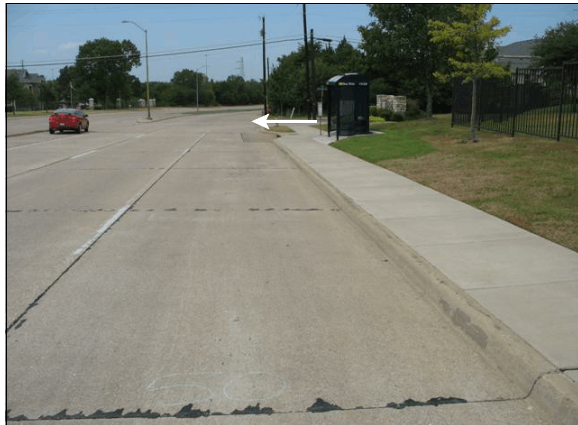
Figure 2: Approach of the Ford; arrow shows approach of the Mazda

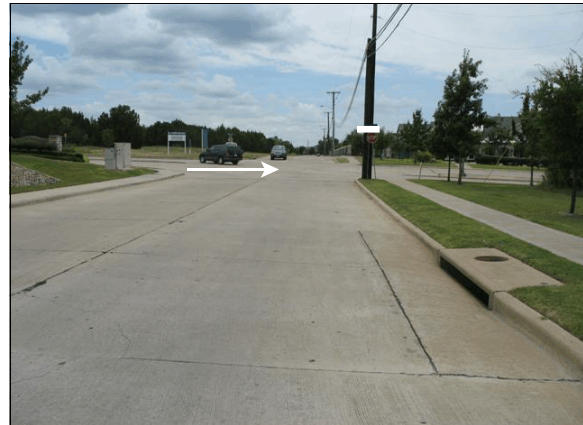
Figure 3: Approach of the Mazda; arrow shows approach of the Ford

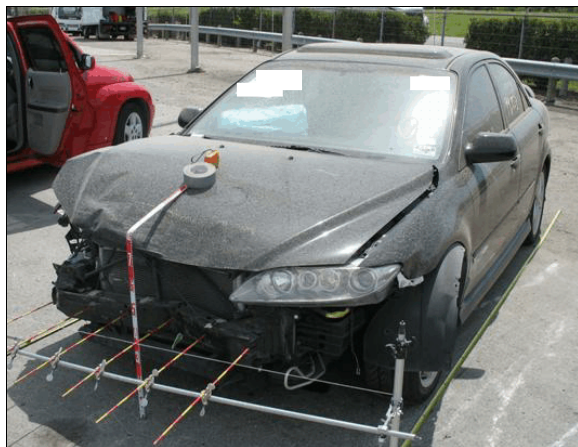
Figure 4: Front plane damage on the Mazda from impact with the right side plane of the Ford

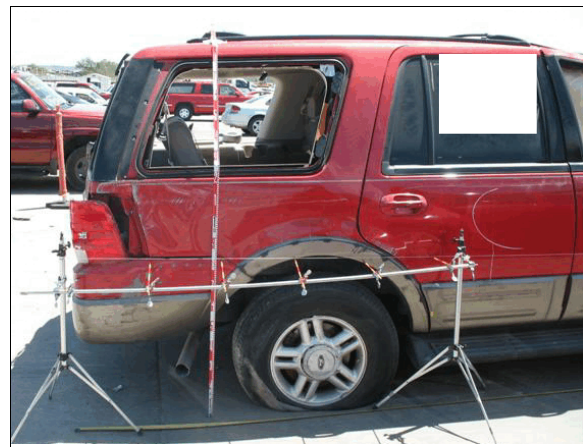
Figure 5: Damage on the right side plane of the Ford from impact by the front plane of the Mazda

Exterior Damage: The impact with the Mazda involved the right side plane of the Ford. The right quarter panel and right rear wheel were directly damaged. The direct damage began 247 cm (97.2 in) rear of the right front axle and extended 164 cm (64.6 in) rearward along the right side. The crush measurements were taken at the lower door level and the residual maximum crush was 3 cm (1.2 in) occurring at C₄. The vehicle's sill height was 50 cm (19.7). While the lower C-pillar sustained minor direct damage, there was no crush on the right rear door. The induced damage involved the right quarter panel and right rear door. The table below shows the right side crush profile.

Damage Classification: The Collision Deformation Classifications (CDC) were **01-RZEW-1 (30 degrees)** for the right side plane impact (event 1) and **00-TDDO-2** for the rollover (event 2). The Damage algorithm of the WinSMASH program calculated the Ford's total Delta V for the right side plane impact as 9 km/h (6 mph). The longitudinal and lateral velocity changes were -7.8 km/h (-4.8 mph) and -4.5 km/h (-2.8 mph), respectively. The results were low since the Ford's right rear wheel was directly engaged in the impact and the sheet metal on the vehicle's quarter panel sustained an average of only 1 cm (0.4 in) of crush. The severity of the rollover damage was minor based on the extent of the roof crush.

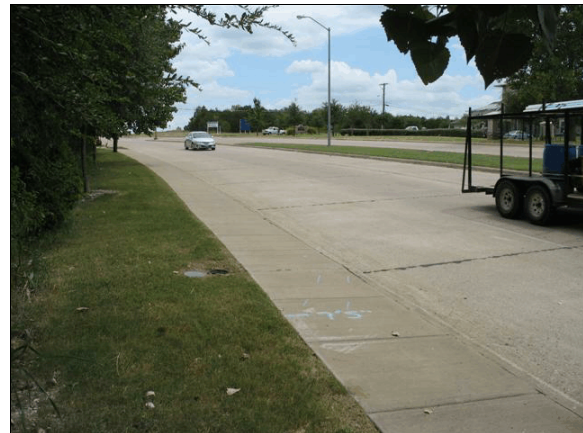
The initial right side plane impact on the Ford induced a clockwise rotation. As the vehicle rotated, the friction force between the left side tires and the concrete pavement caused the vehicle to roll over left side leading. The damage on the vehicle indicated that it rolled over 8 quarter turns. There was insufficient evidence on the roadway to determine the location of rollover initiation or the distance traveled during the rollover.

Figure 6: Look back from Ford's area of final rest to area of rollover on the roadway

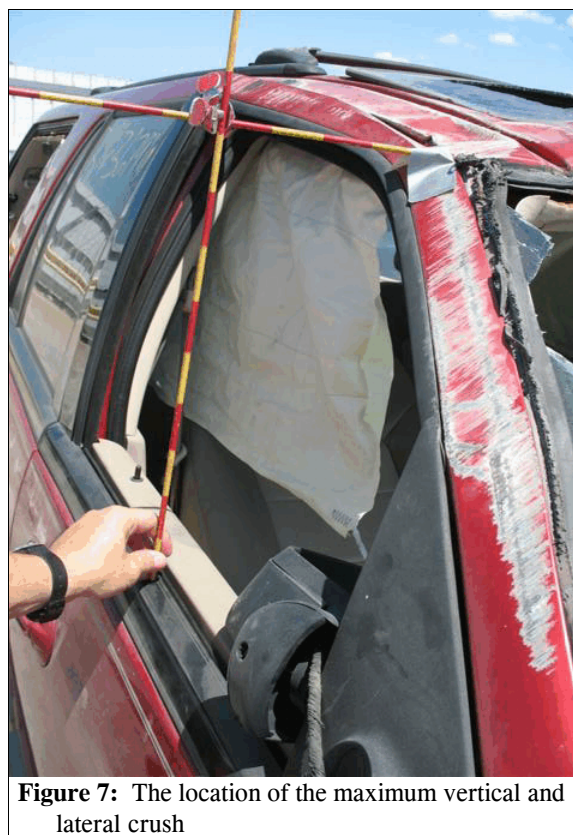
The rollover involved the Ford's top plane, both side planes, and the undercarriage. The direct damage on the top plane involved the hood and extended onto the roof to just rear of the B-pillars and also involved the rear lateral support of the luggage rack. The damage involved the full width of the roof, 114 cm (44.9 in). The direct damage on the right side plane began at the front of the fender and involved the A-pillar, right roof side rail, running board, right rear door and quarter panel. The damage on the left side plane began on the A-pillar and involved the front and rear doors, roof side rail, and the quarter panel. The maximum vertical crush was 4 cm (2 in) and occurred on the windshield header 5 cm (2 in) inboard of the right A-pillar (**Figure 7**). The maximum lateral crush was 3 cm (1.2 in) and involved the right A-pillar.

Figure 7: The location of the maximum vertical and lateral crush

The vehicle sustained four passenger compartment intrusions, which occurred in the front row right. The right A-pillar, windshield header, and roof all intruded vertically 3 cm (1.2 in), while the right roof side rail intruded vertically 1 cm (0.4 in).

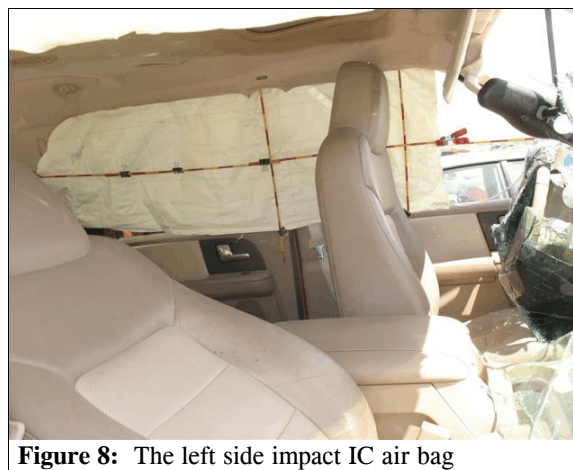
The side impact IC air bags were located along the roof side rails (**Figures 8 and 9**) inside the headliner and extended from the A-pillar to the C-pillar. The air bags were designed with inflation chambers adjacent to the outboard seating positions. There were no external vent ports. The deployed IC air bags were 140 cm (55.1 in) in width and 45 cm (17.7 in) in height. They were attached at the A-pillars by a 36 cm (14.1 in) nylon rope and at the C-pillars by an 8 cm (3.1 in) nylon rope. The gap between the front of each air bag and the A-pillar was 18 cm (7.1 in). Each air bag extended vertically to 3 cm (1.2 in) above the beltline. Inspection of the deployed IC air bags

Figure 8: The left side impact IC air bag

revealed no damage and no discernable evidence of occupant contact.

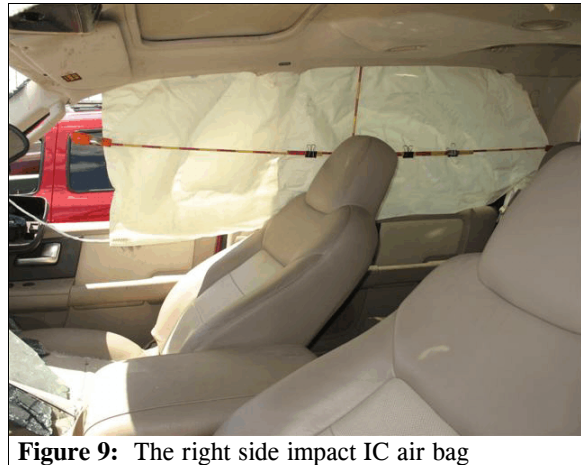
Figure 9: The right side impact IC air bag

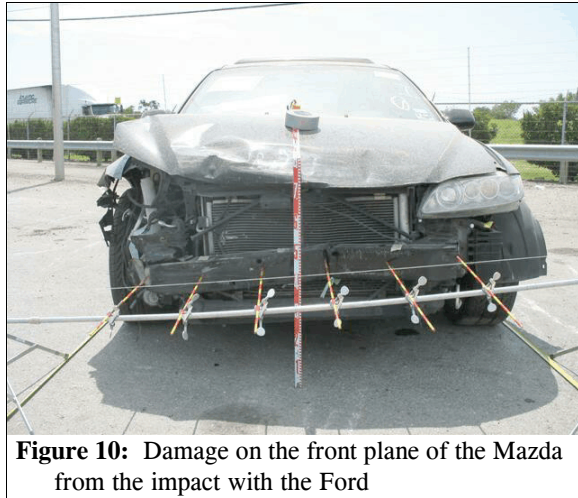
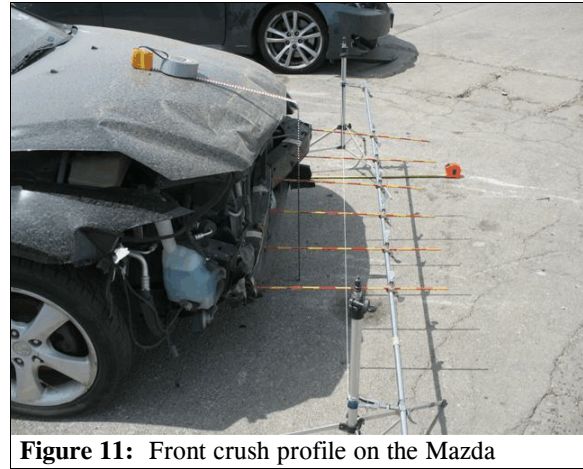
Exterior Damage: The impact with the Ford involved the front plane of the Mazda. The front bumper, grille, hood, and both headlamp/turn signal assemblies were directly damaged (**Figure 10**). The direct damage began at the front left bumper corner and extended across the full width of the front plane. The crush measurements were measured on the bumper bar and the residual maximum crush was 20 cm (7.9 in) occurring at C₆ (**Figure 11**). The table below shows the front crush profile.

Damage Classification: The CDC for the front impact with the Ford was **10-FDEW-1 (300 degrees)**. The Damage Algorithm of the WinSMASH program calculated the Mazda’s total Delta-V for the front impact as 14 km/h (8.7 mph). The longitudinal and lateral velocity changes were -7 km/h (-4.3 mph) and 12.1 km/h (7.5 mph), respectively. The results appeared low for the reasons indicated under the Ford’s vehicle exterior section on page 3 above.
