**CALSPAN ON-SITE ROLLOVER CRASH INVESTIGATION
SCI CASE NO.: CA09028**

VEHICLE: 2008 HONDA ACCORD EX-L V6 SEDAN

LOCATION: NORTH CAROLINA

CRASH DATE: APRIL 2009

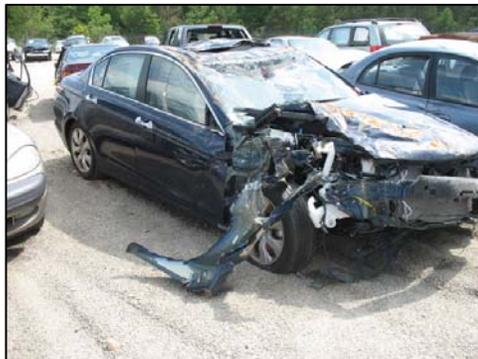
Figure 1. 2008 Honda Accord case vehicle

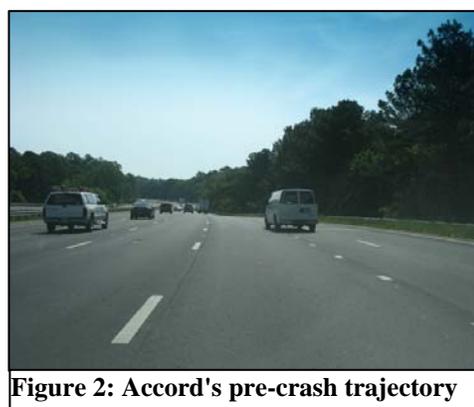
The restrained 35-year-old male driver of the Honda was traveling eastbound in the number two lane of the interstate roadway (**Figure 2**). The Honda was traveling at a police estimated speed of 105 km/h (65 mph). Traffic ahead in the number two lane had come to a stop. According to the driver of the Altima, traffic in the number two lane had stopped due to vehicles merging left from the number one lane, an interchange on-ramp which ended a short distance ahead. The other vehicles were stopped in the following order, west to east:

Figure 2: Accord's pre-crash trajectory

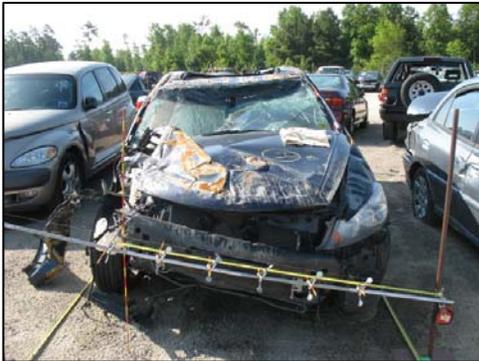
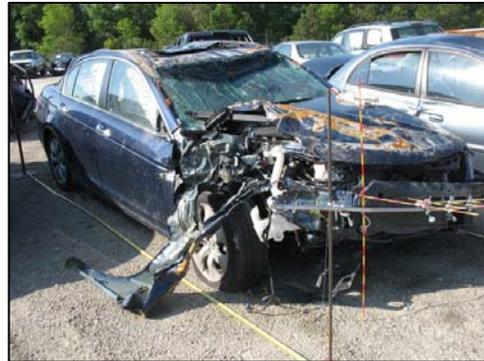
The exterior of the Honda sustained moderate severity damage to the front, left and top planes as a result of this multiple impact crash. The front plane sustained two impacts, both to the front right corner. The left side and top of the Accord sustained damage from the rollover event. A CDC and crush profile which combines the residual crush from the first two impacts was documented along the full frontal width of the front bumper beam. The Collision Deformation Classification (CDC) assigned to the frontal damage was 12-FZEW-1.

Figure 3: Overall view of the frontal damage

Figure 4: Front right view of the frontal damage

Both impacts occurred to the right aspect of the front plane. The direct damage measured 44 cm (17.3 in) and began 17 cm (6.7 in) right of the vehicle centerline, extending right. The maximum crush measured 17 cm (6.7 in) and was located at the right corner of the bumper beam. The crush profile was as follows: C1 = 1 cm (0.4 in), C2 = 2 cm (0.8 in), C3 = 6 cm (2.4 in), C4 = 9 cm (3.5 in), C5 = 10 cm (3.9 in), C6 = 17 cm (6.7 in). **Figures 3 and 4** depict the frontal damage sustained by the Honda.

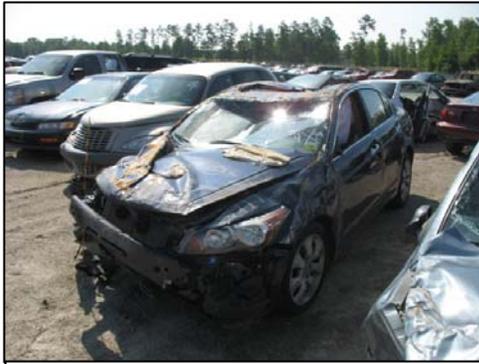
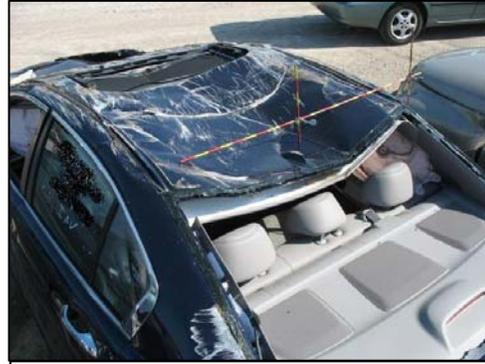
The left and top planes sustained damage from the rollover event. The scratches on the roof were oriented in two directions, but due to the absence of rollover damage to the right plane, it is believed that the vertical scratching was a result of the rollover, and the longitudinal scratching was a result of the vehicle sliding to a stop after rolling onto its roof. The maximum vertical and lateral crush were at different locations. The maximum vertical crush was 11 cm (4.3 in) and was located on the roof 48 cm (18.9 in) left of the right roof side rail and 18 cm (7.1 in) forward of the backlight header. The top direct damage extended laterally from the right roof side rail to the left roof side rail a distance of 118 cm (46.5 in). The top direct damage extended longitudinally from the front edge of the hood rearward 372 cm (146.5 in) to the C-pillars. The maximum lateral crush was located at the junction of the left A-pillar and the windshield header and was 5 cm (2 in). The CDC assigned for the rollover event was 00-TYDO-3. **Figures 5 and 6** depict the rollover damage sustained by the Honda.

Figure 5: Rollover damage from front left

Figure 6: rollover damage from above, left rear

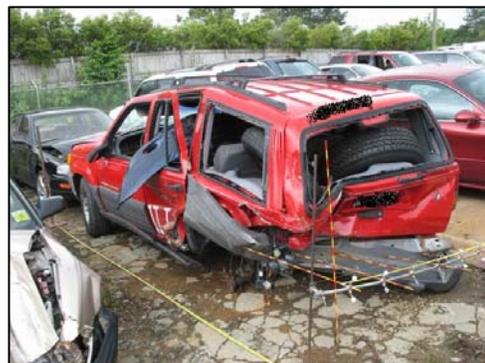
The exterior of the Jeep sustained moderate severity damage to the back, left and top planes as a result of this multiple impact crash. The first impact occurred to the left aspect of the rear plane. The direct damage measured 64 cm (25.2 in) in width and began 12 cm (4.7 in) left of the vehicle centerline, extending left. The maximum crush measured 70 cm (27.6 in) and was located at C2, 42 cm (16.5 in) left of the vehicle centerline. The CDC assigned for this impact was 06-BYEW-4. A crush profile was documented along the full width of the rear bumper and was as follows: C1 = 64 cm (25.2 in), C2 = 70 cm (27.6 in), C3 = 50 cm (19.7 in), C4 = 34 cm (13.4 in), C5 = 23 cm (9.1 in), C6 = 0 cm. The CDC assigned for this impact was 06-BYEW-4. **Figure 7** depicts the rear plane damage to the Jeep.

Figure 7: Rear damage from back left

The CDC assigned for this impact was 06-BYEW-4. **Figure 7** depicts the rear plane damage to the Jeep.

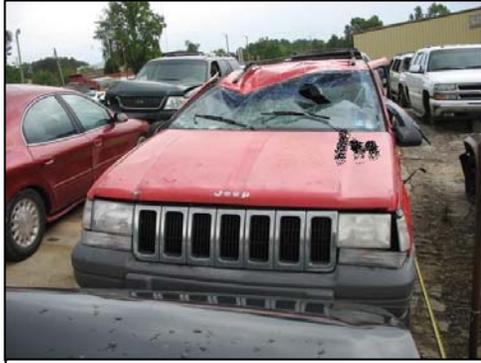
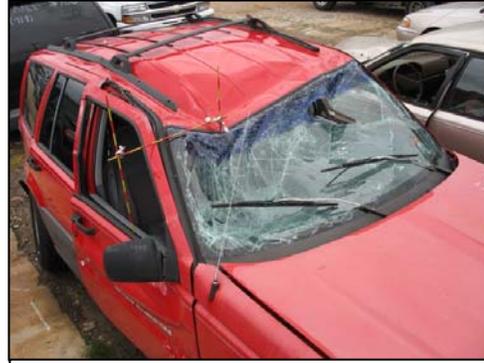
The left and top planes sustained damage from the rollover event. The scratches on the roof were oriented in the same direction. The maximum vertical and lateral crush were at different locations. The maximum vertical crush measured 18 cm (7.1 in) and was located on the windshield header 30 cm (11.8 in) left of the right roof side rail. The top direct damage extended laterally from the right roof side rail to the left roof side rail a distance of 130 cm (51.2 in). The top direct damage extended longitudinally from the front edge of the hood rearward 254 cm (100 in) to a point between the B- and C-pillars. The maximum lateral crush was located at the junction of the right A-pillar and the windshield header which measured 4 cm (1.6 in) right of the left sideline formed by the window sill of the Jeep. The CDC assigned for the rollover event was 00-TYDO-3. **Figures 8 and 9** depict the rollover damage sustained by the Jeep.

Figure 8: Rollover damage from front

Figure 9: Rollover damage from above, right front

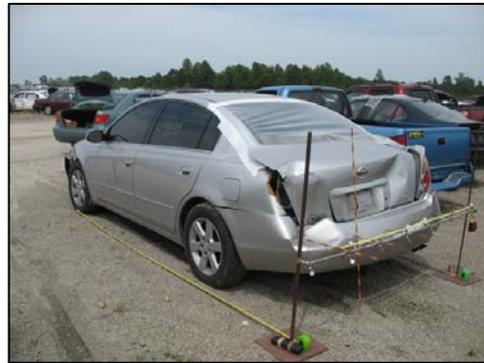
The exterior of the Nissan sustained moderate severity damage to the rear left and the front left as a result of this multiple impact crash. The first impact occurred to the left aspect of the rear plane. The direct damage measured 53 cm (20.9 in) in width and began 20 cm (7.9 in) left of the vehicle centerline, extending left. The maximum crush measured 17 cm (6.7 in) and was located at C1, 73 cm (28.7 in) left of the vehicle centerline on the bumper. The CDC assigned for this impact was 06-BYEW-2. A crush profile was documented along the full width of the rear bumper. This crush profile was as follows: C1 = 17 cm (6.7 in), C2 = 6 cm (2.4 in), C3 = 7 cm (2.8 in), C4 = 6 cm (2.4 in), C5 = 4 cm (1.6"), C6 = 4 cm (1.6"). **Figure 10** depicts the rear end damage sustained by the Altima.

Figure 10: Back left view of the rear end damage.

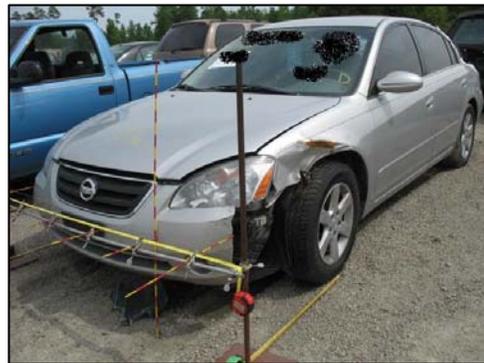
The second impact occurred to the left aspect of the front plane. The direct damage measured 9 cm (3.5 in) in width and began 68 cm (26.8 in) left of the vehicle centerline, extending left. The maximum crush measured 1 cm (0.4 in) and was located at C1, 76 cm (29.9 in) left of the vehicle centerline on the bumper. The CDC assigned for this impact was 12-FLES-3 as the sideswipe damage traveled 64 cm (25.2 in) down the left front fender. A crush profile was documented along the full width of the front bumper. This crush profile was as follows: C1 = 1 cm (0.4in), C2 = 1 cm (0.4 in), C3 = 0 cm, C4 = 0 cm, C5 = 0 cm, C6 = 0 cm. **Figure 11** depicts the front end damage sustained by the Altima.

Figure 11: Front left view of the frontal damage.

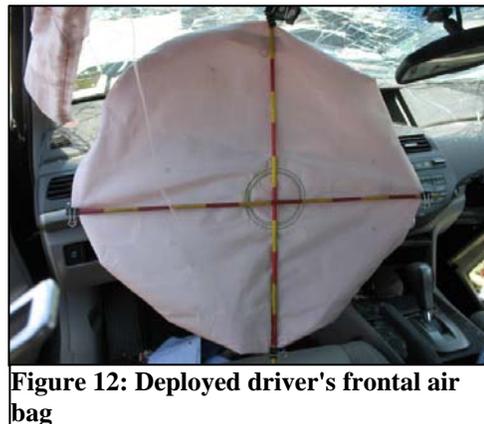
The driver's air bag was concealed within the center hub of a three-spoke steering wheel by three asymmetrical cover flaps. The upper flap was 13 cm (5.1 in) in width at the horizontal tear seam and 8 cm (3.1 in) in height. The 2 lower flaps dimensions were mirrored symmetrically, the upper aspects measuring 7 cm (2.8 in) in width at the horizontal tear seam, the outboard sides measuring 7 cm (2.8 in) in height vertically and the lower aspects measuring 6.5 cm (2.6 in) horizontally. There was a Honda medallion in the center of the flaps that attached to the top cover flap and was 5 cm (2 in) in width and extended 2 cm (0.8 in) into the lower cover flaps. The air bag (**Figure 12**) measured 64 cm (25.2 in) in diameter in its deflated state. The air bag was vented by two vent ports located at the eleven and one o'clock positions. The air bag was tethered by two internal tethers located at the nine and three o'clock positions on a 9 cm (3.5 in) diameter circular seam sewn to the center face of the air bag. There were no occupant contacts to the driver's frontal air bag. The driver's air bag was identified with the stenciled number UEUS1V143.

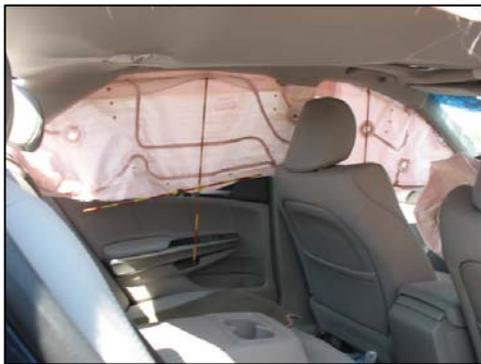
The left and right side curtain air bags deployed from their respective roof side rails (**Figures 13 and 14**). The air bag measured 202 cm (79.5 in) in length. The air bag measured 41 cm (16.1 in) in height at the front seating positions. In the rear seating position, the air bag measured 40 cm (15.7 in) in height. Vertically, the air bag extended below the belt line at each outboard position. The curtain air bags provided head protection from the roof side rail to the belt line and from the C-pillar to the A-pillar. The curtain air bags were free from occupant contact points and damage.

Figure 13: Left curtain air bag.

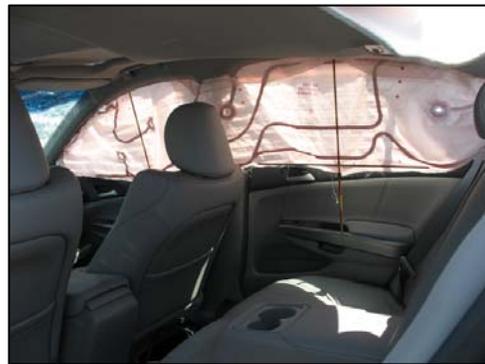
Figure 14: Right curtain air bag.

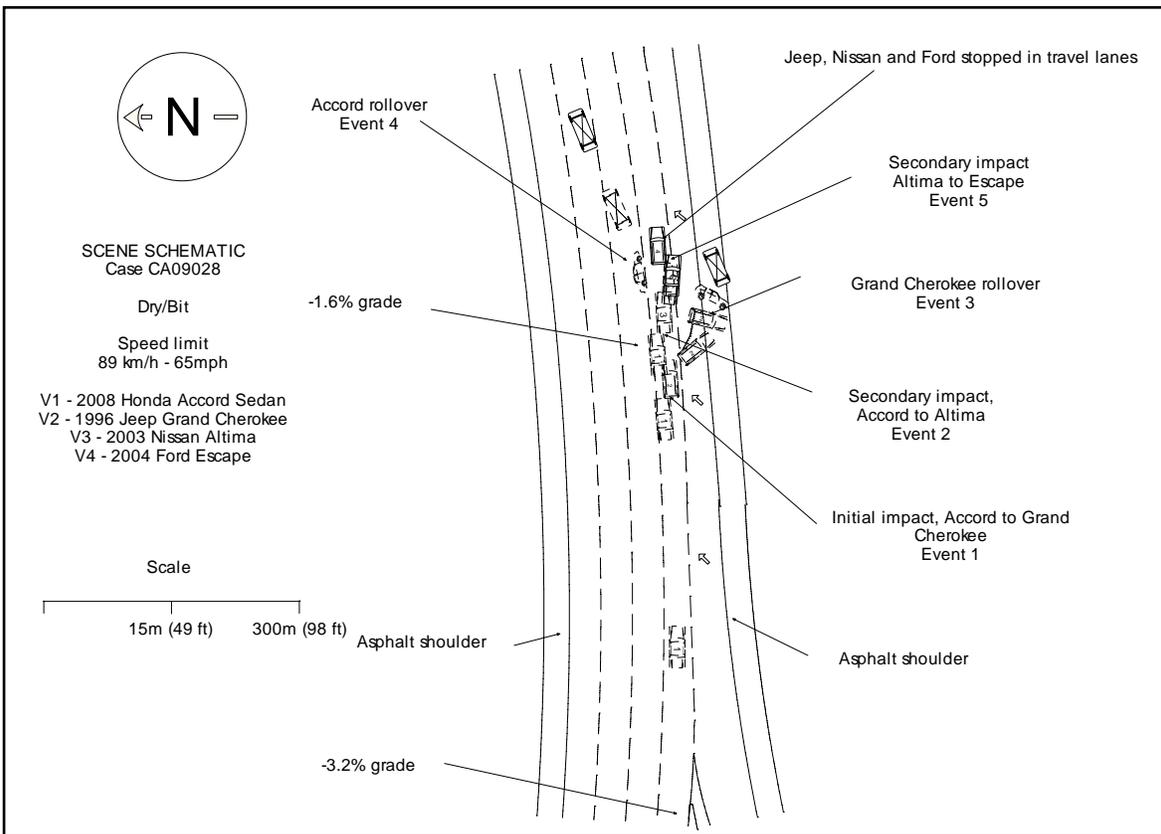
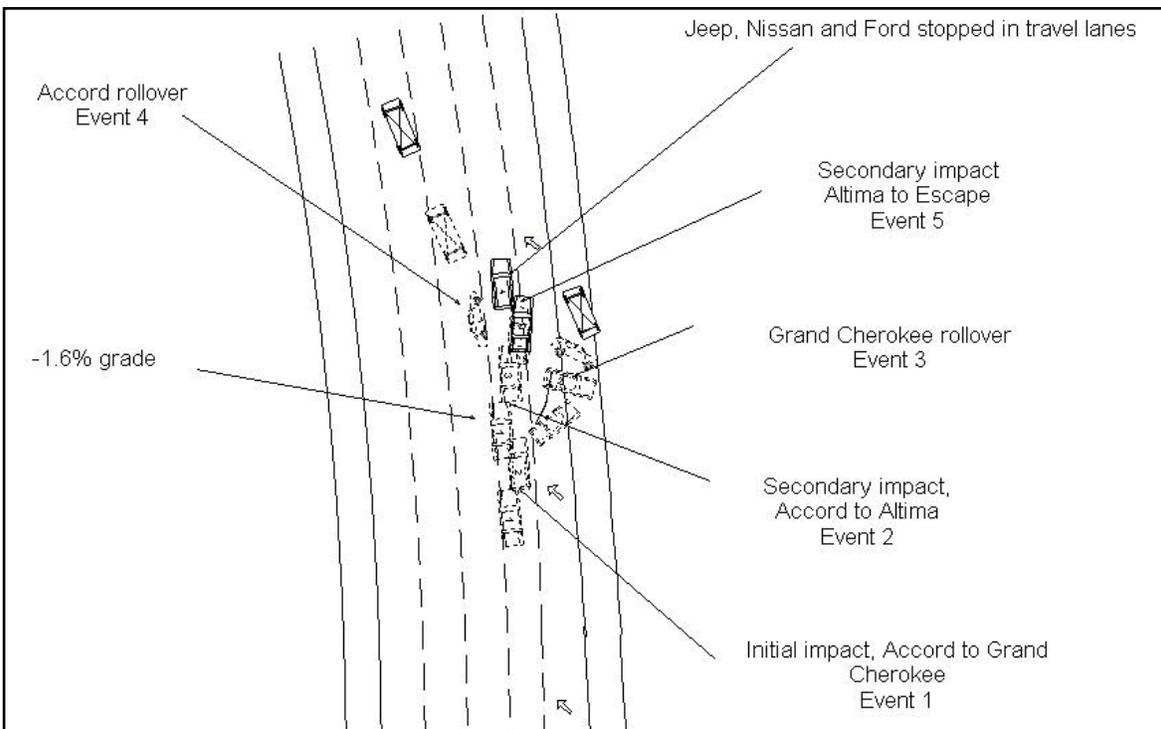
Figure 15: Crash Schematic

The conditions were police-reported as clear, dry and dark (area not lighted). The posted speed limit was 105 km/h (65 mph). Prior to the crash site, the roadway had a negative grade of 3.2 percent. At the crash site, the grade transitioned to a negative grade of 1.6 percent. The Crash Schematic is included as **Figure 15** of this report.
