ON-SITE SIDE IMPACT INFLATABLE OCCUPANT PROTECTION INVESTIGATION

CASE NUMBER - IN09028

VEHICLE - 2008 NISSAN SENTRA S

CRASH DATE - June 2009

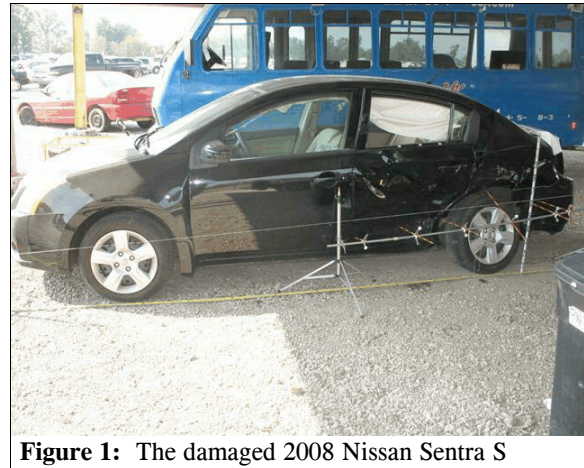
Figure 1: The damaged 2008 Nissan Sentra S

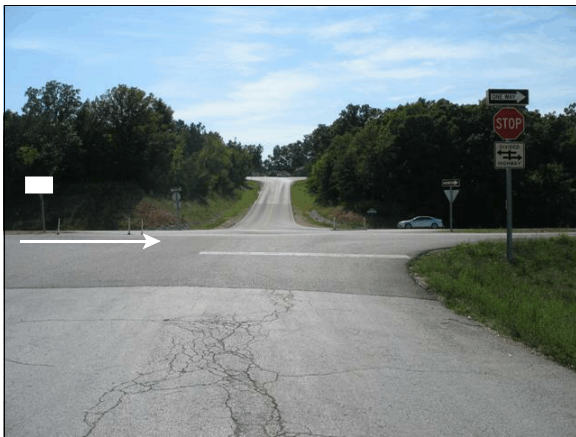
Pre-Crash: The Nissan was occupied by a restrained 17-year-old male driver, a restrained 18-year-old female front row passenger, and an unrestrained 21-year-old male second row right passenger. The Nissan's driver proceeded southwest from the stop sign into the intersection (**Figure 2**), where he intended to proceed through the median crossover and turn left. The Hyundai's restrained 23-year-old male driver was traveling northwest in the outside through lane

Figure 2: Approach of the Nissan into the intersection; arrow shows the approach of the Hyundai

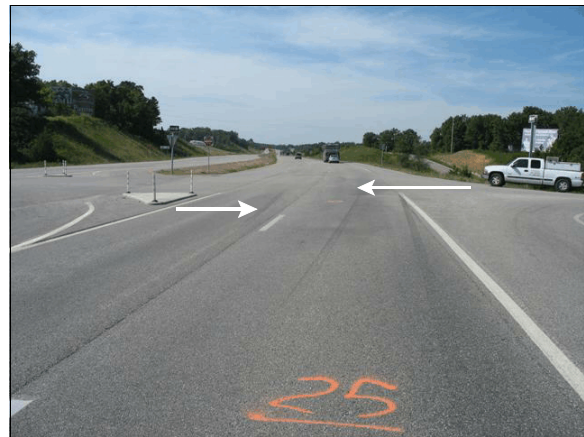
(Figure 3), where he intended to continue straight through the intersection. The Nissan's driver took no actions to avoid the crash. The Hyundai's driver attempted to avoid the crash by initiating a left steering maneuver and applying hard braking. The Hyundai skidded partially into the inside through lane and the crash occurred within the intersection (Figure 3).

Figure 3: Approach of the Hyundai to the impact area; arrow on right shows approach of Nissan; arrow on left shows Hyundai's left front skid mark; skid marks in outside lane are unrelated

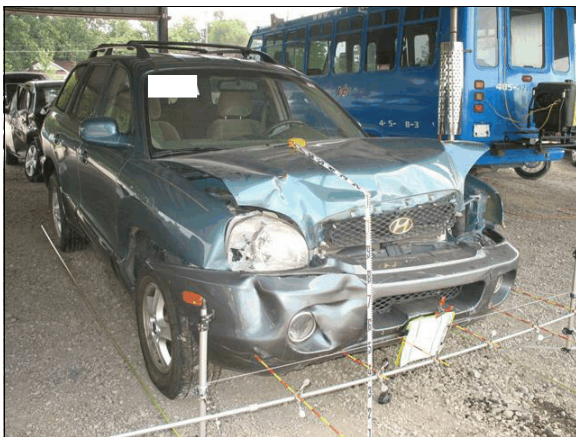
Figure 4: Damage to the front plane of the Hyundai from the impact with the Nissan's left side plane

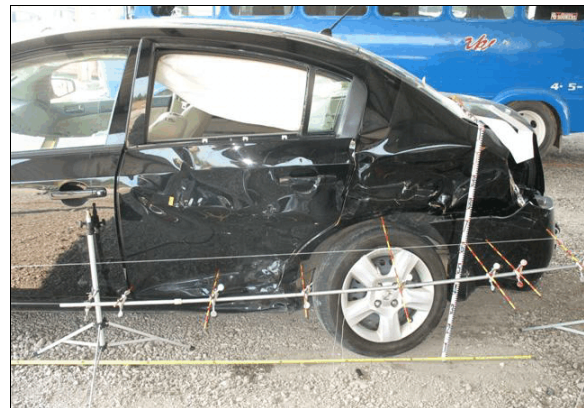
Crash: The front plane of the Hyundai (Figure 4) impacted the left side plane of the Nissan (Figure 5). The direction of force on the Nissan was within the 10 o'clock sector and the impact force was sufficient to trigger the deployment of the left IC air bag and driver's seat-mounted side impact air bag. As a result of the impact, the Nissan's left rear window glazing was disintegrated. The unrestrained second row right passenger was displaced to the left by the impact and ejected through the left rear window opening. The Nissan rotated counterclockwise and came to final rest in the median crossover heading northwest. The Hyundai rotated counterclockwise and came to final rest on the median shoulder heading northwest. The rest positions were based on the police crash report narrative. Both vehicles had been moved prior to arrival of the police. There had been several other crashes in this intersection, and many unrelated and conflicting marks were present.

Figure 5: Damage to the left side plane of the Nissan

Exterior Damage: The impact with the front of the Hyundai involved the left side plane of the Nissan. The left rear door, left rear wheel, and quarter panel were directly damaged. The direct damage began 179 cm (70.5 in) rear of the left front axle and extended 166 cm (65.4 in) rearward along the left side. The crush measurements were taken at the lower door level and the residual maximum crush was 27 cm (10.6 in) occurring 11 cm (4.3 in) rear of C₂ (**Figure6**). The vehicle’s sill height was 32 cm (12.9 in) and the height of the maximum crush was 47 cm (18.5 in). The door sill differential was 3 cm (1.2 in). The induced damage involved the upper C-pillar and quarter panel. The table below shows the left side crush profile.

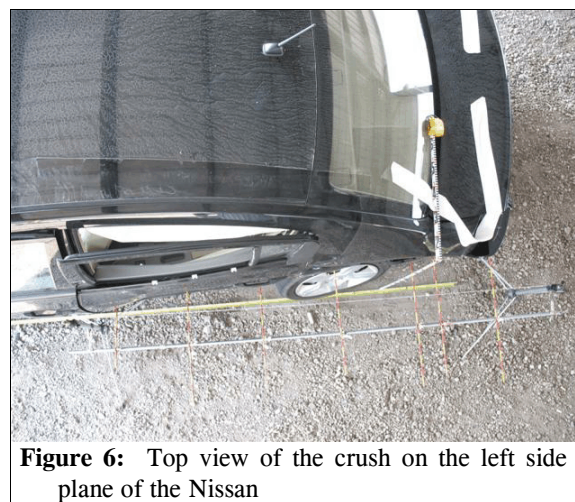
Figure 6: Top view of the crush on the left side plane of the Nissan

Damage Classification: The Collision Deformation Classifications (CDC) was **10LZEW3 (290** degrees) for the left side plane impact. The Damage algorithm of the WinSMASH program calculated the Nissan’s total Delta V as 24 km/h (14.9 mph). The longitudinal and lateral velocity changes were -8.2 km/h (-5.1 mph) and 22.6 km/h (14 mph), respectively. Based on the damage sustained by both vehicles, the results appeared reasonable.

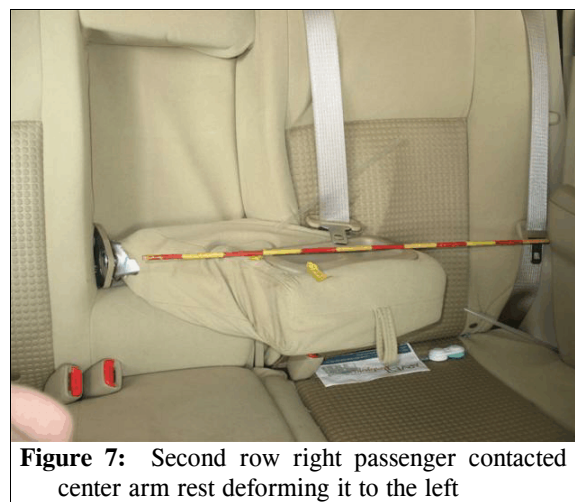
Vehicle Interior: The inspection of the Nissan’s interior revealed no discernable evidence of occupant contact in the front row. In the second row, the right passenger had contacted the center arm rest and deformed it to the left (**Figure 7**). The left IC air bag was scuffed and there was a small tear on the bottom edge rearward of the scuff (**Figure 8**). A transfer of hair and tissue was located on the glass fragments in the left rear window frame (**Figure 9**) and the window frame was slightly bent. The left rear door panel was also dented and deformed outward (**Figure 10**). This occupant contact evidence supported the left rear window opening as the second row right passenger’s ejection portal.

Figure 7: Second row right passenger contacted center arm rest deforming it to the left

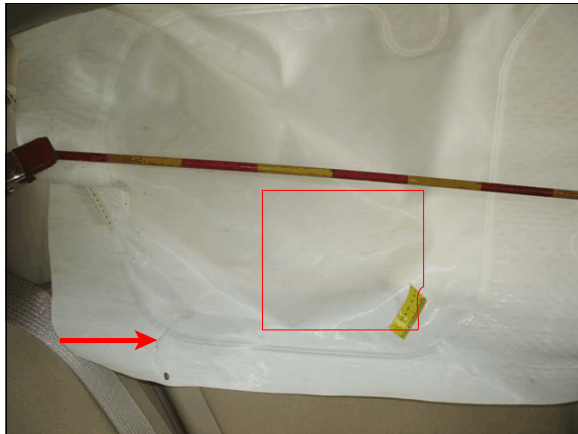
Figure 8: Outline shows area of occupant contact scuff on IC air bag; arrow on left shows location of tear in IC air bag

between the back of the IC air bag and the C-pillar. The IC air bag extended vertically 9 cm (3.5 in) below the beltline. Inspection of the deployed IC air bag revealed no discernable evidence of occupant contact in the front row. In the second row, an occupant contact scuff was located 23 cm (9 in) forward of the back edge of the IC air bag and 10 cm (2 in) above the bottom of the IC. A 7 cm (2.8 in) tear was located at the bottom of the IC air bag 10 cm (2 in) forward of the back edge. The location of the tear (**Figure 8**) corresponded with the location of the hair and tissue transfer on the back of the left rear window frame (**Figure 9**).

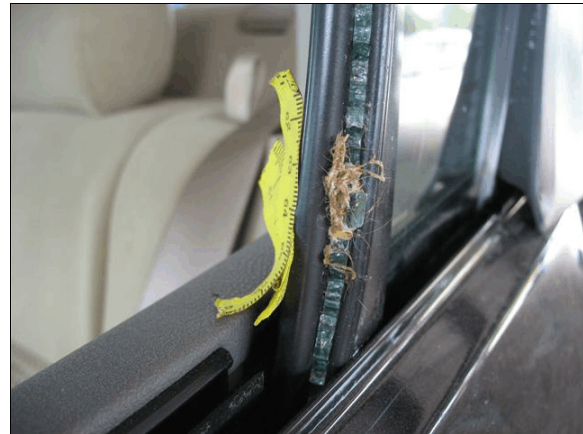
Figure 9: Hair transfer on left rear window frame

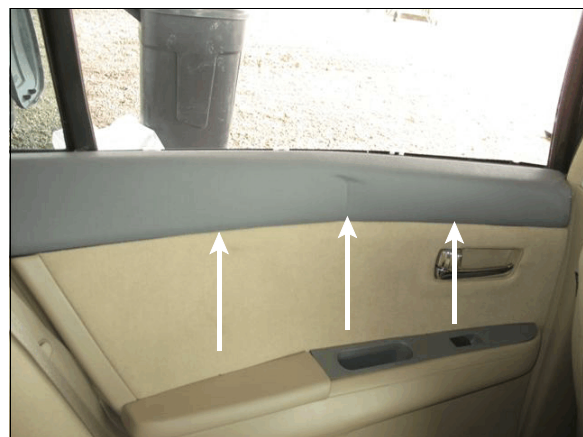
Figure 10: The left rear door panel was dented and deformed outward from occupant contact (arrows)

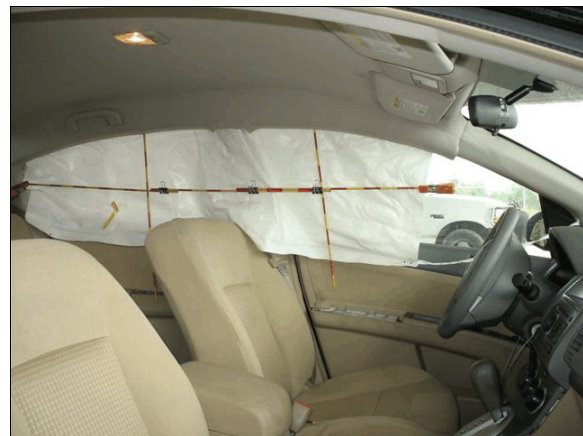
Figure 11: The Nissan's left IC

The IC air bags were located along the roof side rails inside the headliner and extended from the A-pillar to the C-pillar. The IC air bags were designed with inflation chambers adjacent to the outboard seating positions. There were no external vent ports. The deployed left IC air bag (**Figure 11**) was 145 cm (57.1 in) in width and 44 cm (17.3 in) in height. It was attached to the A-pillar by a 51 cm (20.1 in) nylon rope and at the C-pillar by a 14 cm (5.5 in) nylon rope. The gap between the front of the IC air bag and the A-pillar was 41 cm (16.1 in). There was no gap

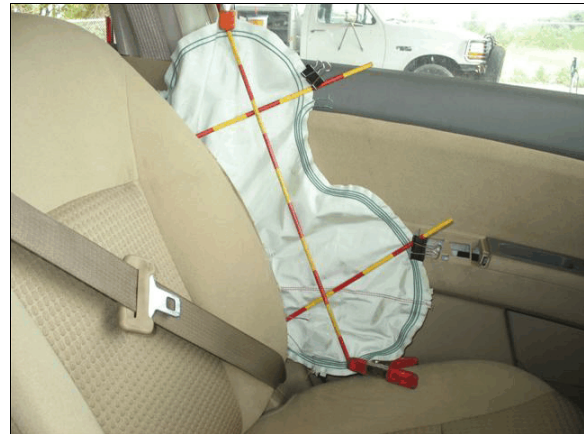
The driver's seat-mounted side impact air bag was located in the outboard side of the seat back and deployed through a tear-seam. The deployed air bag (**Figure 12**) was 53 cm (20.9 in) in height. The upper portion of the air bag was 20 cm (7.9 in) in width, while the middle and lower portions were 17 cm (6.7 in) and 25 cm (9.8 in) wide, respectively. The inspection of the air bag revealed no discernable evidence of occupant contact and no damage.

Figure 12: The front left seat-mounted side impact air bag

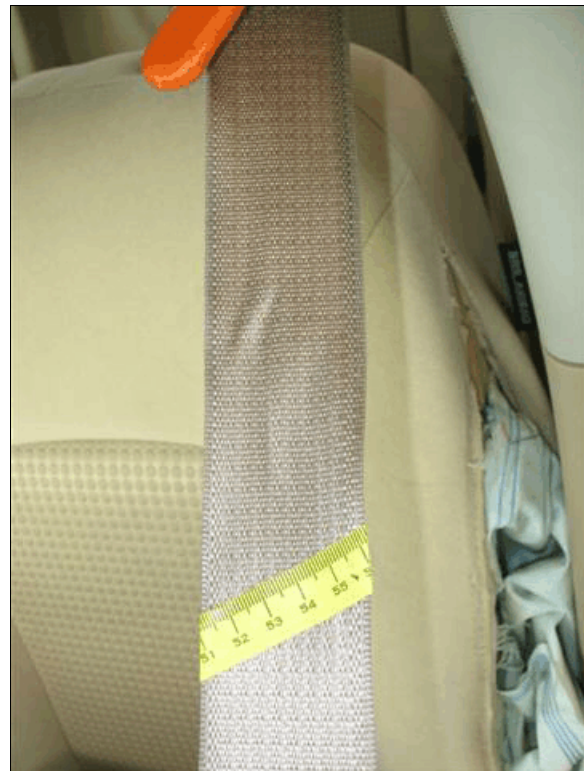
The inspection of the driver's safety belt assembly revealed historical usage scratches on the latch plate. The belt webbing was slightly stretched (**Figure 13**) at 103 cm (40.5 in) above the

Figure 13: Area on driver's safety belt webbing that was slightly stretched

stop button. The driver also sustained contusions during the crash consistent with safety belt usage. Based on this evidence, the driver was restrained by the lap-and-shoulder safety belt.

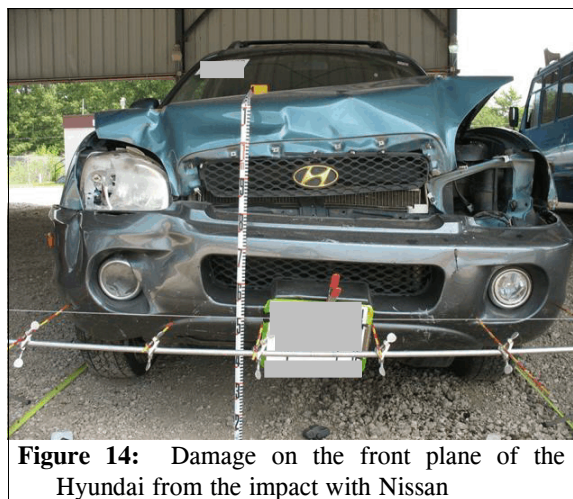
Figure 14: Damage on the front plane of the Hyundai from the impact with Nissan

Exterior Damage: The impact with the Nissan involved the Hyundai’s front plane (**Figure 14**). The front bumper, grille, hood, and both headlamp/turn signal assemblies were directly damaged. The direct damage began at the front right bumper corner and extended 160 cm (63 in) across front plane. The crush measurements were taken at the bumper level and the residual maximum crush was 21 cm (8.3 in) occurring at C₄. The induced damage involved the hood and both fenders. The table below shows the front crush profile.

Damage Classification: The CDC for the front impact with the Nissan was **01FDEW1** (20 degrees). The Damage algorithm of the WinSMASH program calculated the Hyundai’s total Delta-V as 18 km/h (11.2 mph). The longitudinal and lateral velocity changes were -16.9 km/h (-6.7 mph) and 6.2 km/h (2.4 mph), respectively. Based on the damage on both vehicles, the results appeared reasonable.
