**CALSPAN ON-SITE SIDE IMPACT INFLATABLE OCCUPANT PROTECTION
SYSTEM CRASH INVESTIGATION**

SCI CASE NO. – CA09029

VEHICLE – 2009 HONDA CIVIC

CRASH DATE – MAY 2009

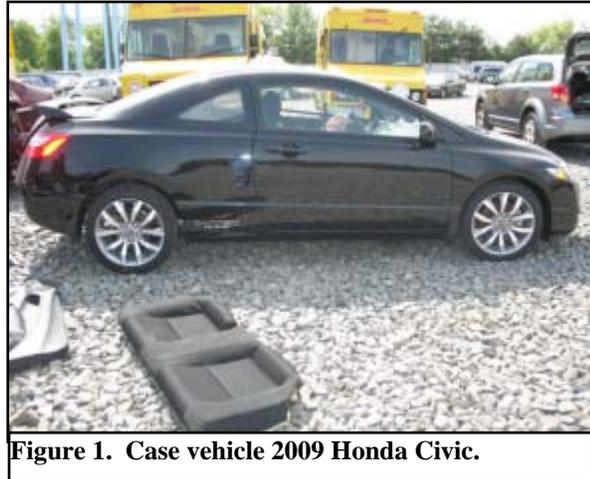
This on-site investigation focused on the side impact inflatable occupant protection system in a 2009 Honda Civic Si (**Figure 1**). The Honda was equipped with front seat back-mounted side impact air bags and Inflatable Curtain (IC) air bags for the outboard positions. Additionally, the vehicle was equipped with a Certified Advanced 208-Compliant (CAC) frontal air bag system and buckle mounted safety belt pretensioners for the front belt systems. The manufacturer of this vehicle has certified that the Civic is compliant to

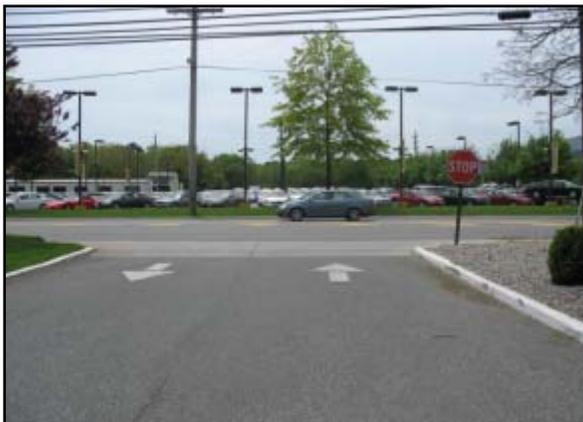
The restrained 20-year-old male driver of the Honda was traveling south approaching the intersection where his intention was to turn left (**Figure 2**). The Dodge was driven by a 52-year-old male and was occupied by a 43-year-old female front right passenger. The driver of the Dodge Durango was operating the vehicle westbound approaching the intersection (**Figure 3**). During the SCI interview, the driver of the Honda stated that he had stopped at the intersection. He did not detect on-coming traffic and initiated the left turn.

Figure 2. Honda's southbound approach to the intersection.

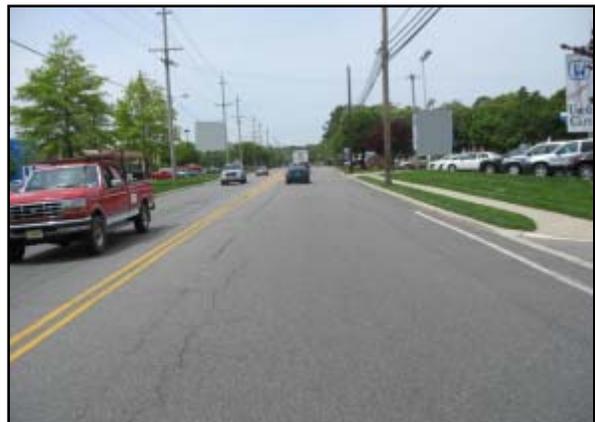
Figure 3. Westbound travel direction of the Dodge.

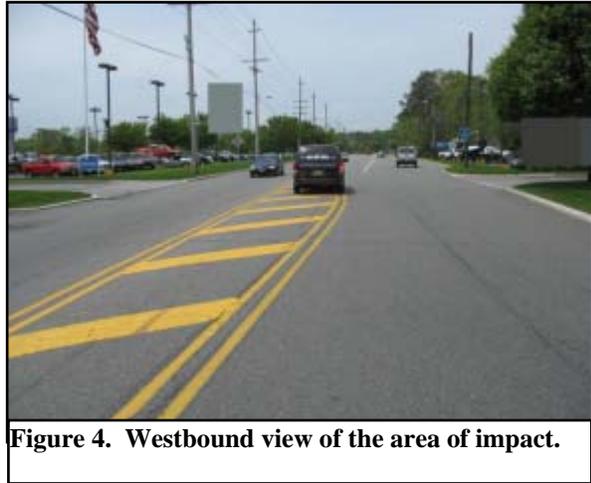
Figure 4 is a view of the area of impact from the Dodge's westbound approach. The resultant directions of force for the Honda and the Dodge were within the 10 and 1 o'clock sectors, respectively. The Damage Algorithm of the WinSMASH program was used to compute the delta-V. The total velocity change for the Honda was 24 km/h (14.9 mph), with a longitudinal component of -15 km/h (-9.3 mph) and a lateral component of 18 km/h (11.2 mph). The total delta-V for the Dodge was 15 km/h (9.3 mph). The longitudinal and lateral components for the Dodge were -14 km/h (-8.7 mph) and -5 km/h (-3.1 mph), respectively.

Figure 4. Westbound view of the area of impact.

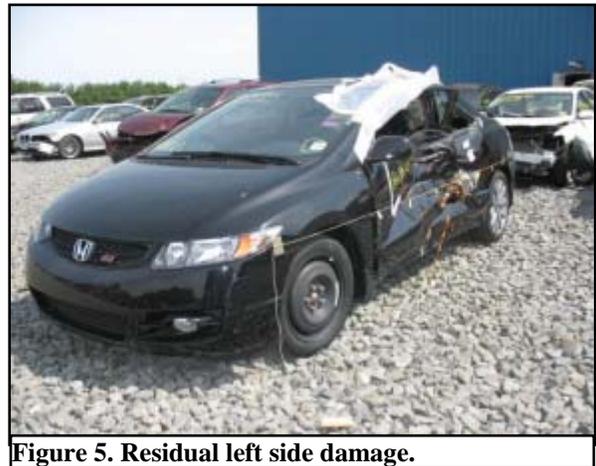
The exterior of the Honda sustained moderate severity damage as a result of the intersection crash (**Figure 5**). The direct contact damage for the impact with the Dodge measured 129 cm (50.1 in) and began 48 cm (18.9 in) forward of the left rear axle. The maximum crush was 20 cm (7.9 in) and was located 141 cm (55.5 in) forward of the left rear axle. The height of the maximum crush was 67 cm (26.3 in).

Figure 5. Residual left side damage.

A crush profile was documented at the mid-door level and was as follows: C1 = 1 cm (0.4 in), C2 = 11 cm (4.3 in), C3 = 16 cm (6.3 in), C4 = 20 cm (7.9 in), C5 = 10 cm (3.9 in), C6 = 0 cm. In addition to the crush profile, a single measurement documenting the distance between the sill and the door was obtained. This measurement is identified as the Door Sill Differential (DSD) and was 13 cm (5 in). The Collision Deformation Classification (CDC) assigned for this crash was 10-LZEW-2.

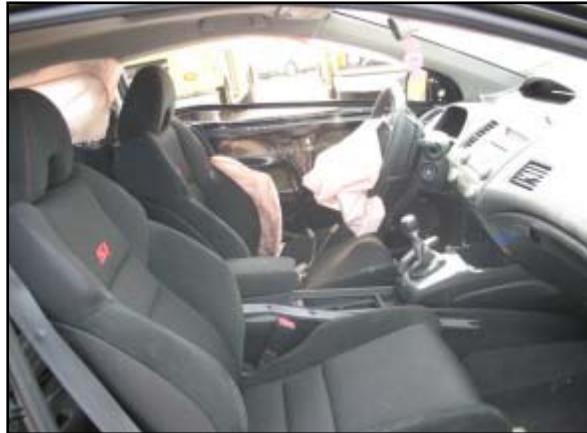
Inspection of the passenger compartment of the Honda revealed damage associated with occupant contacts and passenger compartment intrusions. An occupant contact point was noted to the rear lower quadrant of the left front door panel. This contact was evidenced by deformation to the door panel. A white colored scuff mark was noted to the right aspect of the steering column. The passenger compartment intrusions are listed in the following table:

Figure 6. Overall view of the left front area.

Location	Component	Magnitude	Direction
Left Front	Forward upper quadrant of the left front door	9 cm (3.5 in)	Lateral
Left Front	Left front seat back	7 cm (2.8 in)	Lateral
Left Front	B-pillar	10 cm (3.9 in)	Lateral
Left Front	Roof side rail	3 cm (1.2 in)	Lateral
Left Rear	Side panel rear of B-pillar (plastic panel)	27 cm (10.6 in)	Lateral
Left Rear	Sill	2 cm (0.8 in)	Lateral
Left Rear	Roof side rail	5 cm (1.9 in)	Lateral

The driver's bucket seat track was unbolted during the estimate process and the exact seat track location could not be determined. The driver stated to the SCI investigator that the seat was adjusted to a mid-track position with the seat back in an upright position. The rear seat cushion was also removed during the estimate process and was located in the rear of the vehicle uninstalled. **Figure 6** depicts the front left of the Honda Civic.

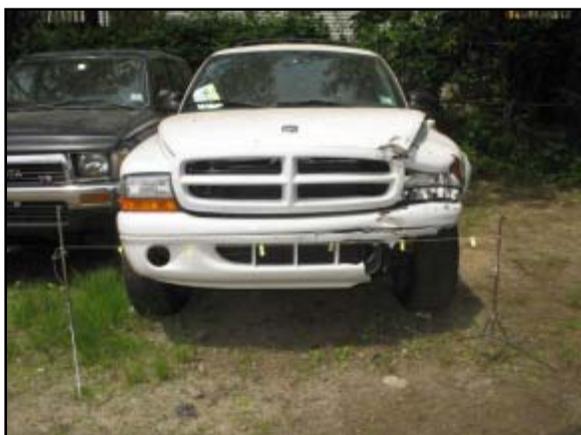
The 2000 Dodge Durango sustained minor frontal damage as a result of the impact with the Honda (**Figure 7**). The direct contact damage was confined to the center and left aspects of the front plane and measured 78 cm (30 in) in width. The direct damage began 5 cm (1.9 in) left of the centerline and extended 83 cm (32.6 in) to left bumper corner. The maximum crush measured 12 cm (4.7 in) and was located at the front left bumper corner. Six equidistant crush measurements were documented along the bumper beam of the vehicle and were as follows: C1 = 12 cm (4.7 in), C2 = 8 cm (3.1 in), C3 = 7 cm (2.8 in), C4 = 3 cm (1.2 in), C5 = 0 cm, C6 = 0 cm. The CDC assigned for this impact was 01-FYEW-1.

Figure 7. Frontal damage to the 2000 Dodge Durango.

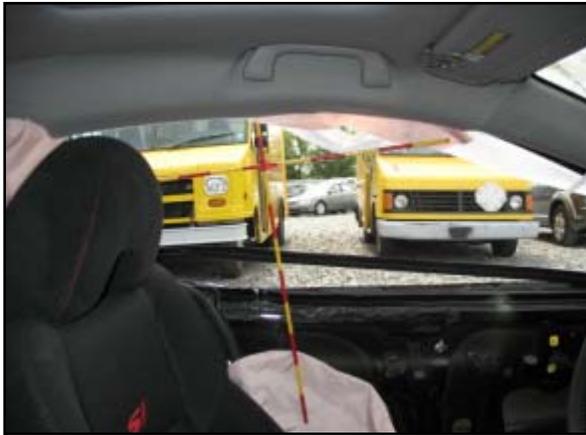
The air bag at the driver's position was cut post-crash. The cut section measured 70 cm (27.6 in) length and was removed from the vehicle (**Figure 8**). A section that measured 7 cm (2.8 in) in height remained attached to the roof rail at the area of the cut fabric. The presence of occupant contacts and damage could not be confirmed at the front position.

Figure 8. Curtain air bag cut from the left front position.

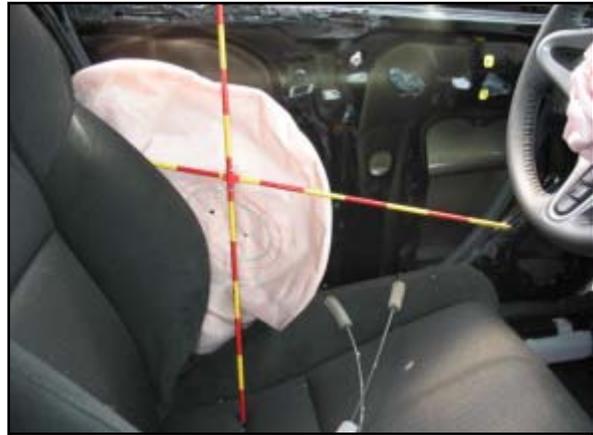
Figure 9. Front seat back mounted air bag.

The left seat back-mounted air bag was concealed within the outboard aspect of the seat back. The air bag deployed through a 44 cm (17.3 in) tear seam at the forward aspect of the seat back. The air bag measured 50 cm (19.7 in) in height and 35 cm (13.8 in) in width and was comprised of two panels sewn together at the forward edge. There was no damage or occupant contact points to the seat back-mounted side air bag. **Figure 9** depicts the inboard aspect of the right seat back-mounted side impact air bag,

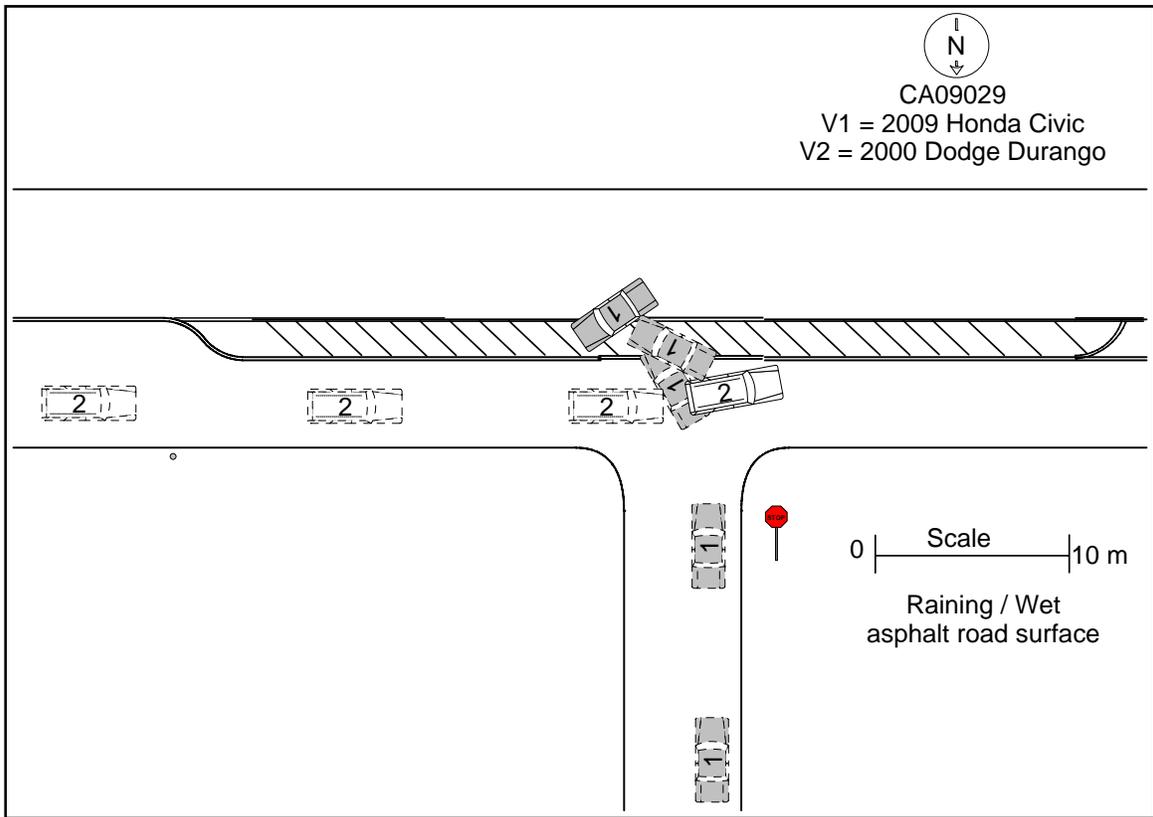
Figure 10: Scene Schematic

This crash occurred during the nighttime hours of February 2009, at a T-intersection. The intersection was comprised of a business driveway and an east/west roadway. The 7.8 meter (25.5 feet) wide driveway was oriented in the north/southbound directions. The travel lanes were not physically separated and were controlled by a stop sign for the exiting southbound lane. The east/west roadway was configured with one travel lane in each direction that was separated by double-yellow centerlines. In the vicinity of the crash site, the double-yellow center lines widened to form a painted median. Both roadways were surfaced with level asphalt and were wet due to rain at the time of the crash. The posted speed limit for east/west roadway was 64 km/h (40 mph). The scene schematic is included as **Figure 10** of this report.
