CALSPAN ON-SITE ROLLOVER CRASH INVESTIGATION
SCI CASE NO.: CA09032

VEHICLE: 2007 GMC SIERRA DENALI CREW-CAB PICKUP TRUCK

LOCATION: NORTH CAROLINA

CRASH DATE: FEBRUARY 2009

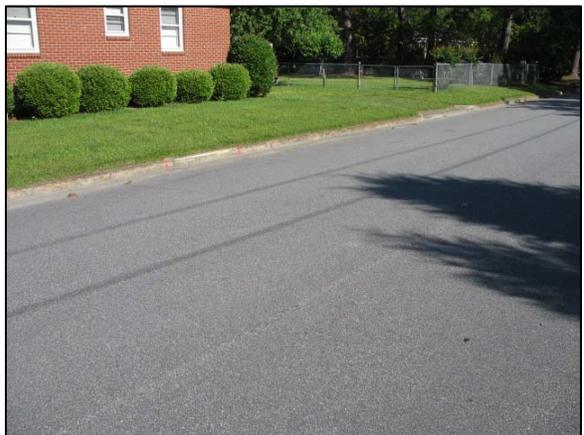
As the front of the Jetta engaged the right side of the GMC, the right rear tire of the GMC rode up the left front aspect of the Jetta. This caused the GMC to initiate a collision-induced rollover event. The GMC rolled left side leading, two-quarter turns onto its roof. The vehicle traveled approximately 15.0 m (49.2 ft) during the rollover sequence in an arced path to the northwest. The GMC came to rest straddling the west curb in the north leg of the intersection (**Figure 3**). The final rest location was evidenced by a gouge still visible in the grass at the time of the scene inspection and abrasions to the curb. The Volkswagen was redirected to a northwest trajectory by the initial impact with the GMC and rotated clockwise as it separated from the impact. The Volkswagen came to rest on the north leg of the intersection facing southeast.

Figure 3: Trajectory of GMC during the rollover.

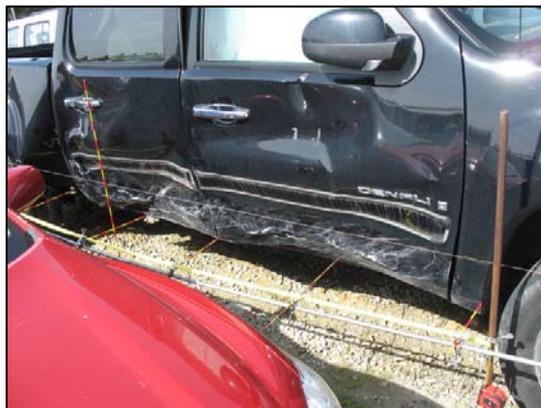
The right, left and top planes of the GMC Sierra Denali were damaged in this multiple event crash. The initial impact involved moderate severity damage to the center aspect of the right plane of the GMC (**Figure 4**). The direct contact damage began 46.0 cm (18.1 in) rear of the right front axle and extended rearward to the right rear wheel area. Lateral crush was present on the right sill and the lower aspect of both doors. The right front and right rear door hinges were intact and remained attached to the A- and B-pillars, respectively. Both right side doors remained closed. The right rear

Figure 4: Initial impact damage to the right side of the GMC.

wheel engaged the Jetta, but was not damaged in the crash. A crush profile for the initial impact was documented at the sill elevation and was as follows: C1 = 0 cm, C2 = 20.0 cm (7.9 in), C3 = 25.0 cm (9.8 in), C4 = 16.0 cm (6.3 in), C5 = 15.0 cm (5.9 in), C6 = 0 cm. The maximum crush was located at C3, 192.0 cm (75.6 in) aft of the right front axle and measured 25.0 cm (9.8 in). The elevation of the maximum crush was 44 cm (17.3 in) which was located at the sill level. As a result of the maximum crush occurring on the right sill, the Door Sill Differential (DSD) was 0 cm. The Collision Deformation Classification (CDC) for the initial impact was 02RPEW2.

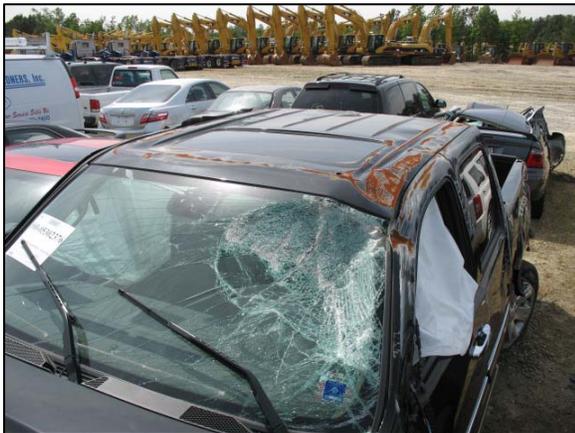
The left and top planes of the GMC were damaged in the rollover event. The scratches on the roof were oriented longitudinally, indicating that the vehicle slid forward on its roof after rolling over two-quarter turns. The direct contact damage to the roof extended laterally from side rail to side rail 153.0 cm (60.2 in). The longitudinal direct contact damage extended longitudinally from the front left of the hood rearward 542.0 cm (213.4 in) to the left rear taillight area. The maximum vertical crush to the roof was 6.0 cm (2.4 in), located at the junction of the left roof side rail and the windshield header. The maximum lateral crush was 1.0 cm (0.4 in), located at the left C-pillar. **Figures 5 and 6** depict the damage sustained by the GMC in the rollover. The CDC for this rollover event was 00TDDO2.

Figure 5: GMC rollover damage from top left.

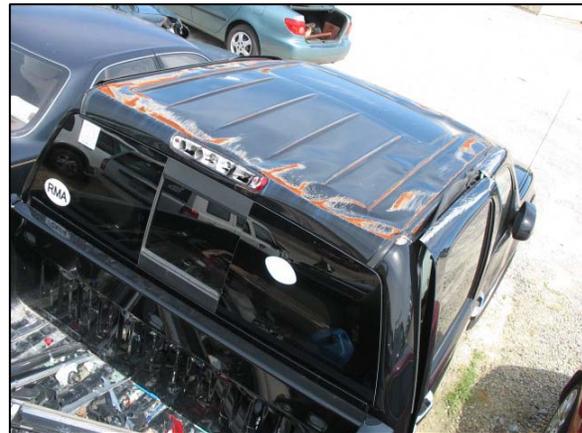
Figure 6: Top damage from rear right.

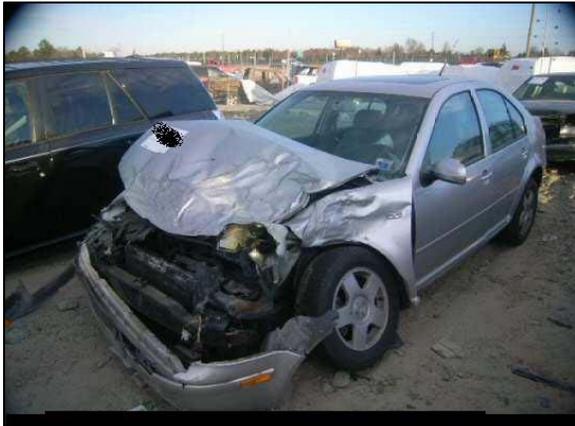
The exterior of the Volkswagen sustained moderate severity damage as a result of the initial impact with the GMC. The direct damage extended from the left bumper corner to the right bumper corner and a profile was estimated from images obtained from the salvage yard that had sold the vehicle. This estimated crush profile was as follows: C1 = 3.0 cm (1.2 in), C2 = 3.0 cm (1.2 in), C3 = 4.0 cm (1.6 in), C4 = 6.0 cm (2.4 in), C5 = 5.0 cm (2 in), C6 = 0 cm. The estimated maximum crush was located left of the centerline of the vehicle. The CDC based on the images of the damaged vehicle was 11FDEW1. **Figures 7 and 8** depict the frontal damage sustained by the Volkswagen in the initial impact.

Figure 7: Impact damage to the Volkswagen from the front left.

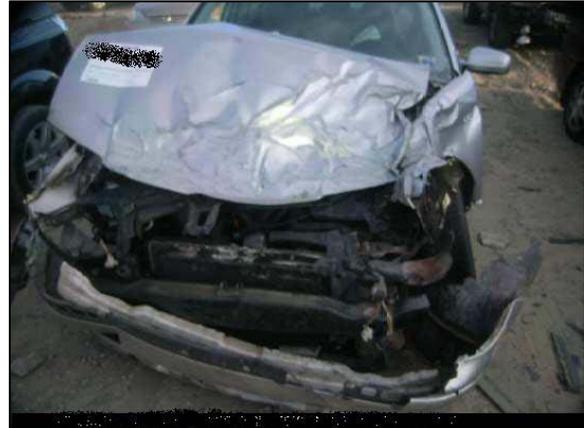
Figure 8: Frontal damage to the Volkswagen.

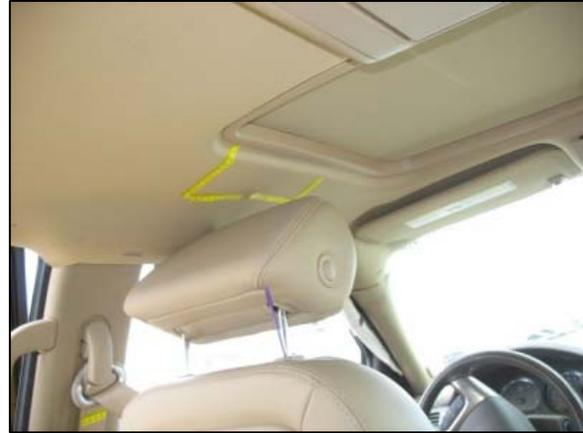
The interior of the GMC sustained damage attributed to occupant contact. There was a scuff with hair on the headliner (**Figure 9**) located 13-23.0 cm (5.1-9.1 in) inboard of the left roof side rail and 29.0 - 45.0 cm (11.4 - 17.7 in) rear of the windshield header.

Figure 9: Roof contact attributed to driver's head.

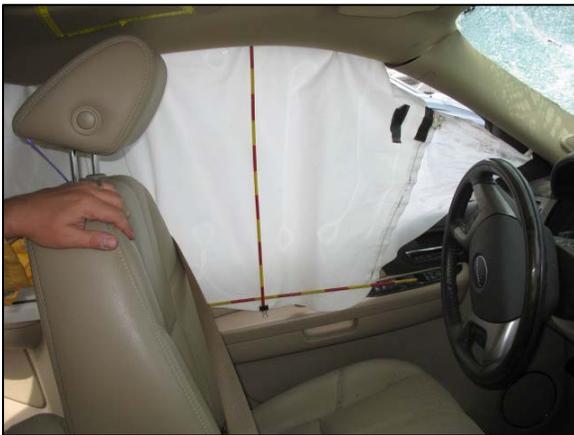
The left IC contained an abrasion on the outboard side, in the area of the left front glazing, which disintegrated during the crash sequence. The abrasion was located 26.0 – 42.0 cm (10.2 - 16.5 in) above the lower edge of the curtain and 37.0 – 56.0 cm (14.6 – 22.0 in) rear of the front. This abrasion was attributed to contact with the ground as the GMC rolled onto its left side plane. There were no identified contacts to the interior side of the left IC. The right IC was free from occupant contact points and damage. **Figures 10 and 11** depict the left and right IC air bags.

Figure 10: Forward aspect of left Inflatable Curtain.

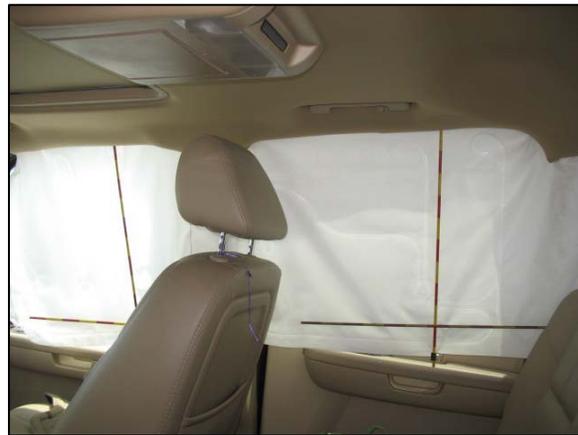
Figure 11: Right Inflatable Curtain.
