## ON-SITE ROLLOVER INVESTIGATION

CASE NUMBER - IN09032

VEHICLE - 2008 HONDA CR-V EX

CRASH DATE - July 2009

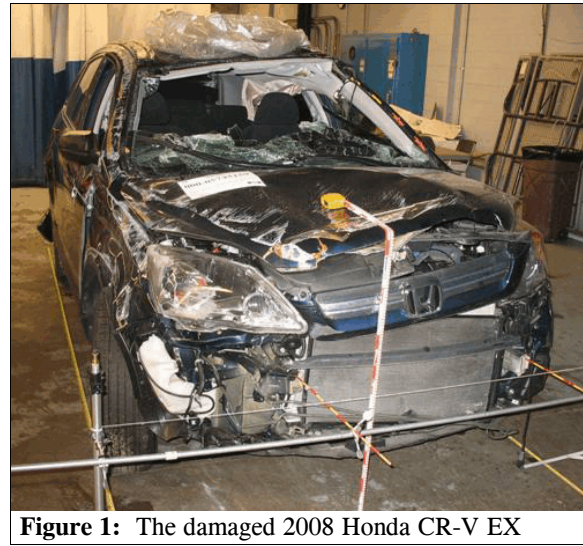
**Figure 1:** The damaged 2008 Honda CR-V EX

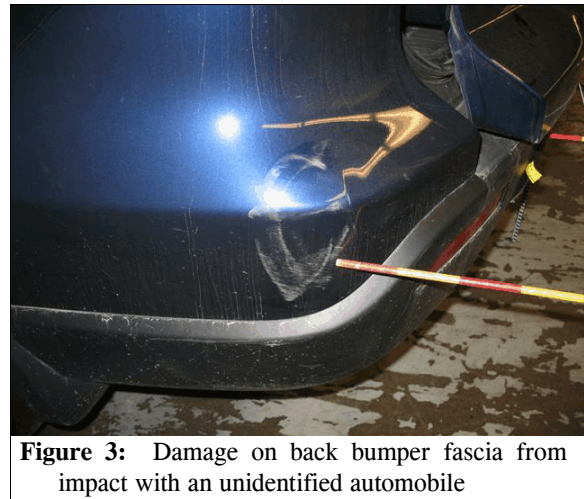
**Figure 3:** Damage on back bumper fascia from impact with an unidentified automobile

**Exterior Damage:** The impact with the unidentified automobile (event 1) involved the left side plane of the Honda. The direct damage involved the left rear corner of the back bumper and consisted of scratches on the bumper fascia. The direct damage began 92 cm (36 in) rear of the left rear axle and extended 8 cm (3.1 in) along the side of the back bumper fascia. There was no residual crush as a result of this impact.

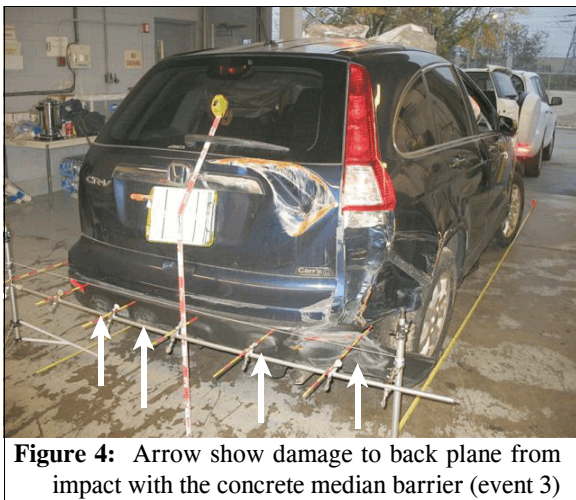
**Figure 4:** Arrow show damage to back plane from impact with the concrete median barrier (event 3)

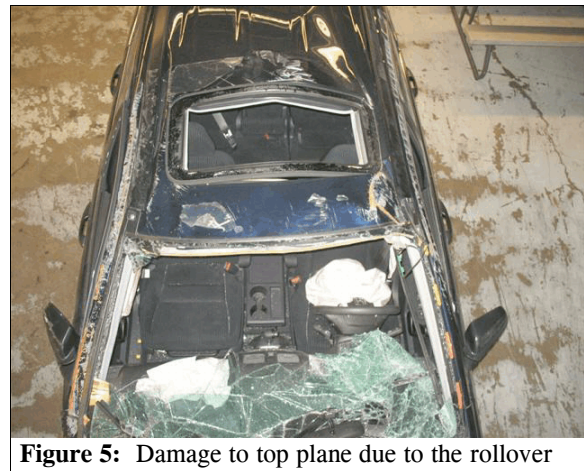
**Figure 5:** Damage to top plane due to the rollover

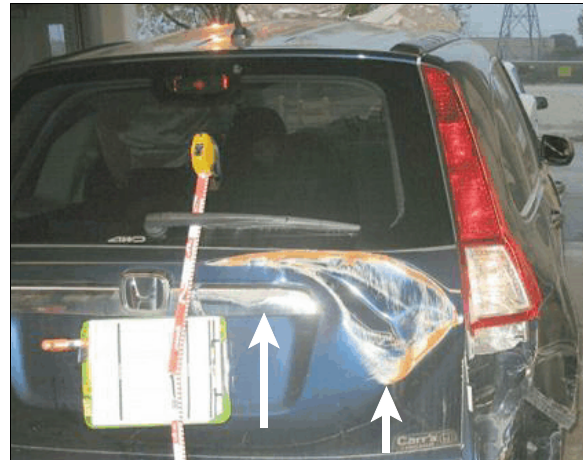
**Figure 6:** Arrows shows the damage to the tailgate from impact with the median barrier during the rollover (event 5)

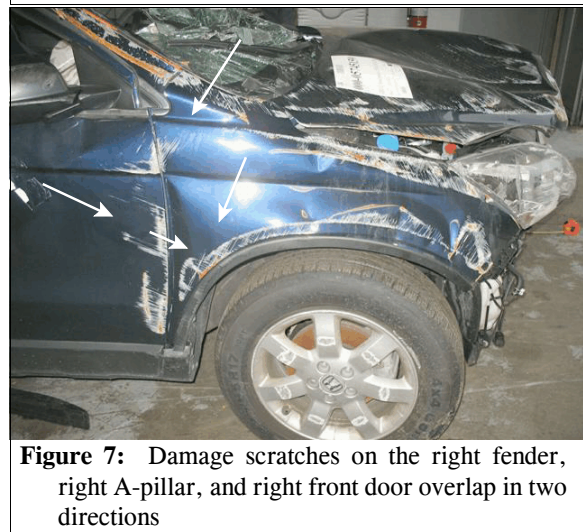
**Figure 7:** Damage scratches on the right fender, right A-pillar, and right front door overlap in two directions

The rollover of the Honda (event 4) occurred following the back plane impact with the concrete median barrier (event 3). As the vehicle rotated counterclockwise off the median barrier, the friction between the left side tires and the pavement caused the vehicle to rollover left side leading. Overlapping scratches formed in two directions on the right fender, right A-pillar, right front door (**Figure 7**), and the left A-pillar indicated that it probably rolled over 8 quarter turns. The vehicle came to final rest on its wheels heading northeast. Due to traffic conditions, it was not possible to inspect the crash scene. The specific location of rollover initiation and the distance traveled during the rollover could not be determined.

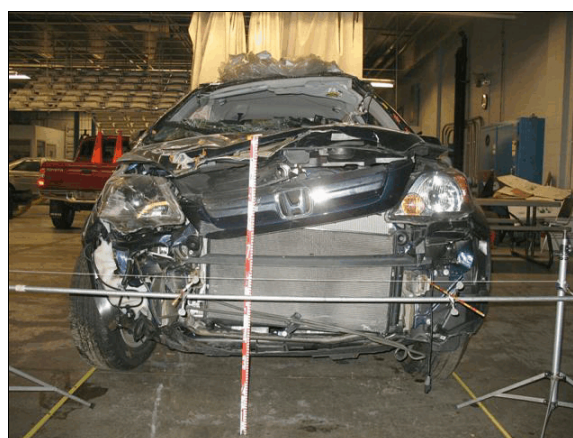
The Honda’s first impact with the concrete median barrier (event 2) involved the front plane (Figure 8). The front bumper, bumper fascia, grille, hood, and the right headlamp/turn signal assembly were directly damaged. The direct damage began at the front right bumper corner and extended 80 cm (31.5 in) across the front bumper. The front bumper was torn off the vehicle, so two crush measurements were taken, one on each frame member. The maximum residual crush was 12 cm (4.7 in) occurring on the right frame member (C<sub>2</sub>). The table below shows the front crush profile.

**Figure 8:** Front plane damage on the Honda from impact with the median barrier

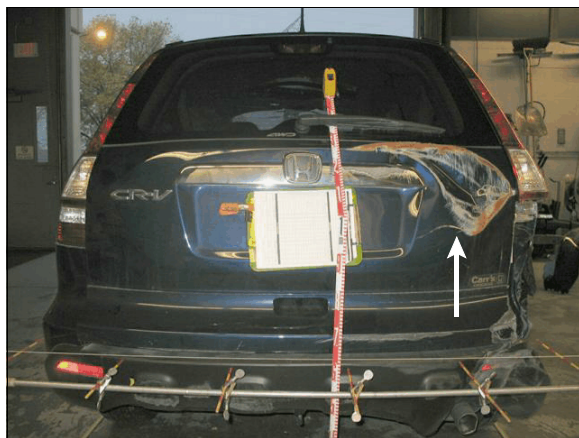
The Honda’s second impact with the median barrier (event 3) involved the back plane. The back bumper, right lower portion of the tailgate, and right taillight assembly were directly damaged (Figure 9). The direct damage began on the back right bumper corner and extended 125 cm (49.2 in) along the bumper. The crush measurements were taken on the back bumper and the maximum residual crush was 7 cm (2.8 in) occurring at C<sub>6</sub> (Figure 10). The induced damage involved the right quarter panel. The table below shows the back crush profile.

**Figure 9:** Damage on the Honda’s back bumper from the impact with median barrier; arrow shows the damage on the tailgate that occurred during the rollover

The impact with the median barrier that occurred during the rollover (event 5) involved the back plane. The tailgate was directly damaged. The direct damage was located between the bottom of the backlight and the bottom of the tailgate and involved approximately the right half of the tailgate (**Figure 9**).

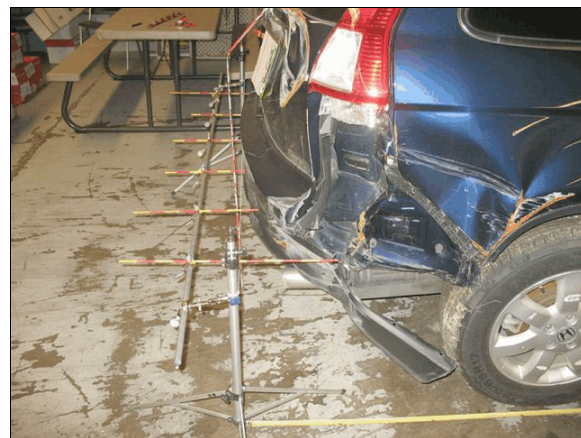
**Figure 10:** Right side view of the back bumper crush

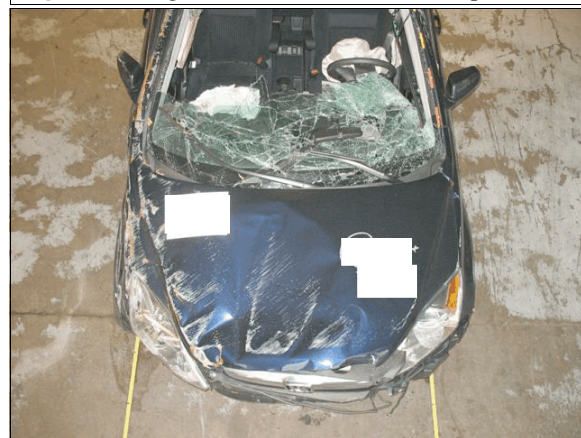
**Figure 11:** Damage to top plane due to the rollover

The rollover (event 4) involved Honda’s top and both side planes. The direct damage on the top plane began at the front of the hood (**Figure 11**) and extended to 4 cm (1.6 in) rear of the left rear axle, and involved the full width of the roof, 103 cm (40.6 in). The direct damage on the left side plane was limited to the fender, left A-pillar, and roof side rail. It began 8 cm (3.1 in) forward of the left front axle and extended 17 cm (6.7 in) rearward on the fender. The direct damage on the left A-pillar began 76 cm (29.9 in) rear of the left front axle and extended rearward on the pillar and along the left roof side rail to the C-pillar. The direct damage on the right side plane began at the front of the fender and extended intermittently along the full length of the vehicle. It involved the fender, roof side rail, both doors and the quarter panel. The maximum residual lateral crush was 4 cm (1.6 in) and occurred at the top of the right A-pillar. The maximum vertical crush (**Figure 12**) was 5 cm (2 in) and occurred at the right corner of the windshield header. Both crush points were located 102 cm (40.2 in) rear of the right front axle.

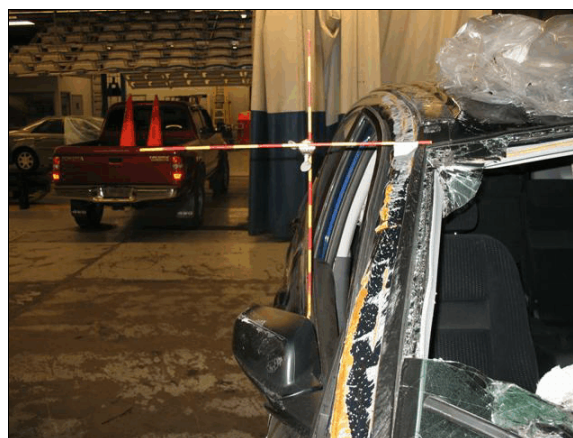
**Figure 12:** The location of the maximum vertical and lateral crush on the Honda

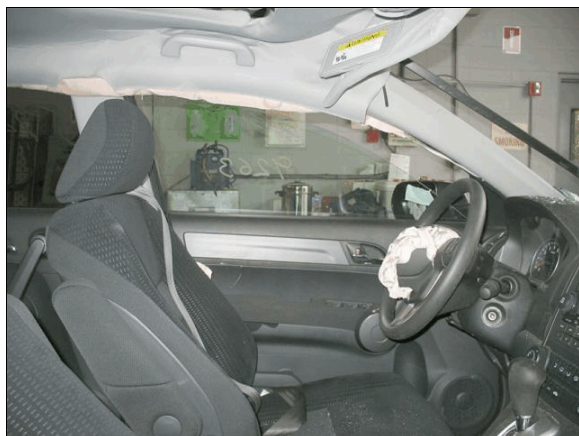
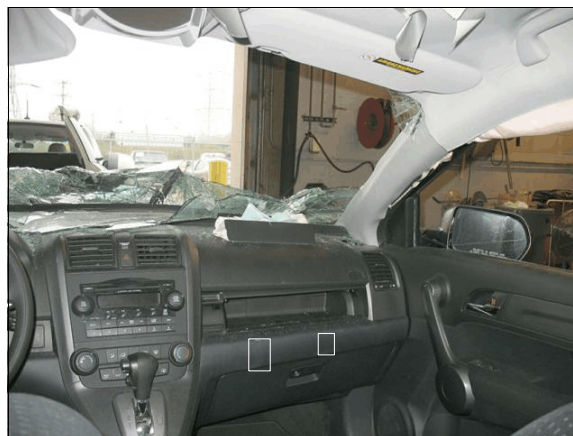
**Vehicle Interior:** The inspection of the Honda's interior (**Figures 13 and 14**) revealed evidence of probable occupant contacts on the right instrument panel above the glove box from the front passenger's knees. There was a possible occupant contact on the center instrument panel adjacent to the top left corner of the glove box door possibly from the passenger's left knee. No discernable occupant contact evidence associated with the driver was observed.

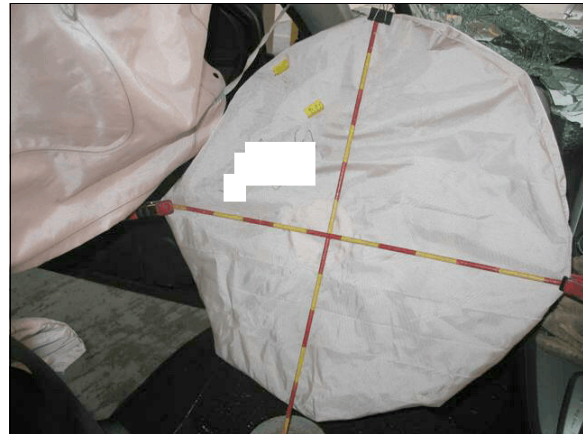
was 8 cm (3.1 in) in width as measured along the tear seams. An inspection of the air bag module cover flaps revealed that they opened at the designated tear points and were undamaged. The deployed air bag (**Figure 15**) was round with a diameter of 60 cm (23.6 in). It was designed with two 4 cm (1.6 in) diameter vent ports located on the back of the air bag at the 11 and 1 o'clock positions. Inspection of the air bag revealed no damage. Two blood transfers were present within the upper left quadrant. The blood transfers appeared to be related to blood spatter and not direct occupant contact.

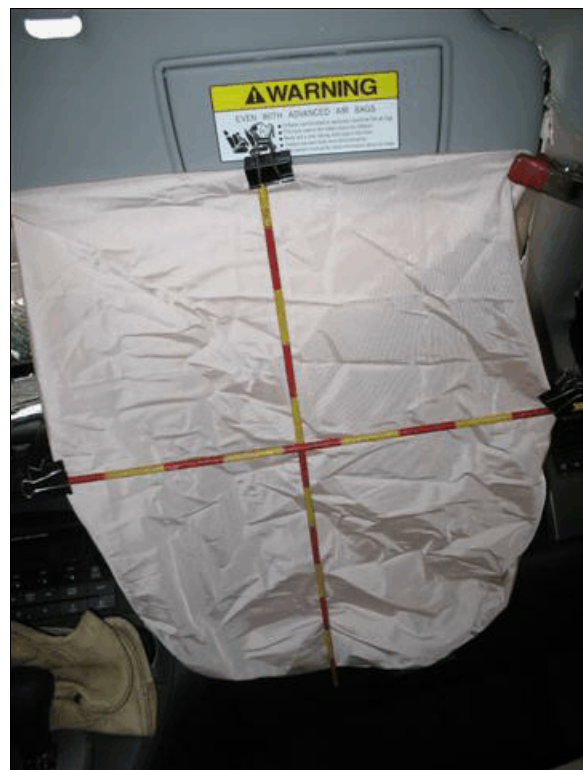
The passenger's frontal air bag was located in the top of the instrument panel and the module cover was a horizontal two-flap configuration constructed of medium gauge vinyl. Both the top and bottom flaps were 24.5 cm (9.6 in) in width and 6 cm (2.4 in) in height. An inspection of the air bag module cover flaps revealed that they opened at the designated tear points and were undamaged. The deployed air bag (**Figure 16**) was rectangular with a width of 44 cm (17.3 in) and a height of 60 cm (23.6). The air bag was not designed with vent ports. Inspection of the air bag revealed no damage. Several small blood transfers were located on the upper right and lower left quadrants, but these appeared to be related to blood spatter.

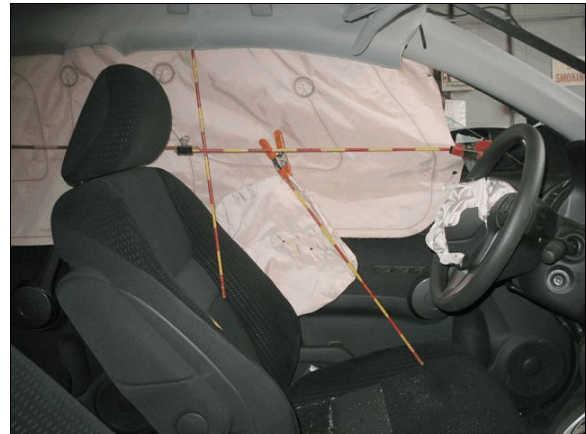
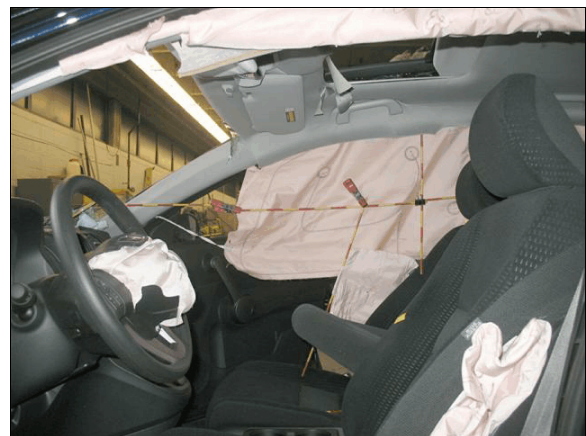
The IC air bags (**Figures 17 and 18**) were located along the roof side rails inside the headliner and extended from the top of the A-pillar to slightly behind the C-pillar. They were designed with inflation chambers adjacent to the outboard seat positions. The deployed IC air bags were 177 cm (69.7 in) in width and 42 cm (16.5 inches) in height. They were attached at the lower A-pillars by a 33 cm (13 in) rope tether. The IC air bags extended 11 cm (4.3 in) below the beltline. The gap between the bottom of IC air bags and the and the front of the window frame at the beltline was 27 cm (10.6 in). There was no visible tether at the C-pillar. Inspection of the ICs revealed no discernable evidence of occupant contact, and they sustained no damage.

The driver's and front passenger's seat-mounted side impact air bags were located in the outboard side of the respective seat backs and deployed from behind a triangular-shaped plastic trim panel. The deployed air bags (**Figures 17 and 18**) were 36 cm (14.2 inches) in height and

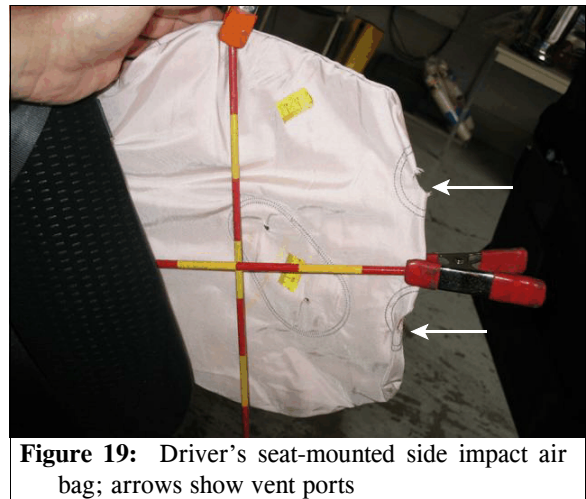
23 cm (9.1 in) in width at the top. Each air bag had an oval-shaped area in the approximate center of the air bag where both sides were sewn together. There were two vent ports on the leading edge of each air bag (**Figure 19**). Inspection of the deployed air bags revealed no damage and no discernable evidence of occupant contact. A yellow mark and small black mark were present on the inboard surface of the driver's air bag, which did not appear to be related to occupant contact. A yellow mark was also located on the front passenger's air bag in the same location.

**Figure 19:** Driver's seat-mounted side impact air bag; arrows show vent ports
