On-Site Side Air Bag Investigation
Dynamic Science, Inc. (DSI), Case Number DS09033
2008 Toyota Corolla
Washington
October 2009

1. Report No. DS09033		2. Government Accession No.		3. Recipient Catalog No.	
4. Title and Subtitle On-Site Side Air Bag Investigation				5. Report Date April 2, 2010

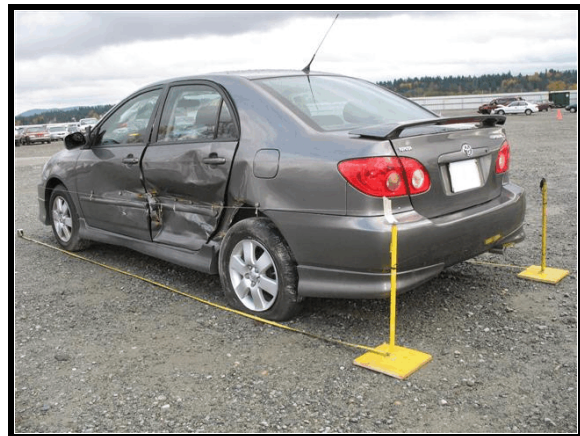
The Toyota sustained direct and induced damage to the left side as a result of the impact with the Thomas Built bus (**Figure 4**). Direct damage began 25.0 cm (9.8 in) aft of the rear axle and extended forward 209.0 cm (82.2 in). The Field L began 25.0 cm (9.8 in) aft of the rear axle and extended forward 200.0 cm (78.7 in). Vertically, the direct damage began 20.0 cm (7.9 in) above the sill and extended upward 56 cm (22.0 in) to the belt line. Six crush measurements were documented at the mid-door level: $C_1 = 0$ cm, $C_2 = 8.0$ cm (3.1 in), $C_3 = 11.0$ cm (4.3 in), $C_4 = 7.0$ cm (2.8 in), $C_5 = 6.0$ cm (2.4 in), $C_6 = 0$ cm. Maximum crush was located between C_3 and C_4 and measured 12.0 cm (4.7 in). The Collision Deformation Classification (CDC) was 11LZEW2. The Toyota sustained direct contact to the

Figure 4. Left side damage

second row door panel from the impact with the bus. The Toyota's sill height measured 28.0 cm (11.0 in), height of maximum door crush measured 62.0 cm (24.4 in), and the Door Sill Differential (DSD) measured 10.0 cm (3.9 in).

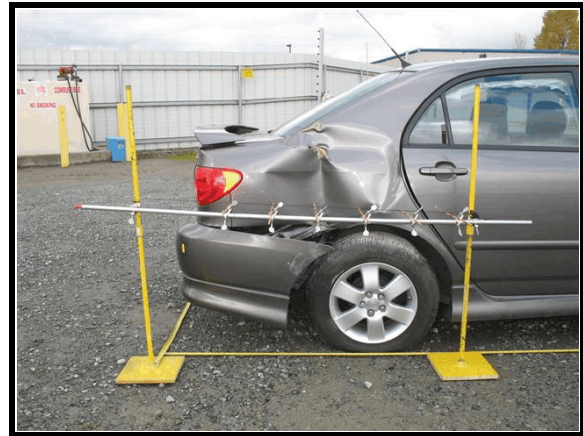
The Toyota sustained direct and induced damage from the impact with the pole (**Figure 5**). Direct damage began 40.0 cm (15.7 in) aft of the rear axle and extended forward 56.0 cm (22.0 in). The Field L began 66.0 cm (25.9 in) aft of the rear axle and extended forward 96.0 cm (37.8 in). Six crush measurements were documented at the mid-door level: $C_1 = 0$ cm, $C_2 = 6.0$ cm (2.4 in), $C_3 = 12.0$ cm (4.7 in), $C_4 = 8.0$ cm (3.1 in), $C_5 = 8.0$ cm (3.1 in), $C_6 = 0$ cm. The CDC for this impact was 03RBAW2.

Figure 5. Right side damage

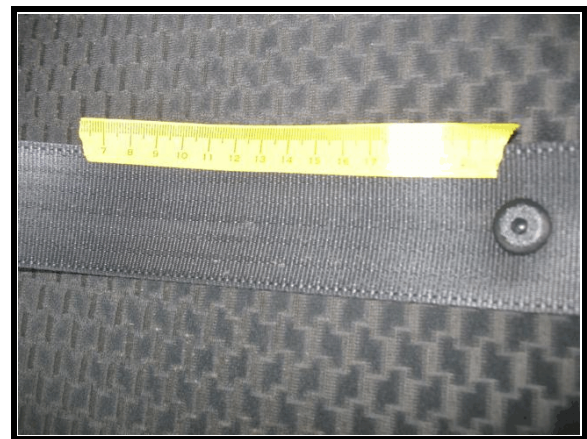
The driver's safety belt D-ring anchorage was in the full-up position. The latch plate was scratched and the shoulder belt revealed wear marks indicating historical usage. There was an area of fraying that measured 15.0 cm (5.9 in) and was located 60.0 cm (23.6 in) from the anchorage (**Figure 6**). The safety belt pretensioner did not actuate in this crash.

Figure 6. Area of fraying to driver's safety belt webbing

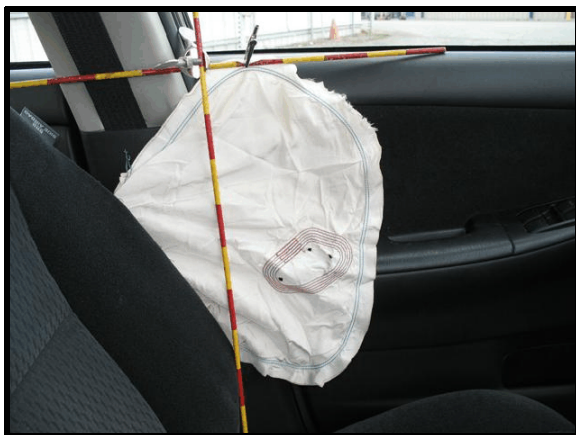
The left seat-mounted side air bag deployed from a module located in the left seat-back (**Figure 7**). The air bag was oval in shape and measured 40.0 cm (15.7 in) in height and 30.0 cm (11.8 in) in width. The air bag was configured with three vent ports located in the non-inflatable section of the air bag. The air bag was configured without internal tethers. A 8.0 x 5.0 cm (3.1 x 1.9 in) skin oil transfers was located toward the middle of the air bag. On the outboard portion of the air bag there was a 4.0 x 4.0 cm (1.6 x 1.6 in) area of black marks that were a result of contact with the interior door surface.

Figure 7. Driver seat-mounted side air bag

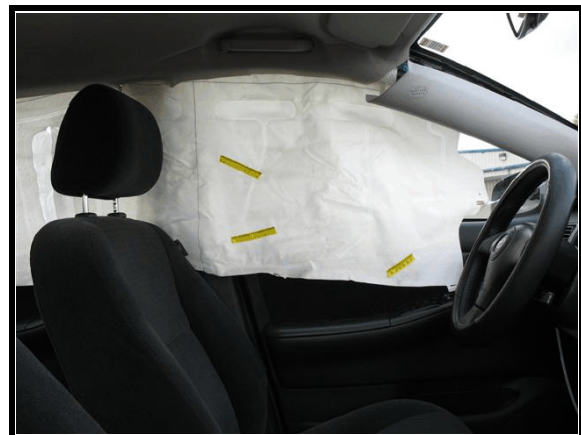
The left IC air bag deployed from a module in the left roof rail above the front and second rows. The IC air bag measured 156.0 cm (61.4 in) in length, 48.0 cm (18.9 in) in height, and extended 16.0 cm (6.3 in) below the window frame. Two areas of possible skin contacts were located on the interior of the air bag near the B-pillar (**Figure 8**). The right IC deployed from a module in the right roof rail above the front and second rows. The air bag was configured the same as the driver's side; there was no damage to the air bag and no contacts identified.

Figure 8. Left IC air bag and possible contacts

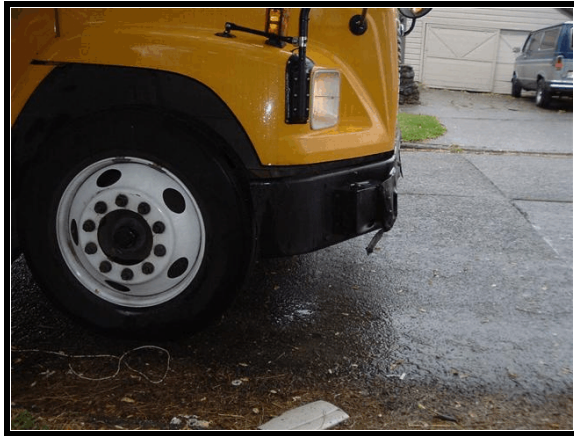
Figure 9. Front right damage (owner photo)

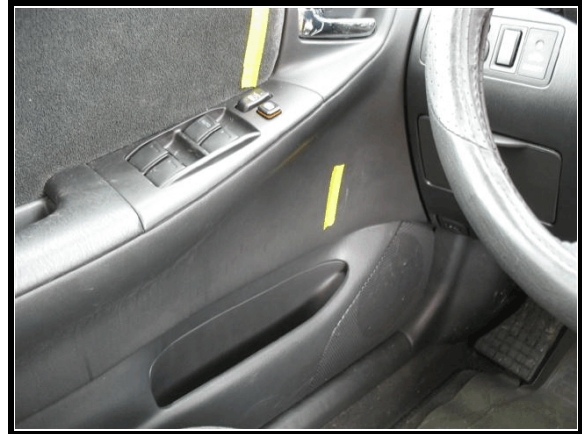
At impact with the bus, the left seat-mounted side air bag and IC air bag deployed. The driver was displaced forward and left in response to the direction of force. He loaded the safety belt and contacted the deployed side air bag and IC air bag. He contacted the steering column with his right knee and the left door panel with his left knee (**Figure 11**). During the right side impact he was slightly displaced to the right but remained belted within his seat. The driver of the Toyota had no obvious injuries but did complain that his back was sore.

Figure 11. Left knee contact to door panel
