**CALSPAN ON-SITE SIDE IMPACT INFLATABLE
OCCUPANT PROTECTION SYSTEM CRASH INVESTIGATION
SCI CASE NO: CA09035**

VEHICLE: 2008 FORD FOCUS

LOCATION: VIRGINIA

CRASH DATE: APRIL 2009

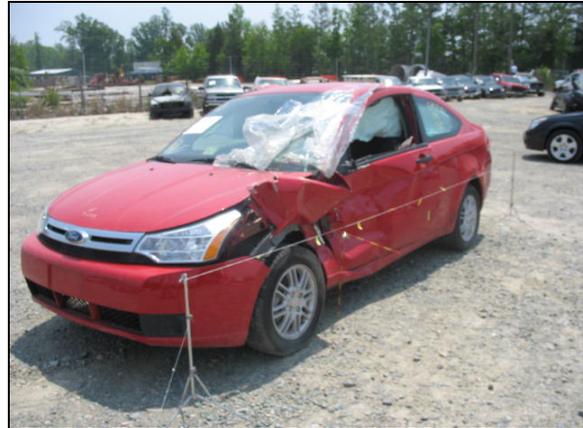
This investigation focused on the deployment of the side impact air bag protection system in a 2008 Ford Focus (**Figure 1**). The Ford was involved in an intersection crash with a 2006 GMC Envoy. The Ford was equipped with side impact Inflatable Curtain (IC) air bags, front row seatback-mounted side impact air bags, Certified Advanced 208-Compliant (CAC) frontal air bags and front row safety belt pretensioners. The crash occurred when the southbound Ford was struck on the left side by the frontal area of the westbound GMC as both vehicles entered a 4-leg intersection. The crash

Figure 1: Left front oblique view of the 2008 Ford Focus.

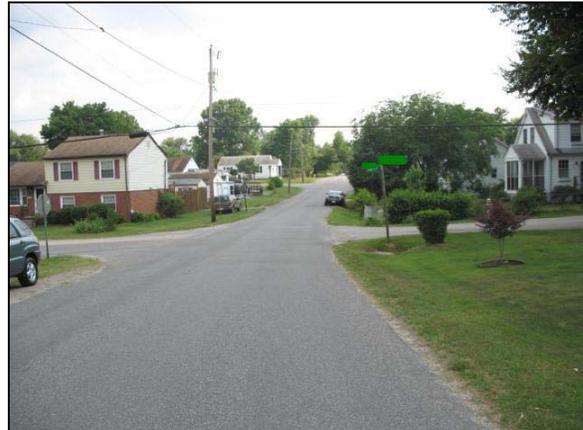
Figure 2: Southbound view for the Ford's pre-crash path of travel

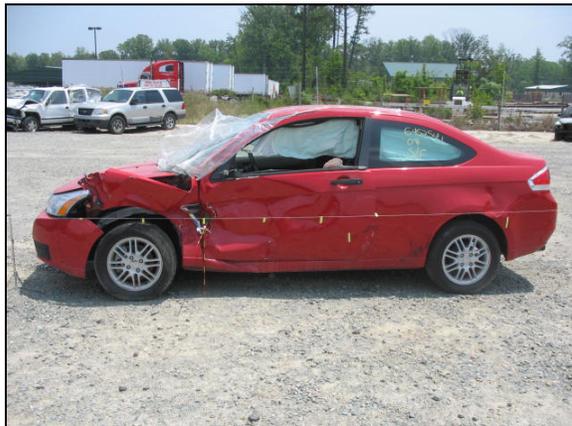
The exterior of the Ford sustained two separate impacts to the left side plane (**Figure 3**). The initial impact damage was located on the left front fender and door while the secondary side slap was located on the left rear quarter panel. The direct contact damage for the initial impact event began 104 cm (40.9 in) forward of the left rear axle and extended 195 cm (76.8 in) forward to the left front corner. The impact resulted in deformation to the left front fender, left door panel, A-pillar and sill areas. The Ford's left wheelbase was reduced by 2 cm (0.8 in). The combined induced and direct contact damage began 77 cm (30.3 in) forward of the left rear axle position and extended 222 cm (87.4 in) forward to the left front corner. The crush profile was measured at the mid-door level and was as follows: C1 = 3 cm (1.2 in), C2 = 3 cm (1.2 in), C3 = 11 cm (4.3 in), C4 = 23 cm (9.1 in), C5 = 10 cm (3.9 in), C6 = 15 cm (5.9 in). The maximum crush was located at C4. The Collision Deformation Classification (CDC) for this impact event was 10LYEW2.

Figure 3: View of the crush profile on the left side of the Ford (Event 1).

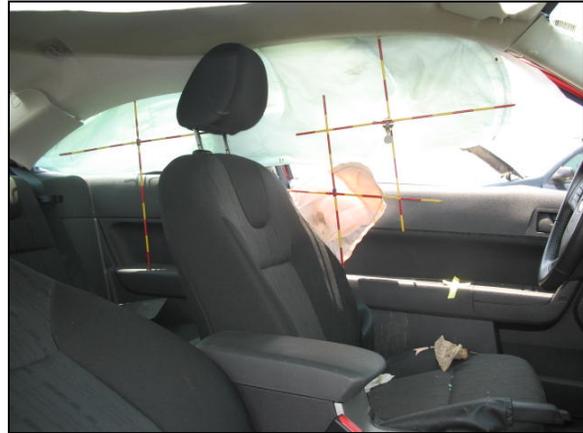
The Ford was equipped with IC air bags (**Figure 4**) mounted in the roof side rails. Both IC air bags deployed as a result of the crash sequence. The IC air bags measured 150 cm x 36 cm (59.1 in x 14.2 in) length x height in overall dimensions and provided coverage from the upper aspect of the A- to C-pillar area. A non-inflatable sail panel was sewn to the forward aspect of the curtain to fill the triangular void at the forward aspect of front glazing formed by the slope of the A-pillars. This area measured 20 cm x 29 cm (7.9 in x 11.4 in) length x height. A 12 cm (4.7 in) long tether extended from the lower portion of the A-pillar and was sewn to the forward aspect of the sail panel. The vertical coverage of the curtain extended to 5 cm (2 in) above the beltline within the front row. However, the second row coverage extended to the beltline. There was no contact evidence or damage to the deployed IC air bags.

Figure 4: View of the left side (IC) air bag and the driver seatback mounted air bag in the Ford.

The Ford was also equipped with front row seatback-mounted side impact air bags. The driver's seatback air bag deployed as a result of the crash. This air bag was trapezoidal in shape with overall measured dimensions of 37 cm x 28 cm (14.6 in x 11 in) length x height. This air bag deployed from a stitched seam within the seat back that measured 35 cm (13.8 in) in height. A reddish brown discoloration of body fluid was found on the inboard aspect of the air bag. It was located 22cm to 27 cm (8.7 in to 10.6 in) inboard of the leading edge and 7 cm to 17 cm (2.8 in to 6.7 in) below the top of the air bag. A 9cm (3.5 in) overlap existed between the deployed seatback air bag and IC air bag curtain.

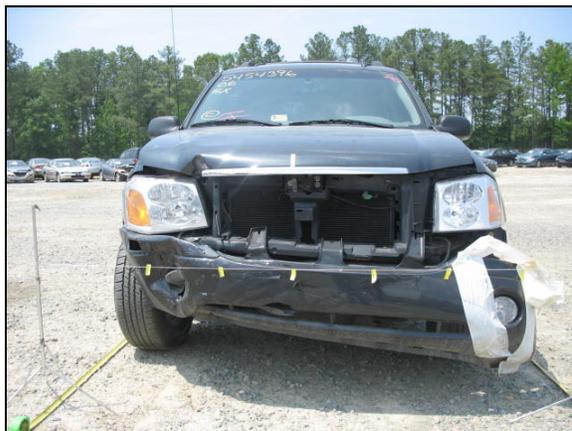
The GMC sustained front and right side damage as a result of the crash sequence. The first event produced frontal damage (**Figure 5**) which consisted of deformation to the front bumper fascia, bumper reinforcement beam, right head lamp assembly and the hood. The direct contact damage began 62 cm (24.4 in) left of the bumper beam centerline and extended 142 cm (55.9 in) to the right front bumper corner. The crush profile measured along the bumper fascia was as follows: C1 = 15 cm (5.9 in), C2 = 1 cm (0.4 in), C3 = 2 cm (0.8 in), C4 = 3cm (1.2 in), C5 = 0 cm, C6 = 37 cm (14.6 in). The CDC for this damage was 01FDEW2.

Figure 5: View of the crush profile on the front plane of the GMC (Event 1)

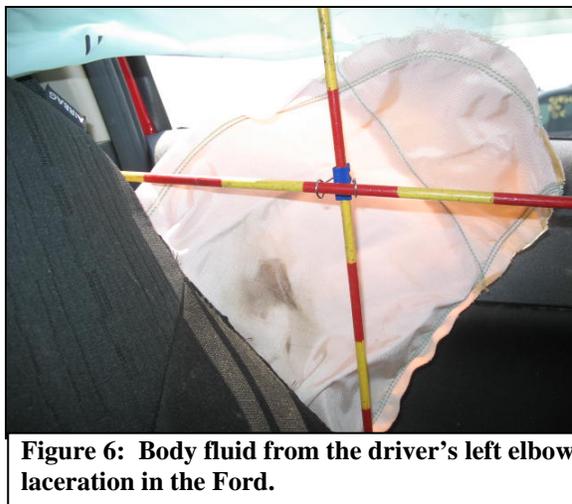
During the initial engagement between the vehicles, the left front door of the Ford deformed and the glazing disintegrated. The crash forces were sufficient to deploy the side impact sensing left seatback-mounted air bag and the IC air bags, and actuate the driver's buckle pretensioner. The actuated pretensioner removed slack from the belt system and tightened the webbing around the driver as the driver responded to the 10 o'clock direction of force by initiating a left and slightly forward trajectory. He loaded the safety belt system, evidenced by the frictional abrasions on the latch plate. The driver's left elbow impacted the presumed left rear upper quadrant of the left front door panel. As the elbow struck the panel, glass fragments were captured between the elbow and the door panel resulting in an irregular 5 cm (2 in) laceration of the posterior aspect of the elbow with glass embedded into the laceration. There was no contact evidence on the interior surfaces with the exception of a body fluid stain on the inboard aspect of the deployed seatback-mounted airbag (**Figure 6**).
