On-Site Certified Advanced 208-Compliant Investigation
Dynamic Science, Inc. (DSI), Case Number DS09035
2007 Chevrolet Equinox
Arizona
August 2009

1. Report No. DS09035	2. Government Accession No.		3. Recipient Catalog No.	
4. Title and Subtitle On-Site Certified Advanced 208-Compliant Investigation		5. Report Date May 13, 2010

Dynamic Science, Inc.
Crash Investigation
Case Number: DS09035

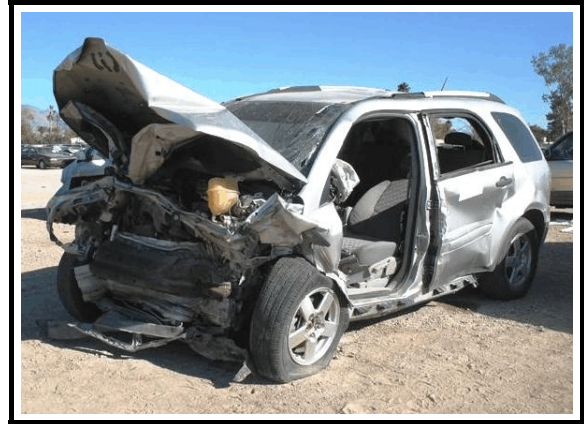
Figure 1. Subject vehicle, 2007 Chevrolet Equinox

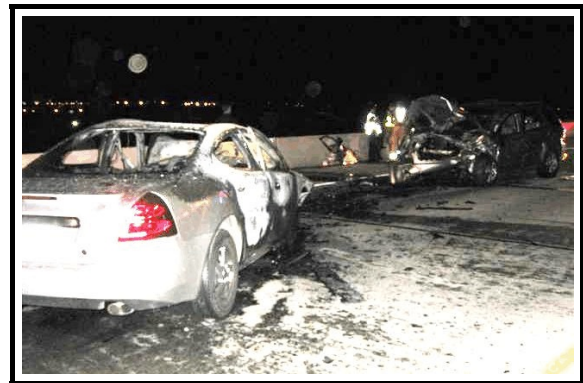
The front end of the Chevrolet impacted the front end of the Pontiac in a head-on configuration. The Chevrolet was displaced rearward and came to rest in the outboard lane facing 10 degrees clockwise from its at-impact heading angle. The Pontiac was displaced rearward and left, and came to rest in both lanes facing 20 degrees counterclockwise from its at-impact heading angle. Based on the police report, the vehicles' at-rest locations measured 5.0 m (16.4 ft) apart (**Figure 3**). Minutes after the impact, the Pontiac caught fire and sustained major fire damage.

Figure 3. At-rest positions of vehicles, subject vehicle in background (police photograph)

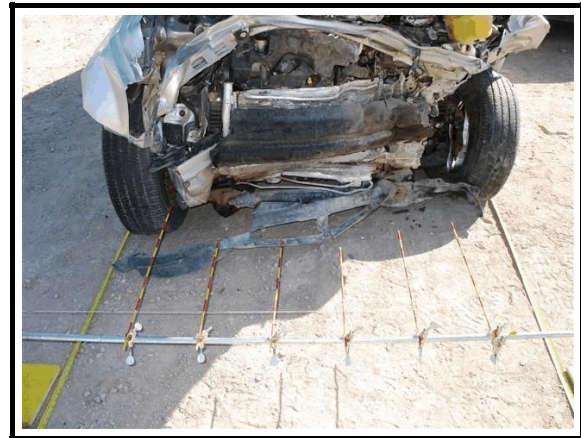
The Chevrolet sustained direct damage to the front end and induced damage to the front, left, right, bottom, and top planes. The front axle was displaced rearward 51.0 cm (20.1 in) on the left side and 14.0 cm (5.5 in) on the right side. Direct damage to the front end was distributed from bumper corner to bumper corner and measured 156.0 cm (61.4 in). The bumper fascia was displaced from the vehicle during the crash and the bumper backing bar was used to obtain longitudinal crush measurements. The Field L included the entire length of the bumper backing bar and measured 105.0 cm (41.3 in) (**Figure 4**). Six crush measurements were taken at bumper level as follows: $C_1 = 105.0$ cm (41.3 in), $C_2 = 101.0$ cm (39.8 in), $C_3 = 91.0$ cm (35.8 in), $C_4 = 85.0$ cm (33.5 in), $C_5 = 78.0$ cm (30.7 in), $C_6 = 64.0$ (25.2 in). Maximum crush was located at C_1 . The Collision Deformation Classification (CDC) for Event 1 was 12FDEW5.

Figure 4. Front end crush profile measurement

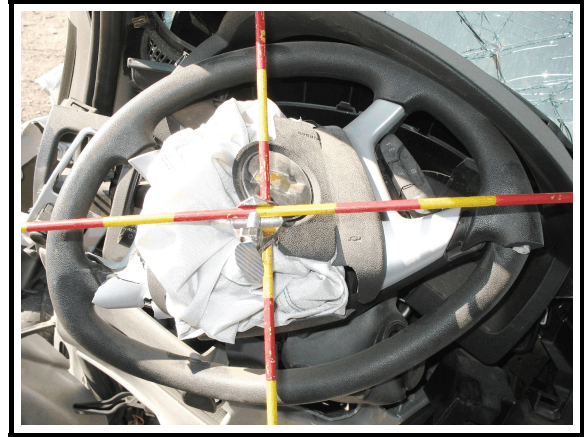
bag, IP, seat cushion back, center console, and steering wheel. The air bag exhibited scuffs and transfers; the IP, seat cushion and seat back were scuffed; and the center console was deformed. The steering wheel rim was fractured completely through and sustained deformation to all four quadrants (**Figure 5**). The steering wheel rim collapsed due to loading and was deformed 7.0 cm (2.8 in) laterally, 14.0 cm (5.5 in) vertically, and 3.0 cm (1.2 in) longitudinally relative to the hub. The steering column was displaced upward 13.0 cm (5.1 in) vertically, 6.0 cm (2.4 in) laterally left, and 3.0 cm (1.2 in) longitudinally rearward.

Figure 5. Steering wheel rim deformation

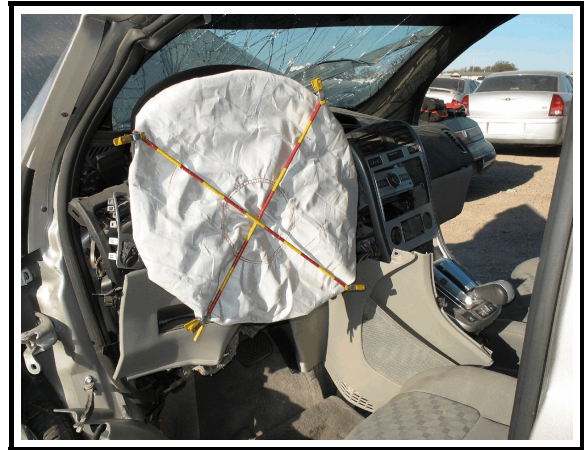
The frontal air bag deployed from the steering wheel hub through an I-configured cover flap. The air bag was oval in shape measuring 56.0 cm (22.0 in) in height and 46.0 cm (18.1 in) in width (**Figure 6**). The air bag was configured with two vent ports on the upper back panel and two internal tethers.

The frontal air bag exhibited evidence of occupant loading in the forms of skin oil transfers, fabric transfers, scuffs, and holes. A combination fabric and skin oil transfer was located on the lower aspect of the air bag's front panel that measured 14.0 x 14.0 cm (5.5 x 5.5 in). To the left of that transfer and located in the lower left quadrant of the front panel was a skin oil transfer measuring 6.0 x 6.0 cm (2.4 x 2.4 in). Those transfers began at the seam and extended upward. On the seam at the lower aspect of the air bag, a 14.0 cm (5.5 cm) section was holed (**Figure 7**). Two holes each measuring 2.0 cm (0.8 in) in length were located on the seam, and the remaining stitching in that area was stretched. On the upper aspect of the front panel a dark-colored scuff measuring 1.0 x 2.0 cm (0.4 x 0.8 in) was located 1.0 cm (0.4 in) from the seam. On the lower aspect of the back panel, an area measuring 10.0 x 12.0 cm (3.9 x 4.7 in) contained multiple scuffs, abrasions and small holes. The damage on the back panel resulted from contact with the cover flaps when the driver loaded the air bag.

Figure 6. Driver's deployed frontal air bag

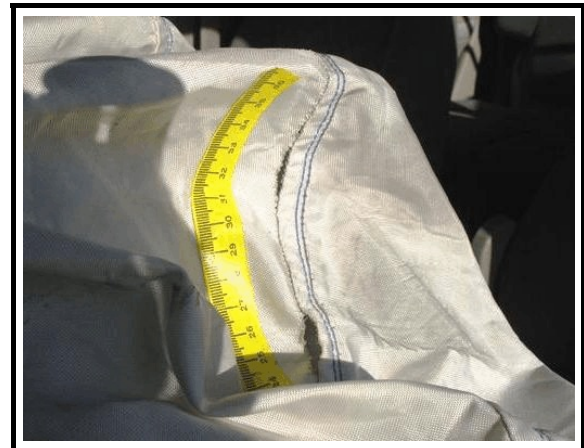
Figure 7. Driver's deployed frontal air bag showing holes at the seam

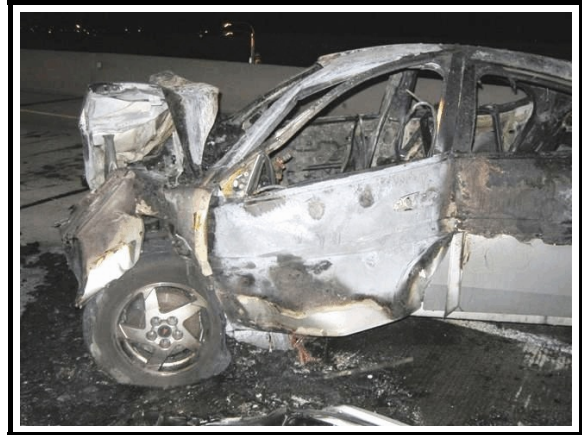
The Pontiac sustained direct front end damage and induced left, right, and top plane damage in the impact. The vehicle sustained additional interior and exterior damage from the post-crash fire (**Figure 8**). The front axle was displaced rearward, shortening the wheelbase on the left and right sides. Direct damage to the front end was distributed from bumper corner to bumper corner and maximum crush was located at and the front left bumper corner. For the Pontiac, the estimated CDC for Event 1 was 12FDEW4. The origin of the fire was not determined. The fire damage included the interior and exterior.

Figure 8. 2004 Pontiac Grand Prix (police photograph)

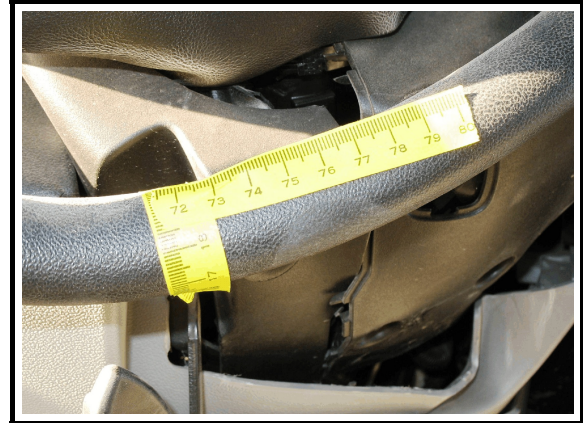
As the driver continued to be displaced forward, he loaded the steering assembly with his chest and abdomen. This combined with the intrusion of the steering assembly resulted in injuries to the thoracic aorta, a contusion of the myocardium, contusions to both lungs, and a laceration to the liver. He also sustained fractures to fifteen ribs including R1-R10 and L1-L5.

Figure 9. Steering wheel rim showing scuff to upper quadrant

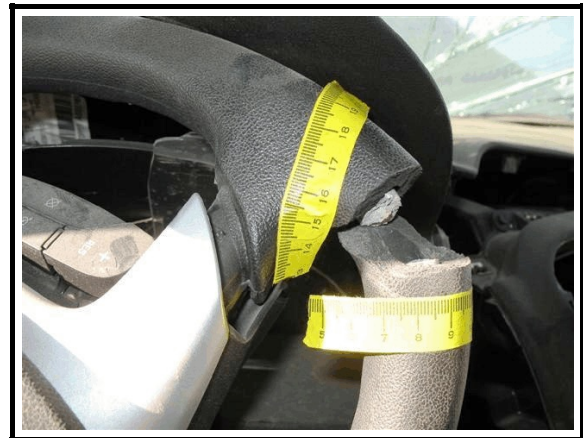
Figure 10. Steering wheel rim showing fracture in left quadrant
