ON-SITE SIDE IMPACT INFLATABLE OCCUPANT PROTECTION INVESTIGATION

CASE NUMBER - IN09036

VEHICLE - 2008 TOYOTA HIGHLANDER

CRASH DATE - September 2009

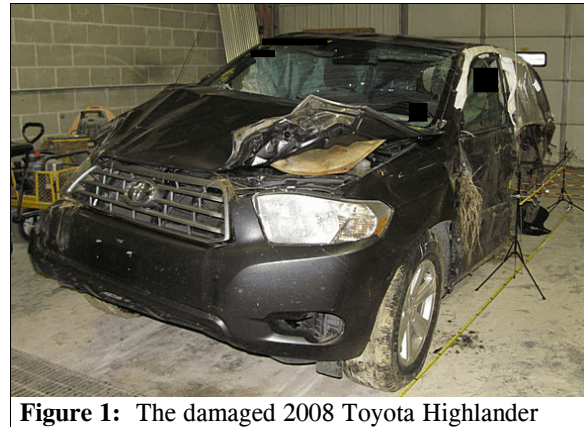
Figure 1: The damaged 2008 Toyota Highlander

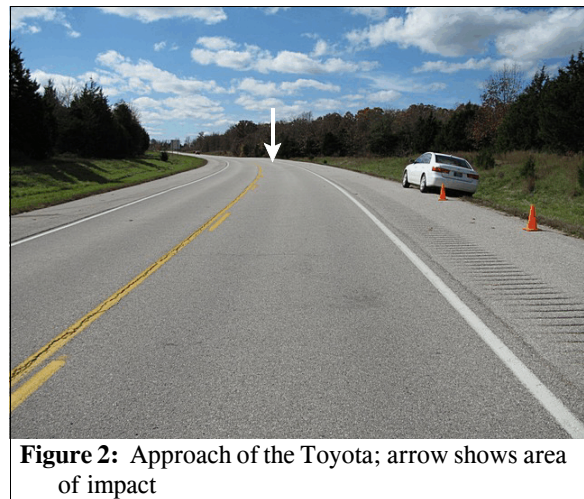
Figure 2: Approach of the Toyota; arrow shows area of impact

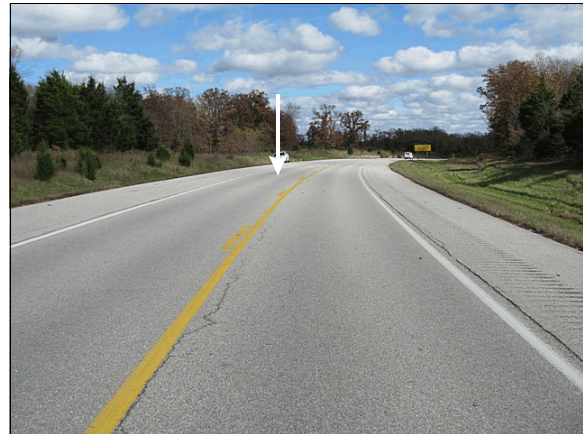
Figure 3: Approach of the Dodge to the area of impact (arrow)

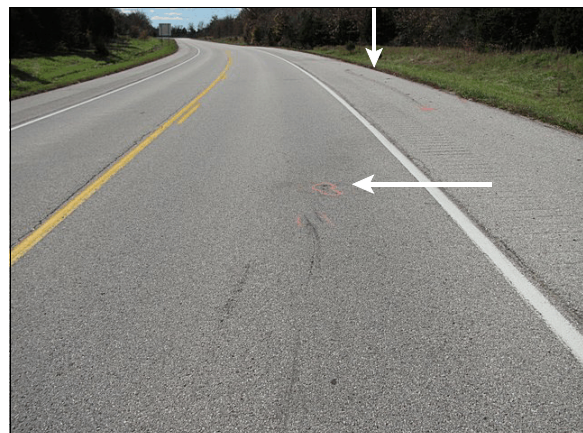
northeast. The driver of the Dodge told police that he attempted to throw a cigarette out of the window and it blew back into the vehicle. He became distracted trying to find the cigarette allowing the Dodge to cross the centerline into the southwest-bound travel lane. The driver of the Toyota attempted to avoid the crash by initiating a right steering maneuver. The crash occurred 2.9 m (9.5 ft) into the southwestbound travel lane (**Figure 4**).

Figure 4: Approach of Toyota to impact; arrow in foreground shows location of impact with the Dodge; arrow in background shows location of rollover initiation for the Toyota

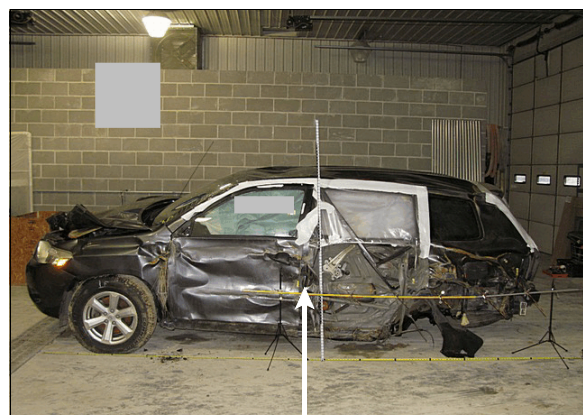
Crash: The left side plane of the Toyota (**Figure 5**) was impacted by the front plane of the Dodge (**Figure 6**, event 1). The direction of force on the Toyota was within the 11 o'clock sector and the impact force was sufficient to trigger the deployment of the left rollover/side impact inflatable curtain (IC) air bag and the driver's seat-mounted side impact air bag. The right IC air bag also deployed during the crash. As the engagement continued down the left side plane of the Toyota, the left front wheel of the Dodge engaged the left rear wheel of the Toyota. As a result, the left rear wheel of the Toyota was torn off the vehicle and the left front wheel of the Dodge was dislodged from the differential. The Toyota rotated counterclockwise and rolled over right side leading (event 2). The vehicle came to final rest on its top plane on the northwest side of the roadway heading south (**Figure 7**). The Dodge was redirected to northeast. It traveled 40 m (131.2 ft) and came to final rest on the southwest shoulder.

Figure 5: Arrow shows the location of the initial contact with the front of the Dodge; damage from the rollover overlaps the damage from this impact

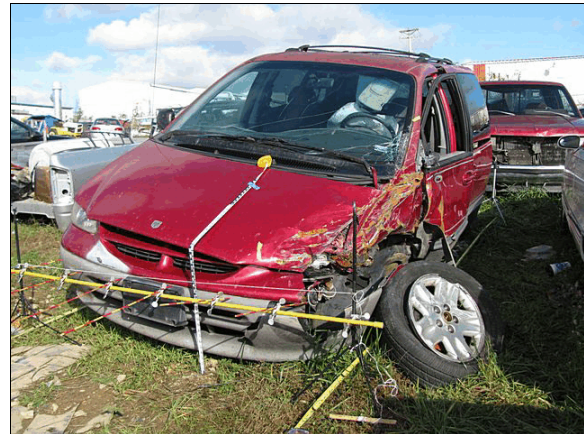
Figure 6: Damage to the front and left side plane of the Dodge from the impact with the left side plane of the Toyota

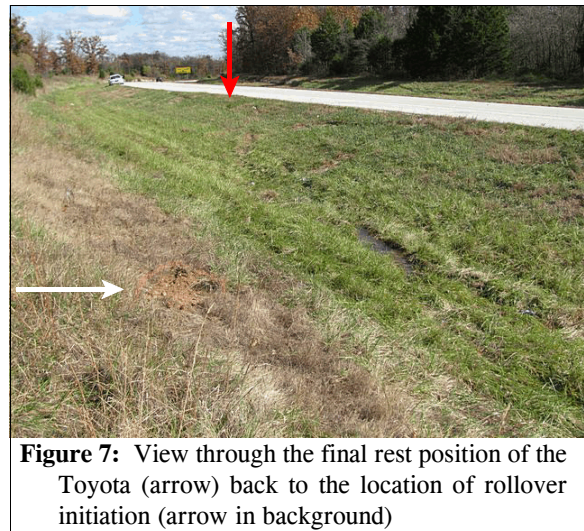
Figure 7: View through the final rest position of the Toyota (arrow) back to the location of rollover initiation (arrow in background)

The rollover of the Toyota (event 2) was initiated following the left side plane impact with the front of the Dodge (event 1). The impact with the Dodge caused the Toyota to rotate counterclockwise 115 degrees as it traveled 22 m (72.2 ft) toward the northwest edge of the road (**Figure 8**). The vehicle tripped and rolled over right side leading when the right rear wheel (**Figure 9**) furrowed into the ground and the right front wheel rim (**Figure 10**) gouged the bituminous surface of the shoulder (**Figure 11**). The vehicle rolled over 6 quarter turns across a distance of 30 m (98.4 ft) and came to final rest near the top of the back slope of the ditch (**Figure 7**).

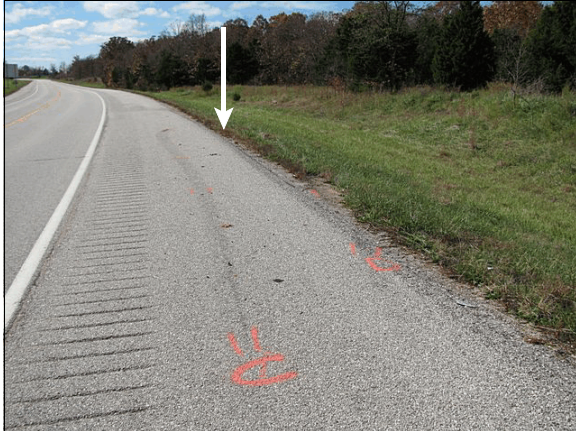
Figure 8: Yaw marks from the right side tires of the Toyota as the vehicle rotated counterclockwise approaching location of rollover initiation (arrow); yaw mark on left is from the left front tire, yaw mark on right is from the right rear tire

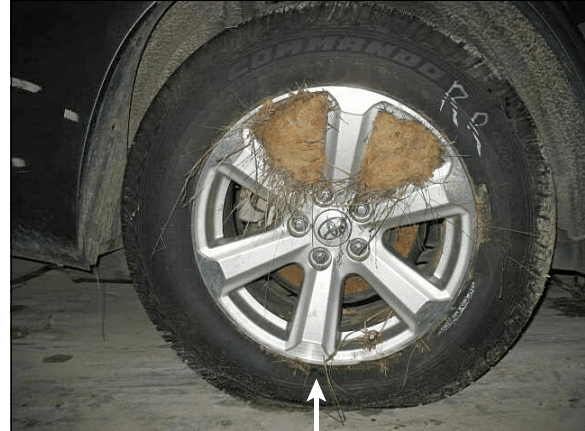
Figure 9: Grass in right rear wheel rim (arrow) from furrowing ground on approach to trip point; dirt in rim is from ground contact during the rollover

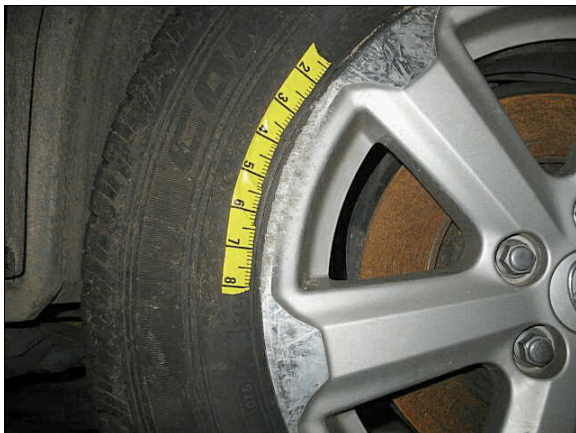
Figure 10: The numbered tape [each increment is 1 in (2.5 cm)] outlines the abrasion on the right front wheel rim due to gouging the bituminous surface of the shoulder

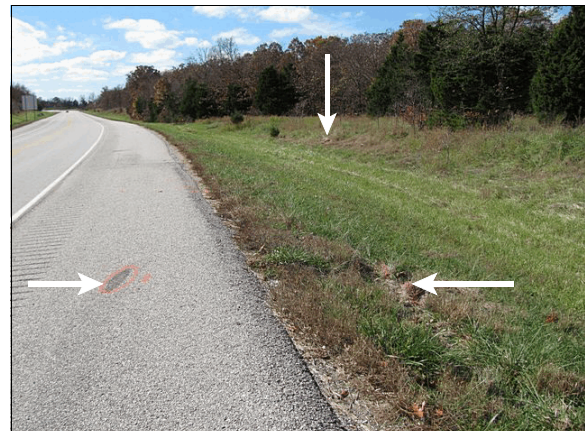
Figure 11: Location of rollover initiation; arrow on left shows gouge on shoulder from right front wheel; arrow on right shows furrow on ground from right rear wheel; arrow in background shows the location of the final rest of the Toyota

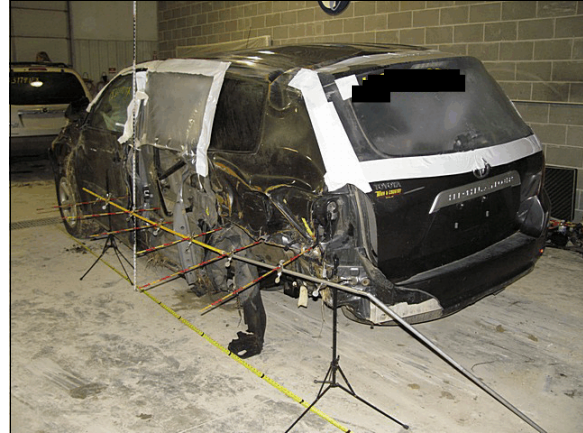
Exterior Damage: The impact with the front plane of the Dodge involved the left side plane of the Toyota. The left rear door, left B-pillar, left rear wheel, and quarter panel were directly damaged (**Figure 12**). The left rear wheel was also torn off the vehicle. The direct damage began 159 cm (62.6 in) rear of the left front axle and extended 192 cm (65.4 in) rearward along the left side. A crush profile could not be measured for this impact since the sheet metal of the left rear door had been torn off and there was overlapping damage on the quarter panel from the rollover. The crush gauge was positioned on the left side plane to illustrate the location of the damage (**Figure 12**).

Figure 12: Damage on the left side plane of the Toyota from the impact with the Dodge and the rollover

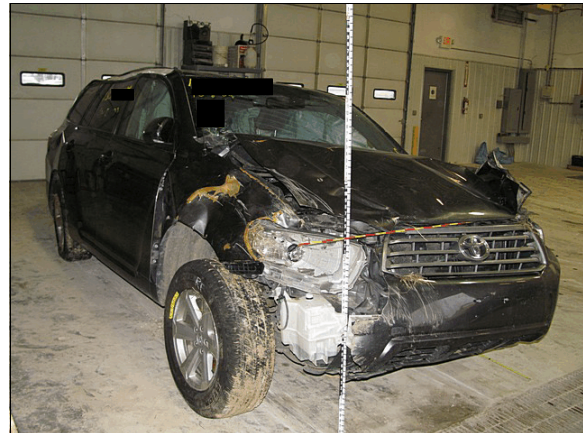
The direct damage from the rollover involved the top plane, both side planes, and the right portion of the front plane (**Figures 12-14**). The direct damage on the left side plane extended from the front bumper fascia to the back of the quarter panel and involved the full height of the side plane. The direct damage on the right side plane involved the front bumper and roof side rail. The direct damage on the front plane was 55 cm (21.7 in) in length and began at the right bumper corner. The direct damage on the top plane extended from the front of the hood to the back of the vehicle and involved the full width of the roof, 121 cm (47.6 in). The maximum vertical crush (**Figure 15**) was 7 cm (2.8 in) and occurred on the roof over the driver's seat 16 cm (6.3 in) inboard of the left roof side rail. The maximum residual lateral crush (**Figure 16**) was 5 cm (2 in) and occurred on the right roof side rail immediately forward of the right D-pillar.

Figure 13: Damage on the front and right side planes from the rollover

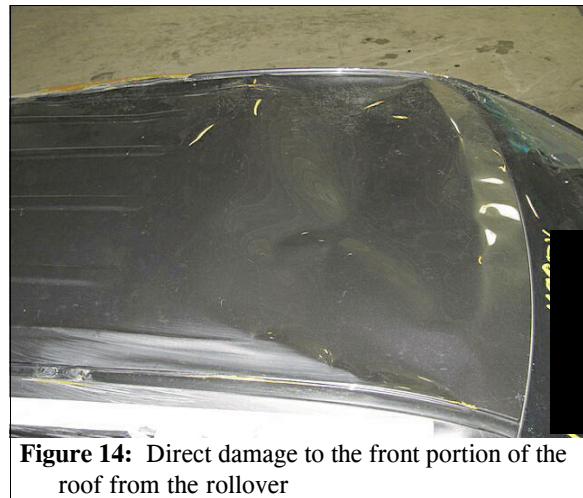
Figure 14: Direct damage to the front portion of the roof from the rollover

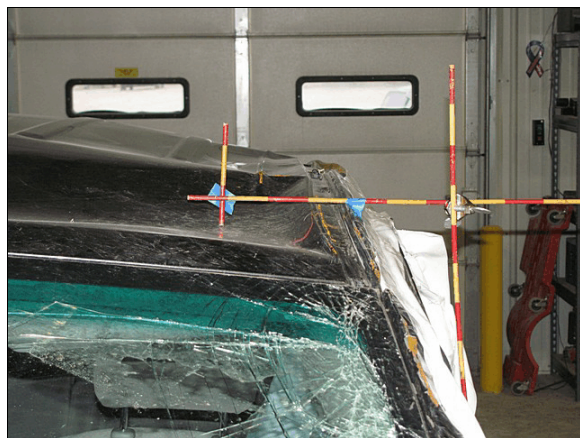
Figure 15: The maximum vertical crush was located on the roof over the driver's seat

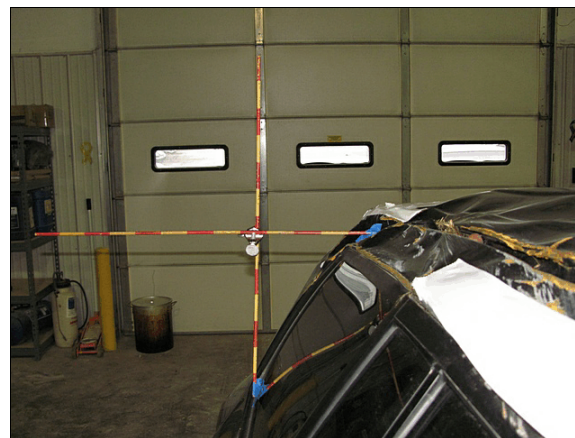
Figure 16: The maximum lateral crush occurred on the right roof side rail immediately forward of the right D-pillar

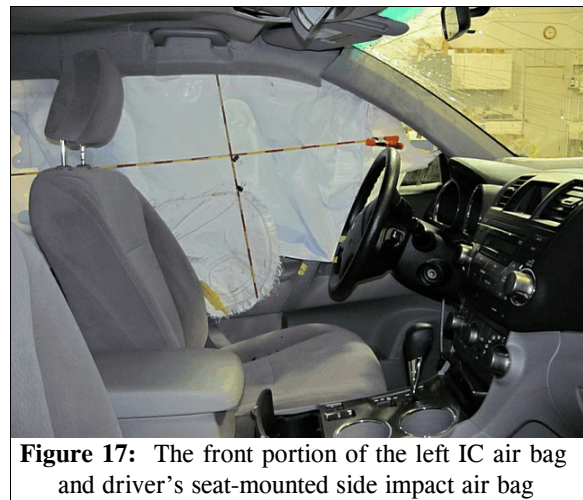
The left IC air bag was located along the roof side rails inside the headliner and extended from the A-pillar to the D-pillar. The IC was designed with inflation chambers adjacent to the outboard seating positions. There was a non-inflatable fabric panel on the second row portion of the IC air bag that was 38 cm (15 in) in width and 41 cm (16.1 in) in height. There were no visible external vent ports. The deployed left IC air bag (**Figures 17 and 18**) was 234 cm (92.1 in) in width and 58 cm (22.8 in) in height. It was attached to the A-pillar by a 12 cm (4.7 in) nylon rope. A triangular-shaped fabric panel was present at the front of the IC air bag that was 16 cm (6.3 in) in width and 34 cm (13.4 in) in height. The IC air bag extended vertically 24 cm (9.4 in) below the beltline. Inspection of the

Figure 17: The front portion of the left IC air bag and driver's seat-mounted side impact air bag

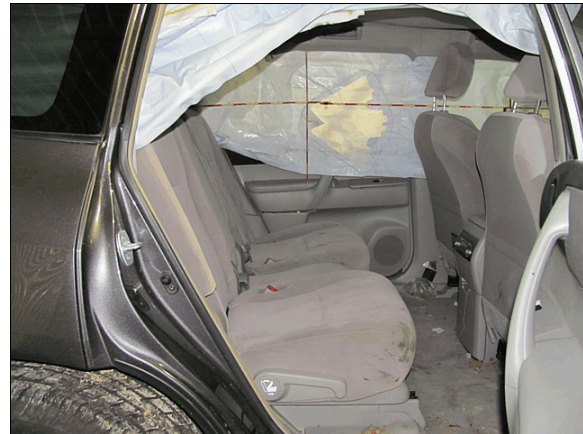
Figure 18: The second row left portion of the left IC air bag

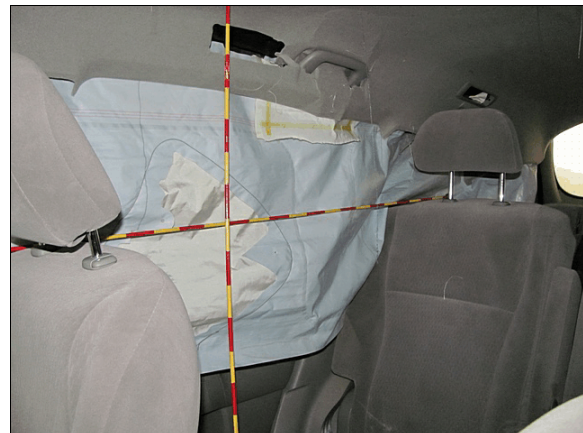
deployed IC air bag revealed no discernable evidence of occupant contact. A 1 cm (0.4 in) diameter hole was present on a non-inflatable section of the IC air bag located between the second seat back and the left rear door. It was located 69 cm (17.6 in) forward of the back of the IC air bag and 6 cm (2.4 in) above the bottom of the IC air bag. The source of the hole was probably glass fragments from the disintegrated second left rear window glazing. The right IC air bag was of the same features and dimensions. There was no discernable evidence of occupant contact and no damage on the right IC air bag adjacent to the second row right passenger's seating position (**Figure 19**).

Figure 19: The second row right portion of the right IC air bag

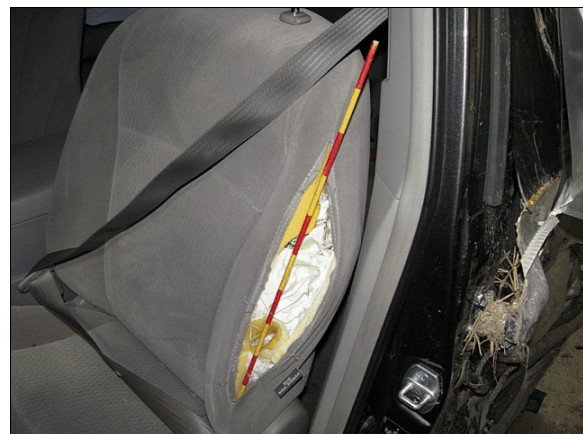
Figure 20: The location of the left front seat-mounted side impact air bag

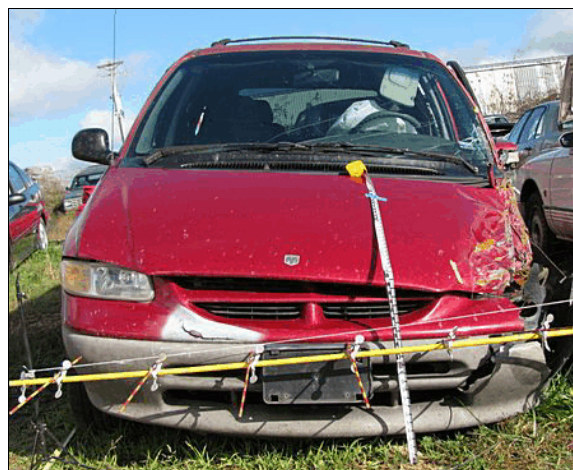
Exterior Damage: The impact with the Toyota involved the front plane of the Dodge (**Figure 22**). The front bumper, grille, hood, and left headlamp/turn signal assembly, left fender, left front wheel, and left front door were directly damaged. The direct damage began at the front left bumper corner and extended 19 cm (7.5 in) across the bumper and hood. The direct damage also extended down the left side plane 219 cm (86 in) ending near the back of the left front door. The crush measurements were taken at the bumper

Figure 22: Damage to the front of the Dodge from the impact with the left side plane of the Toyota
