ON-SITE SIDE IMPACT INFLATABLE OCCUPANT PROTECTION INVESTIGATION

CASE NUMBER - IN09037

VEHICLE - 2008 CHEVROLET IMPALA LT

CRASH DATE - August 2009

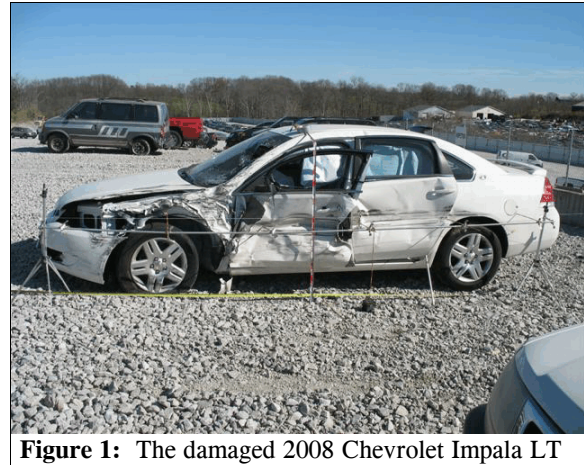
Figure 1: The damaged 2008 Chevrolet Impala LT

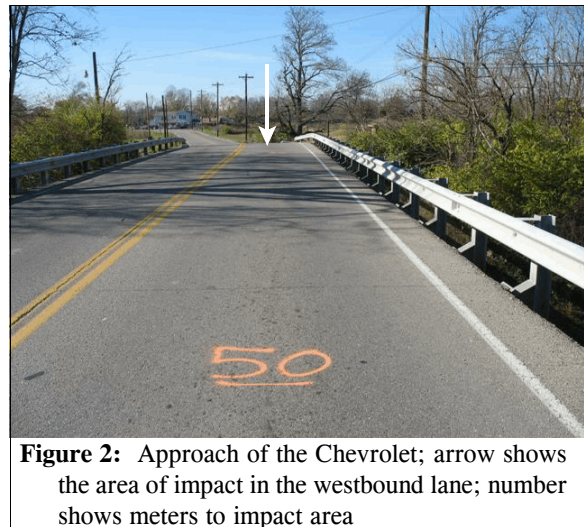
Figure 2: Approach of the Chevrolet; arrow shows the area of impact in the westbound lane; number shows meters to impact area

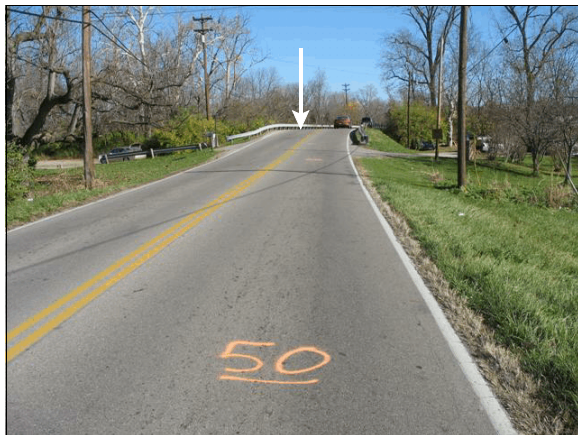
Figure 3: Approach of the Mazda to the area of impact (arrow)

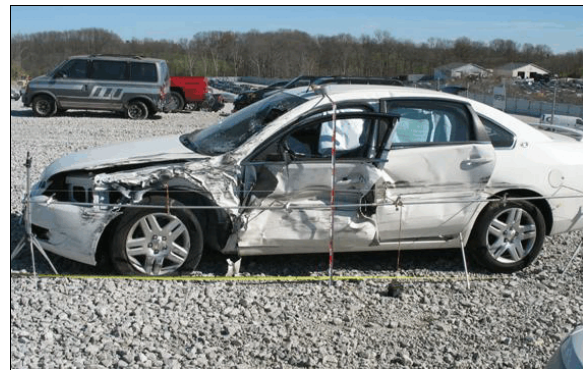
Crash: The left side plane of the Chevrolet (**Figure 4**) was impacted by the front plane of the Mazda (**Figure 5**, event 1). The direction of force on the Chevrolet was within the 11 o’clock sector and the impact force was sufficient to trigger deployment of the left and right side impact inflatable curtain (IC) air bags. The impact also triggered a first stage deployment of the driver’s and front passenger’s frontal air bags. The Chevrolet was redirected to the northwest and the right fender sustained a minor sideswipe impact with the bridge rail (event 2, **Figure 6**). The Chevrolet came to final rest next to the bridge rail heading west. The Mazda came to final rest on the westbound lane heading east.

Figure 4: Damage on the left side plane of the Chevrolet from the impact with the Mazda

Exterior Damage: The impact by the front of the Mazda involved the left side plane of the Chevrolet. The fender, hood, A-pillar, front door, B-pillar, rear door, and quarter panel were directly damaged. The direct damage ended 44 cm (17.3 in) rear of the left rear axle and extended 401 cm (157.8 in) forward along the left side. The crush measurements were taken at the mid-door level and the residual maximum crush was 15 cm (5.9 in) occurring at C₄ (**Figure 7**). The vehicle’s sill height was 26 cm (10.2 in) and the height of the maximum crush was 68 cm (26.8 in). The Door Sill Differential was 8 cm (3.1 in). The induced damage involved the hood, both left side doors, A-pillar, roof side rail, and quarter panel. The table below shows the vehicle’s left side crush profile.

Damage Classification: The Collision Deformation Classification (CDC) was 11LDAS2 (330 degrees) for the left side plane impact with the Mazda and 12RFMS1 (10 degrees) for the right side plane impact with the bridge rail. The WinSMASH program could not be used to calculate the Delta V for either impact since sideswipes are out of scope for the program. The Chevrolet's EDR recorded the maximum longitudinal and lateral velocity changes as -13.76 km/h (-8.55 mph) and 10.33 km/h (6.42 mph), respectively for the impact with the Mazda.

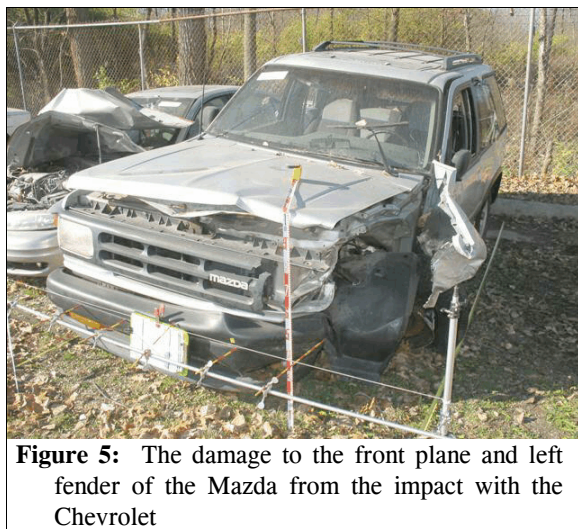
Figure 5: The damage to the front plane and left fender of the Mazda from the impact with the Chevrolet

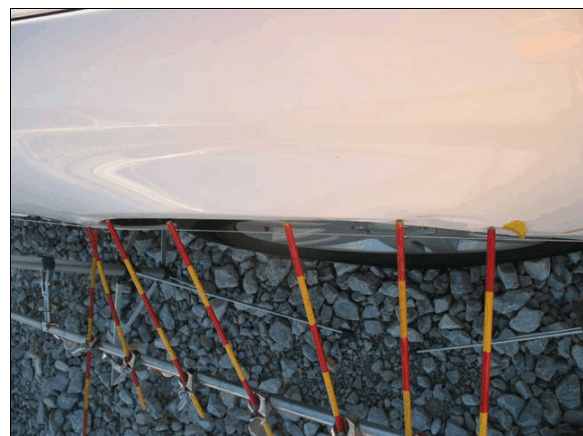
Figure 6: Top view of damage on the right fender of the Chevrolet; each increment is 5 cm (2 in)

The impact with the bridge rail involved the right fender. The direct damage began 24 cm (9.4 in) forward of the right front axle and extended rearward 70 cm (27.6 in). The crush measurements were taken at the mid-fender level and the residual maximum crush was 1 cm occurring 7 cm (2.8 in) rear of C₆. There was no induced damage on the fender. The table below shows the crush profile on the right fender.

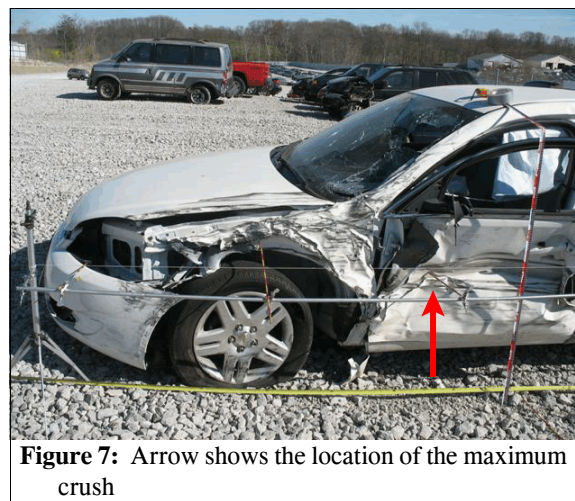
Figure 7: Arrow shows the location of the maximum crush

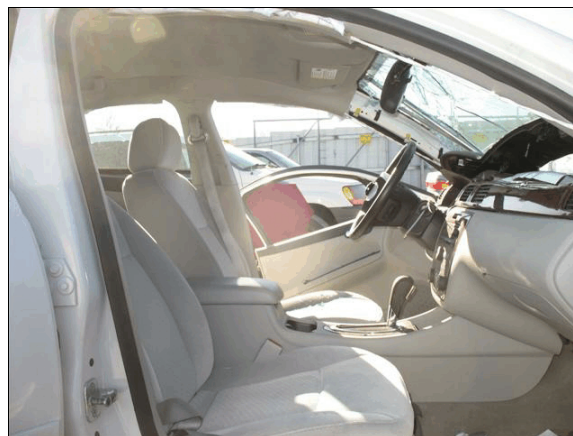
Vehicle Interior: The interior inspection of the Chevrolet (**Figure 8**) revealed no discernable evidence of occupant contact. There was no deformation of the steering wheel and no compression of the energy absorbing steering column.

Figure 8: Front row viewed from right front door

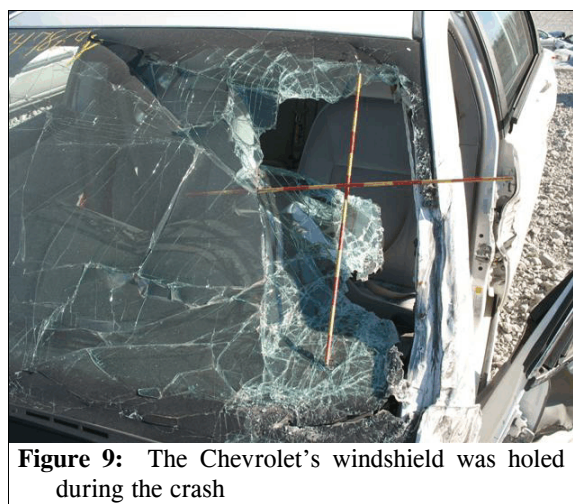
The left front door was jammed shut, while the other doors remained closed and operational. The pre-crash status of the window glazings was either fixed or closed. The left front window glazing was disintegrated from impact forces. The windshield was in place and holed (**Figure 9**)

during the crash as a result of contact by the left fender of the Mazda. The remaining glazings were undamaged.

Figure 9: The Chevrolet's windshield was holed during the crash

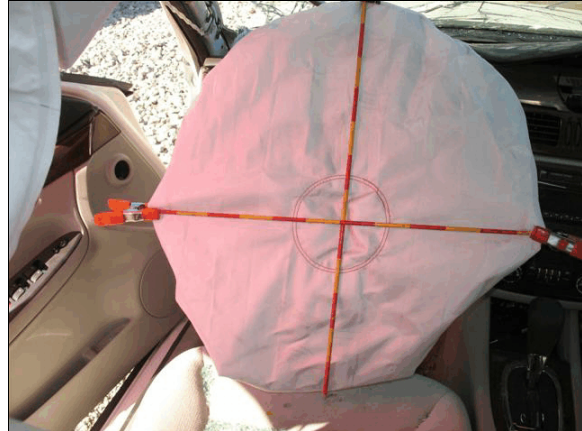
The driver's frontal air bag was located within the steering wheel hub and the module cover was a two-flap configuration constructed of pliable vinyl. Each cover flap was 6.5 cm (2.6 in) in width and 13.5 cm (5.3 in) in height. The flaps opened at the designated tear points and were undamaged. The deployed air bag (**Figure 10**) was 61 cm (24 in) in diameter and was designed with four 5.5 cm (2.2 in) wide tethers and two 2.5 cm (1 in) diameter vent ports. The vent ports were located on the back of the air bag at the 11 and 1 o'clock positions. Inspection of the air bag revealed no discernable evidence of occupant contact. There was a 1.5 cm long cut on the back of the air bag adjacent to the left vent port (**Figure 11**). This damage probably occurred when the windshield was holed during the impact and intruded into the passenger compartment.

Figure 10: The driver's frontal air bag

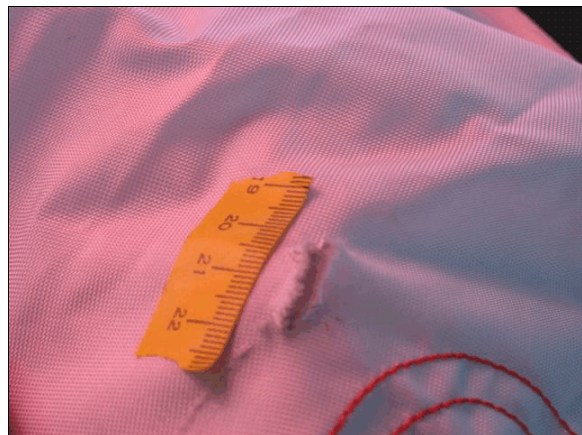
Figure 11: Cut in the fabric of the driver's frontal air bag; cut is near the left vent port

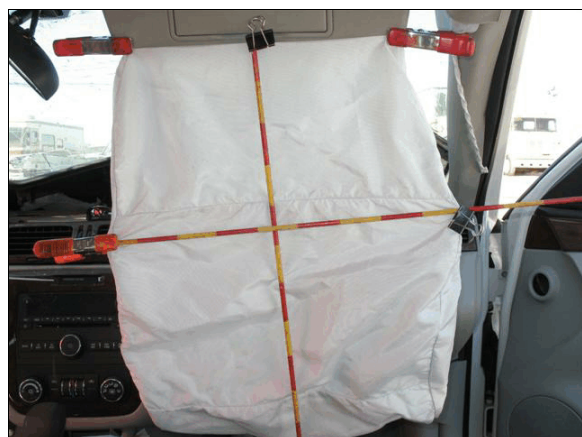
The front passenger frontal air bag was located within the top of the instrument panel. There was no air bag cover flap. The top of the instrument panel was designed to displace vertically as the air bag deployed. The deployed air bag (**Figure 12**) was 43 cm (16.9 in) in width and 54 cm (21.3 in) in height. The air bag was designed with two tethers each 25 cm (6.5 in) in width. There was one vent port on each side of the air bag. The vent ports were located at the 3 and 9 o'clock positions and were 5 cm (2 in) in diameter. There was no discernable evidence of occupant contact on the air bag and no damage.

Figure 12: The front passenger's frontal air bag

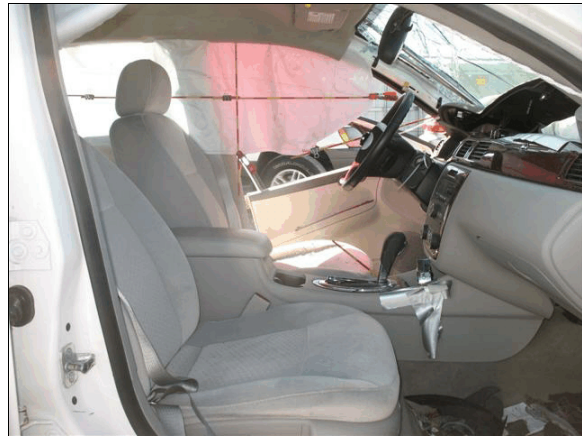
Figure 13: The left side impact IC air bag

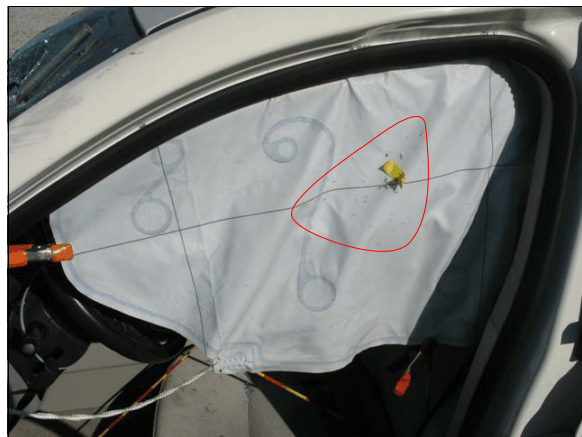
Figure 14: Area of small punctures outlined by red line; punctures caused by flying glass fragments from the disintegrated left front window glazing

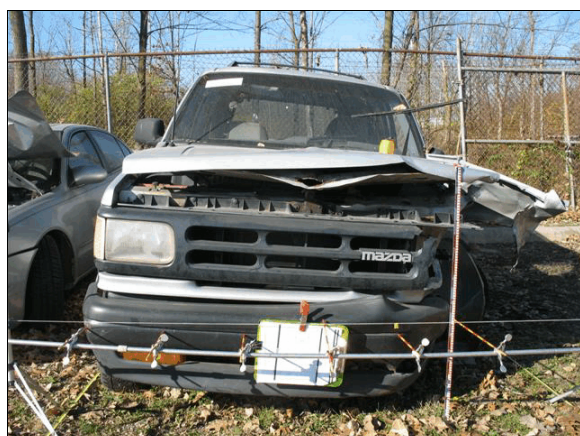
The impact with the Chevrolet involved the front plane of the Mazda (**Figure 16**). The front bumper, left headlamp/turn signal assembly, grille, hood, left fender, left front wheel, and left front door were directly damaged. The direct damage began at the front left bumper corner and extended 40 cm (15.7 in) across the bumper. The crush measurements were taken at the bumper

Figure 16: Damage to the front plane of the Mazda

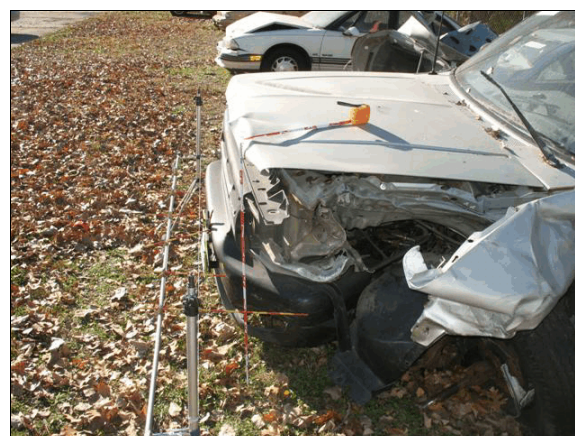
level and the residual maximum crush was 32 cm (12.6 in) occurring at C₁ (**Figure 17**). The induced damage involved the bumper, grille, hood, and left front door. The left side wheelbase was reduced 41 cm (16.1 in), while the right side wheelbase was extended 4 cm (1.6 in). The table below shows the front crush profile.

Figure 17: Left side view of the crush on the front bumper of the Mazda
