On-Site Hybrid Vehicle Investigation
Dynamic Science, Inc. (DSI), Case Number DS09037
2008 Toyota Prius
Washington

1. Report No. DS09037	2. Government Accession No.		3. Recipient Catalog No.	
4. Title and Subtitle On-Site Hybrid Vehicle Investigation		5. Report Date July 7, 2010

Dynamic Science, Inc.
Crash Investigation
Case Number: DS09037

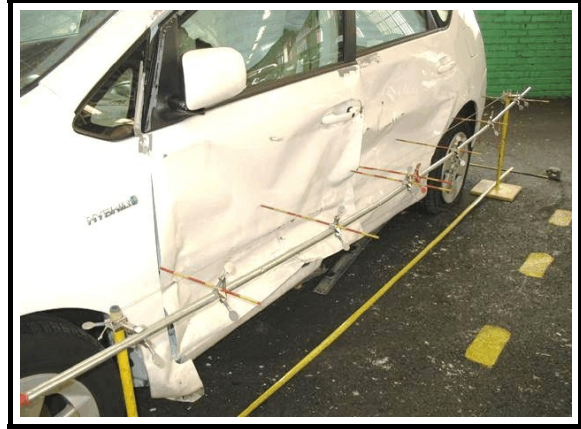
Figure 3. Left side crush profile

measurement was identical to the direct damage measurement. Six crush measurements were taken at mid-door level (**Figure 3**) as follows: $C_1 = 0$, $C_2 = 1.0$ cm (0.4 in), $C_3 = 9.0$ cm (3.5 in), $C_4 = 11.0$ cm (4.3 in), $C_5 = 8.0$ cm (3.1 in), $C_6 = 0$. Maximum crush was located 118.0 cm (46.5 in) forward of the rear axle between C_3 and C_4 at the left B-pillar and measured 14.0 cm (5.5 in). The CDC for Event 1 was 10LZEW2.

The Toyota sustained direct damage to the left side door panels from the impact with the Chevrolet. The Toyota's sill height measured 22.0 cm (8.7 in), height of maximum door crush measured 52.0 cm (20.5 in), and the Door Sill Differential (DSD) measured 6.0 cm (3.1 in). The sill sustained 2.0 cm (0.8 in) of lateral crush.

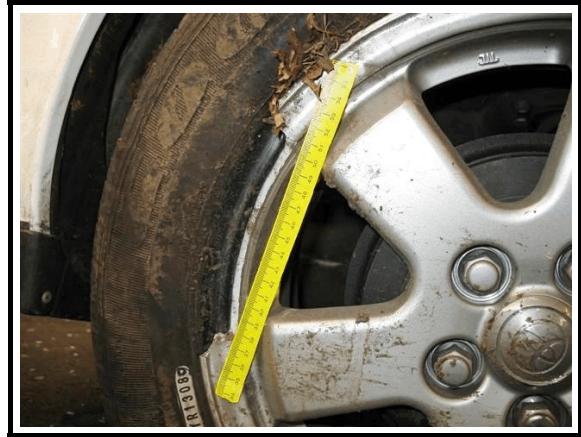
Figure 4. Rim fracture (Event 3)

For Event 3 the direct damage to the tire and rim began 26.0 cm aft of the rear axle, extended 52.0 cm forward, and ended 26.0 cm forward of the rear axle. A 3.0 x 15.0 cm (1.2 x 5.9 in) section of rim was fractured and displaced from the flange (**Figure 4**). Additionally, the impact resulted in a negative cant measuring 5.0 cm (2.0 in) inboard of its original position. The tire was abraded circumferentially and dirt and grass were embedded at the bead. The CDC for Event 3 was 04RBWN1.

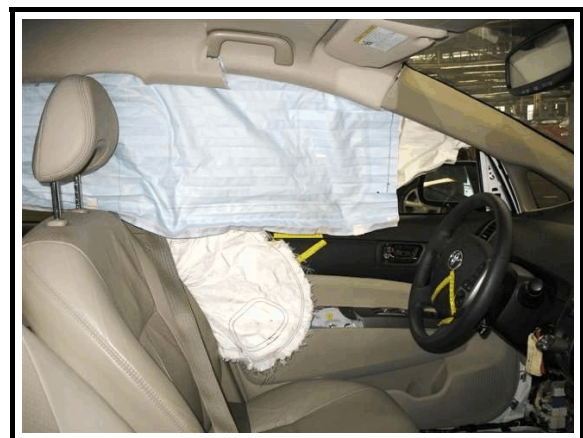
Figure 5. Deployed IC air bag and seat-mounted side air bag

The vehicle's Supplemental Restraint System (SRS) included an air bag control module (ACM), driver and passenger frontal air bags, seat-mounted side air bags for the front row, and side impact IC air bags. At impact with the Chevrolet, the left seat-mounted side air bag and IC air bag deployed (**Figure 5**).

The seat-mounted side air bag was scuffed from occupant loading on the upper aspect of the inboard panel. A 2.0 cm (0.8 in) scuff was located 6.0 cm (2.4 in) below the upper edge and 15.0 cm (5.9 in) aft of the leading edge, placing the scuff midway between the leading edge of the air bag and the seat back. A second scuff measuring 2.0 x 8.0 cm (0.8 x 3.1 in) began at the leading edge and extended rearward. The scuffs resulted from loading of the air bag from the driver's left shoulder and flank. The outboard panel of the air bag was unremarkable.

The IC air bag revealed a hair and skin oil transfer measuring 8.0 x 24.0 cm (3.1 x 9.4 in) that was deposited by the driver when her head and face loaded the air bag. The IC air bag revealed no additional damage and the outboard panel was unremarkable.

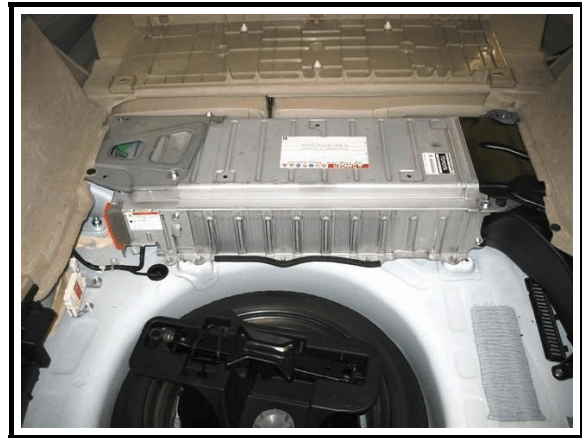
Figure 6. NiMH Propulsion battery pack encased in aluminum cover

1. There were no indications of electrolyte spillage from the propulsion battery either outside or inside the passenger compartment (**Figure 6**).

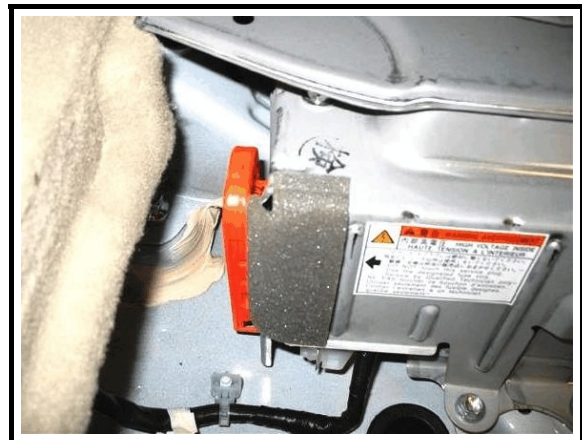
Figure 7. Propulsion battery service plug in place (orange component)

2. There was no movement of the propulsion battery or other system components including the service plug (**Figure 7**). The service plug was removed from the propulsion battery by the DSI investigator and the receptacle was unremarkable. With the service plug removed, the propulsion battery failed to register any reading on voltage meters.

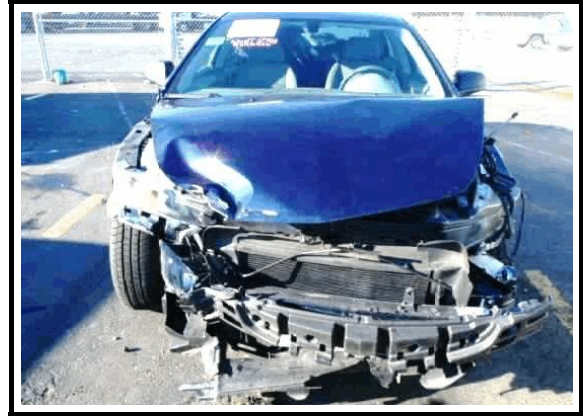
Figure 8. Other vehicle, 2008 Chevrolet Malibu LS (auction facility photo)

The Chevrolet sustained direct and induced damage to the frontal plane (**Figure 8**), and induced damage to the top and side planes. The front bumper fascia was displaced and the grille and front fender panels were missing. Based on the photographs the damage to the front end was distributed from bumper corner to bumper corner encompassing the vehicle's undeformed end with of 148.0 cm (58.3 in). For Event 1, the estimated CDC for the Chevrolet was 01FDEW2. For Event 2, the estimated CDC was 10FL9999.
