**CALSPAN ON-SITE ROLLOVER CRASH INVESTIGATION  
SCI CASE NO.: CA09037**

**VEHICLE: 2007 CHRYSLER ASPEN**

**LOCATION: NORTH CAROLINA**

**CRASH DATE: MAY 2009**

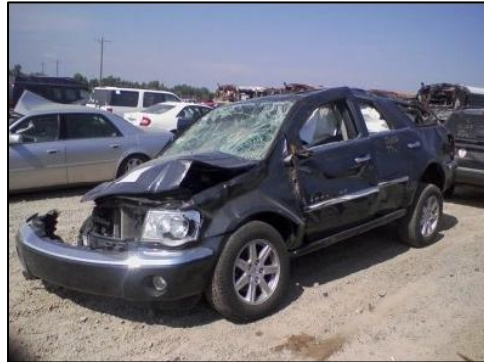
**Figure 1: 2007 Chrysler Aspen case vehicle.**

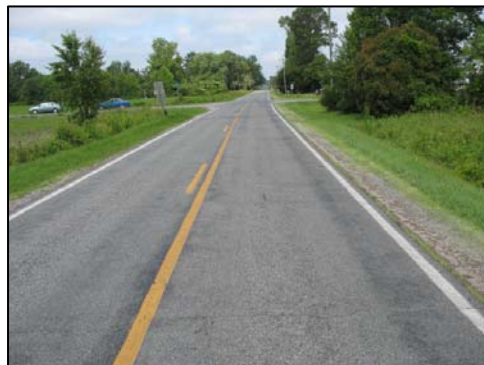
**Figure 2: Westbound approach to the intersection.**

The driver of the Aspen stated in the interview that his view of the southbound approach to the intersection was obstructed by trees and brush on the north roadside and a house on the northeast corner. He stated that he did not see the Ford until he was nearly in the intersection and he did not have time to initiate avoidance actions prior to the initial impact.

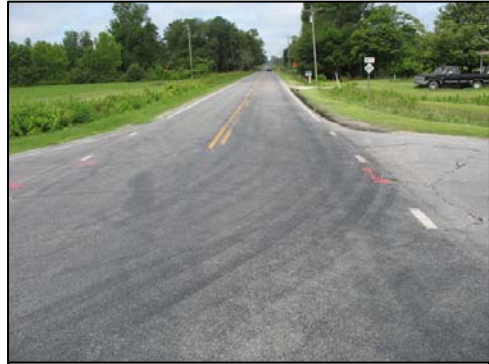
The front of the F-150 impacted the right front and center aspects of the Aspen in the intersection. The direction of force to the Aspen was within the one o'clock sector. The direction of force to the F-150 was within the ten o'clock sector. The Damage algorithm of the WINSMASH program was used to calculate a total delta-V of 21 km/h (13 mph) for the Aspen and 36 km/h (23 mph) for the F-150. The longitudinal delta-V's for the Aspen and the F-150 were -16 km/h (-10 mph) and -23 km/h (-14 mph), respectively. The lateral delta-V was -13 km/h (-8.1 mph) for the Aspen and 28 km/h (17 mph) for the F-150. **Figure 3** is a view of the initial impact location. The Aspen was redirected to the left approximately 20 degrees and began to travel towards the southwest corner of the intersection.

**Figure 3: Area of initial impact.**

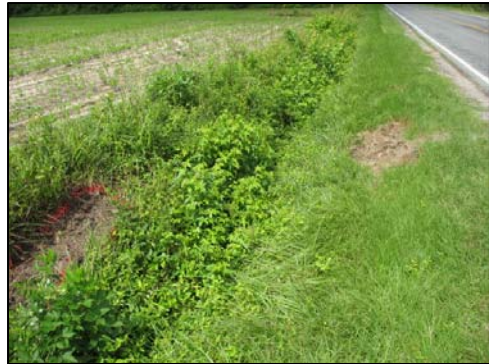
The driver of the Aspen attempted to steer right to stay on the roadway. The Aspen entered a clockwise yaw and departed the roadway at the southwest corner of the intersection. The Aspen traveled in the left side leading yaw for approximately 16 m (52.5 ft). The left rear wheel left a yaw mark 16.8 m (55.12 ft) in length and the left front wheel left a yaw mark 12.4 m (41.9 ft) in length, beginning on the asphalt in the intersection and ending in the grass/ditch area. The Chrysler rotated 85 degrees clockwise before initiating a trip-over rollover event to the left. The left rear wheel tripped on the wall of the ditch bordering the roadway, and the left front wheel tripped on the ground of the roadside. The Aspen rolled three-quarter turns to the left for a distance of 10 m (32.8 ft), coming to rest between the top and right planes in the ditch off the south roadside, facing northwest. The rollover was not interrupted. **Figure 4** is a view of the location of the rollover of the Aspen. The F-150 came to rest in the southwest corner of the intersection, facing southwest.

**Figure 4: Location of Aspen rollover.**

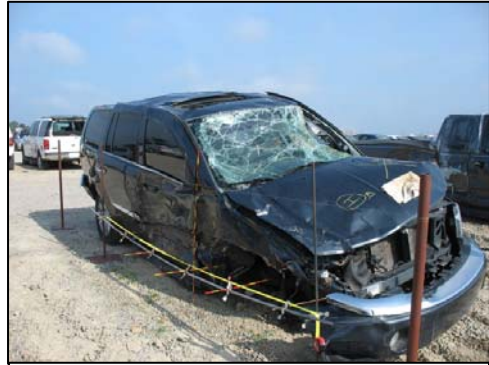
The exterior of the Chrysler sustained moderate severity damage to the right, left, and top planes as a result of this multiple impact crash. The front aspect of the right plane sustained damage in the initial impact (**Figure 5**). The right side door hinges were intact and remained attached to the A- and B-pillars, respectively. Both right side door latches remained engaged, and the right front door was jammed closed after the crash. The right rear and both left side doors remained operational after the crash. The right front wheel

**Figure 5: Right side damage to the Aspen.**

separated from the suspension components. The direct damage measured 276 cm (108.7 in) and began 96 cm (37.8 in) forward of the right rear axle and extended forward to the front right bumper corner. The maximum crush measured 22 cm (8.7 in) and was located at C5, 318 cm (125.2 in) forward of the right rear axle. The documented crush profile was as follows: C1 = 0 cm, C2 = 15 cm (5.9 in), C3 = 16 cm (6.3 in), C4 = 21 cm (8.3 in), C5 = 22 cm (8.7 in), C6 = 18 cm (7.1 in). The Collision Deformation Classification (CDC) assigned for this impact was 01-RYEW-3.

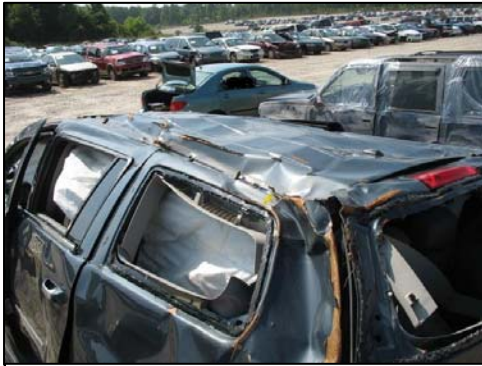
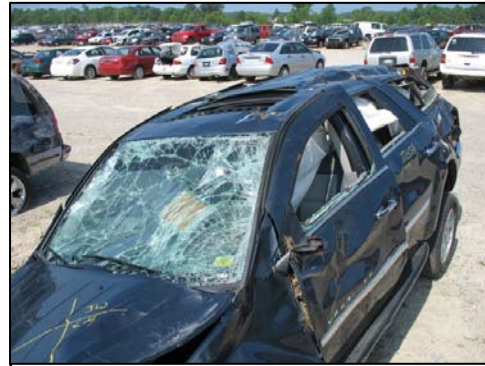
As a result of the rollover event, the Chrysler sustained moderate severity damage to the left and top planes. The windshield glazing was 100 percent fractured with a laminate tear along the full length of the left A-pillar. The left front, left rear, left rear quarter window and backlight all disintegrated as a result of this multiple event crash sequence. The left rear door quarter window and all right side glazing were not damaged. The sunroof was intact and partially open at the time of the inspection. The scratches on the roof were oriented laterally. The direct contact damage to the roof extended 126 cm (49.6 in) laterally from the left roof side rail to the right roof side rail. The longitudinal direct contact damage extended 440 cm (173.2 in) from the leading edge of the hood to the backlight header. The maximum vertical and lateral crush was located on the left roof side rail 76 cm (29.9 in) aft of the left rear door. The maximum lateral crush measured 22 cm (8.7 in). The maximum vertical crush measured 13 cm (5.1 in). **Figures 6 and 7** depict the rollover damage sustained by the Aspen. The CDC assigned for the rollover was 00-TDDO-3.

**Figure 6: Rollover damage to the left rear of the Aspen.**

**Figure 7: Rollover damage to the left front of the Aspen.**

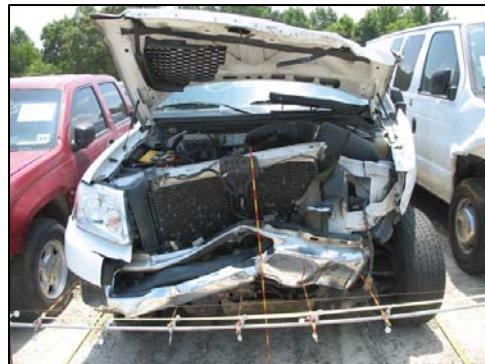
The front plane of the Ford F-150 sustained moderate severity damage in the initial impact with the Chrysler. The direct contact damage extended from bumper corner to bumper corner on the front plane and measured 152 cm (59.8 in) in width (**Figure 8**). The maximum crush measured 33 cm (13 in) and was located at C2, 31 cm (12.2 in) right of the damaged left front bumper corner. A crush profile was documented on the front bumper and was as follows: C1 = 20 cm (7.9 in), C2 = 33 cm (13 in), C3 = 27 cm (10.6 in), C4 = 11 cm (4.3 in), C5 = 7 cm (2.8 in), C6 = 25 cm (9.8 in). The CDC assigned for this impact was 10-FDEW-2.

**Figure 8: Overall view of the frontal damage to the Ford.**

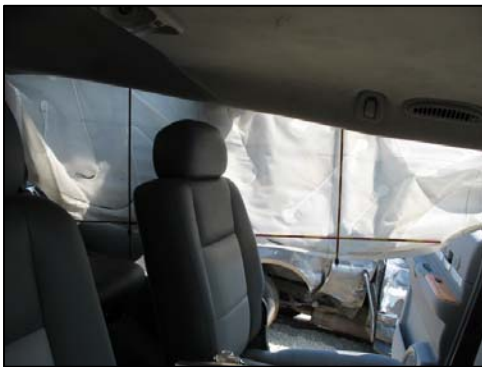
**Figure 9: Left IC air bag.**

There was an occupant contact attributed to the driver's left shoulder on the inboard side of the left IC. This scuff mark was located 12-30 cm (4.7-11.8 in) above the lower edge of the membrane and 18-30 cm (7.1-11.8 in) rear of the front edge of the membrane. Due to the intrusion, the left B-pillar was in contact with the front left seat back. The left IC was not captured between the pillar and the seat back.

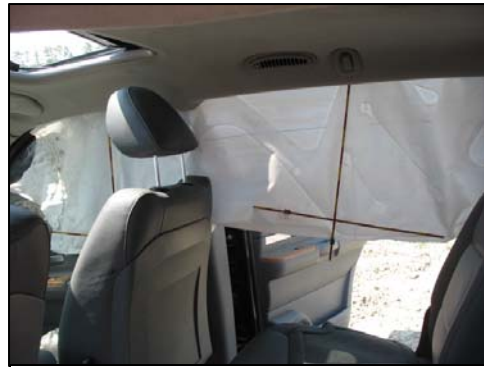
**Figure 10: Right IC air bag.**

There were two plastic-type deployment transfers on the right IC. The first was located on the outboard side of the air bag 28-33 cm (11-13 in) forward of the B-pillar and 0-8 cm (0-3.1 in) below the roof side rail. The second was located on the inboard side, 34-40 cm (13.4-15.7 in) forward of the rear of the curtain air bag and 9-19 cm (3.5-7.5 in) above the lower edge of the membrane.

The right IC was labeled with the number 28038450. The inboard side of the right air bag in the front row had food particles adhered to the fabric. The food was consistent with a Styrofoam box of food found in the front right seat at the time of the inspection.

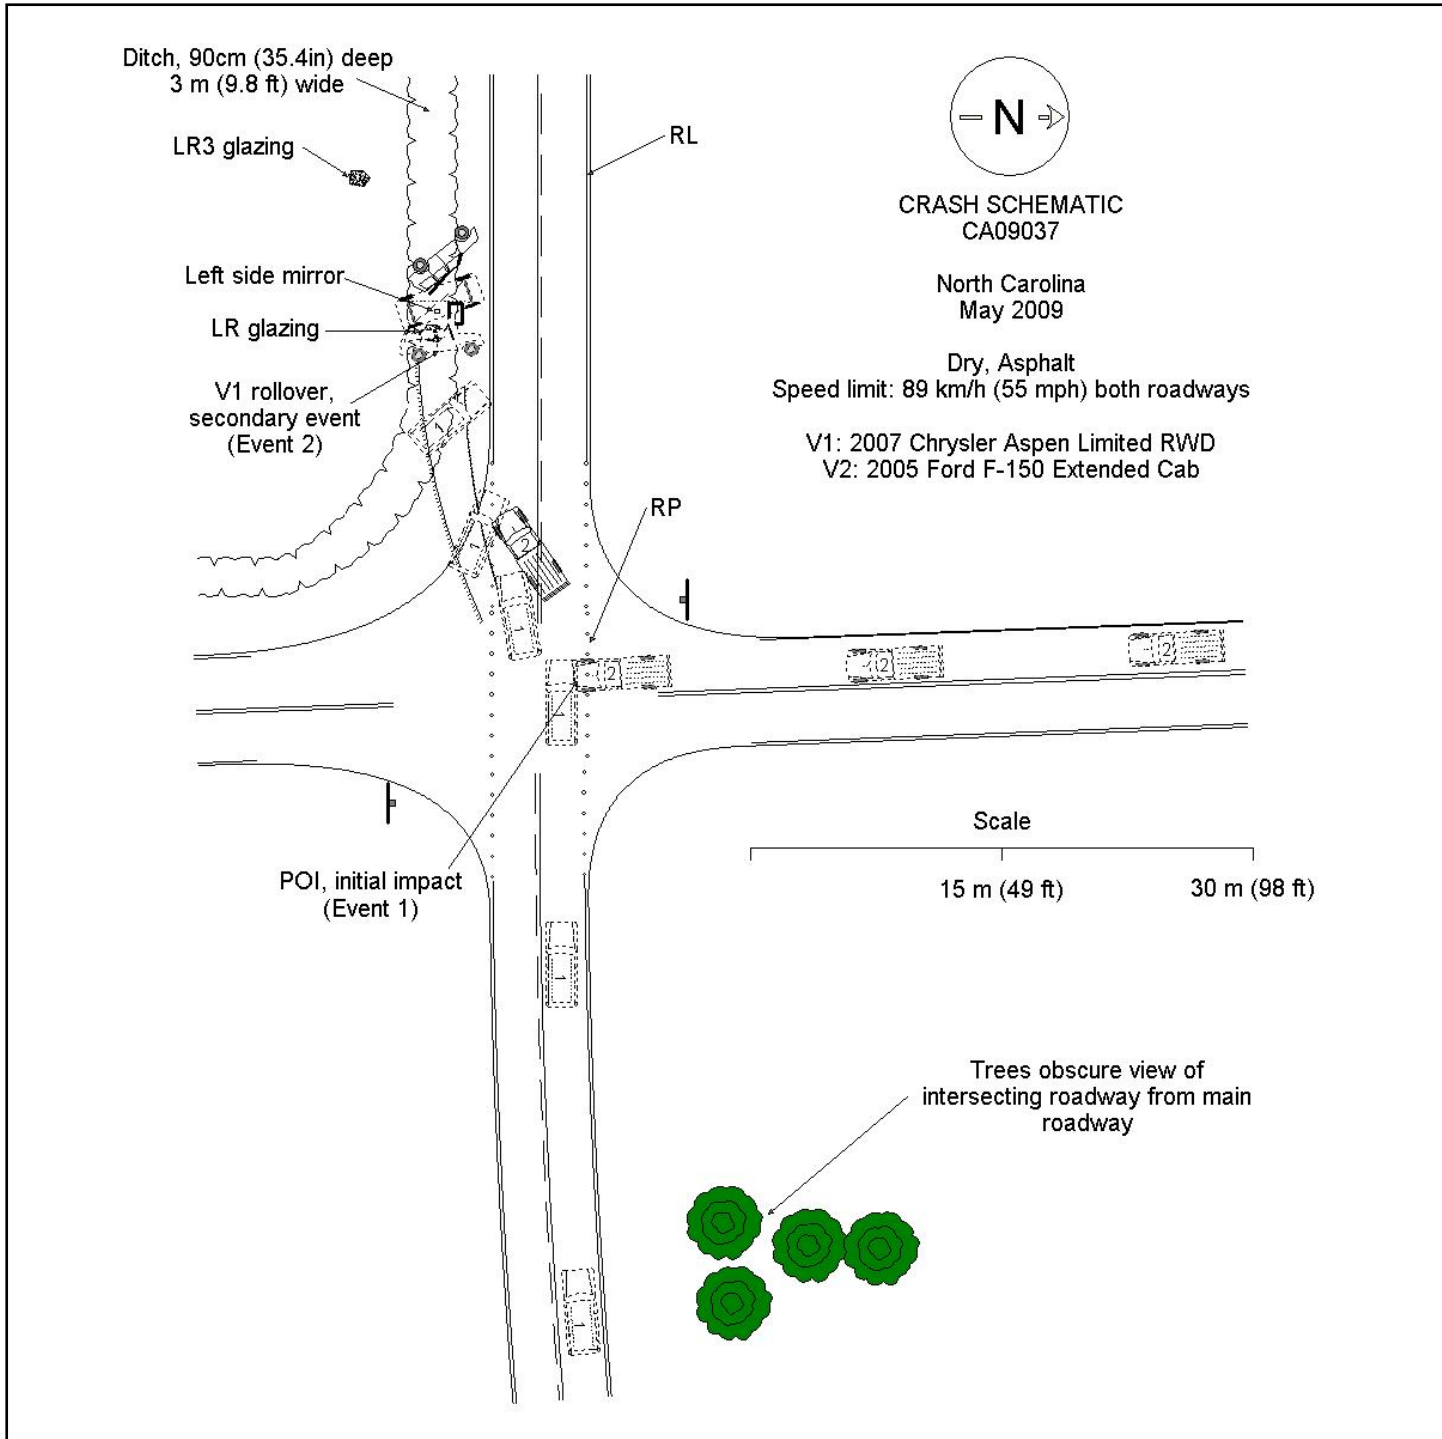
**Figure 11: Crash Schematic**

intersected the east/west roadway at an angle of 85 degrees. Both roadways and shoulders were surfaced with asphalt. Outboard of the narrow shoulders at the southwest corner of the intersection was a roadside surfaced with cut grass. This roadside was 2.1 m (6.9 ft) in width adjacent to the east/west roadway and 2.9 m (9.5 ft) in width adjacent to the north/south roadway. A 0.9 m (3 ft) deep ditch 3 m (9.8 ft) in width was located outboard of the cut grass. Tall grass and wild brush covered the ditch. Located behind the ditch was a field planted with rows of soybean plants. The posted speed limit for both roadways was 89 km/h (55 mph). The driver of the Aspen stated that he was familiar with the route and had traveled it many times before. The crash schematic is included as **Figure 11** of this report.
