CALSPAN ON-SITE MOTORCOACH FIRE INVESTIGATION

SCI CASE NO.: CA09038

VEHICLE: 1999 MCI MODEL 102-EL3 56-PASSENGER MOTORCOACH

INCIDENT DATE: MAY 2009

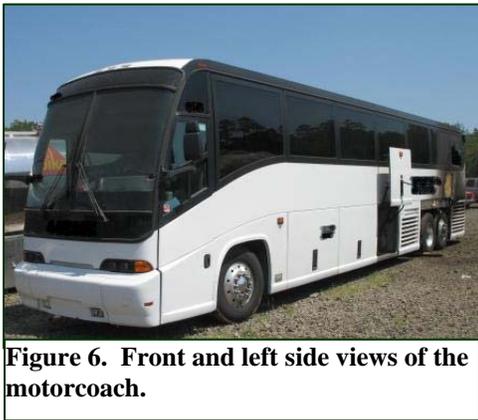
The fire damage to the left side of the motorcoach was confined to the rear area, aft and inclusive of the rear axles (**Figure 6**). The fiberglass skirt panel over the rear tires (drive

and tag axles) was burned at the rear aspect and was removed post-incident. Smoke staining on the white outer body panels began at the centerline of the drive axle area and extended upward and rearward. The same body panel directly over the tag axle tire displayed three levels of fire related damage, starting with the burning of the paint on the aluminum outer surface, extending to the disintegration of the aluminum outer surface, to the full-thickness burning of the fiberglass backer panel. The rigid insulation located between the inner and outer body panels did not burn. The burning of the fiberglass panel and the aluminum outer panel extended rearward to the aft edge of the rear wheelbase opening and vertically to the level of the beltline. This fire/burn pattern extended from under the rear tag axle area.

Figure 6. Front and left side views of the motorcoach.

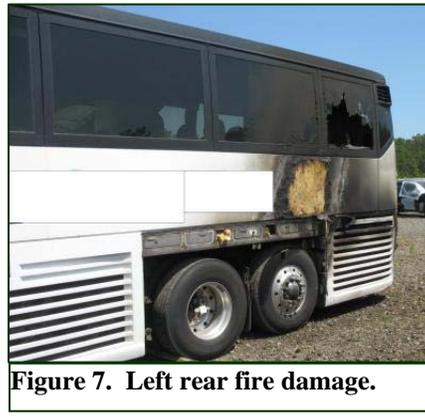
Figure 7. Left rear fire damage.

The fire extended vertically above the axles and involved the side window glazing (**Figure 7**). There were seven glazing panels within the passenger area of the motorcoach. The rear two-thirds of the sixth panel from the front of the motorcoach was smoke and soot stained. The lower rear third of this glazing panel was heat cracked with an area of the outer layer of the laminated glazing burned away. The plastic laminate and the inner glazing panel remained intact. The seventh glazing panel located aft of the rear axles was burned more extensively than the sixth panel. The lower half of this panel was melted and out of place. The remaining upper section was heat cracked and in place.

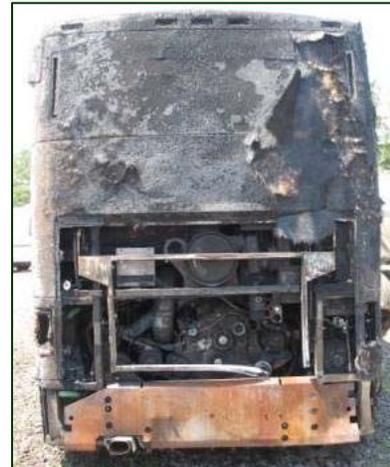
The back of the motorcoach sustained extensive fire-related damage (**Figure 8**). The composite rear bumper fascia was completely consumed by the fire. The underlying sheet metal panel exhibited two areas of high heat oxidation. The lower mid point and the right edge of this component was clean with minimal surface rust present.

Figure 8. Fire damage to the back of the motorcoach.

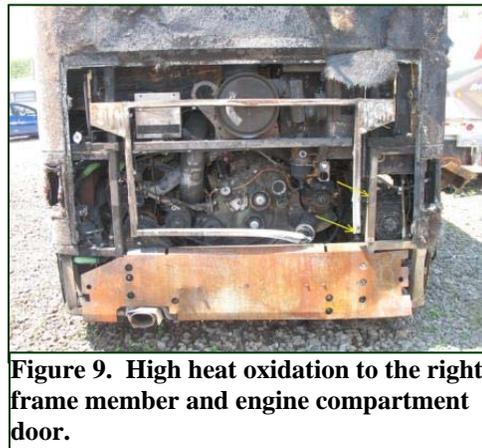
The square stock framework at the back aspect of the motorcoach was exposed by consumption of the engine compartment door. The left upright located outboard of the engine compartment door was blacked by the fire. The same component on the right side of the engine compartment exhibited a high heat pattern (**Figure 9**). The steel of the right side component was clean and free of soot-like material.

Figure 9. High heat oxidation to the right frame member and engine compartment door.

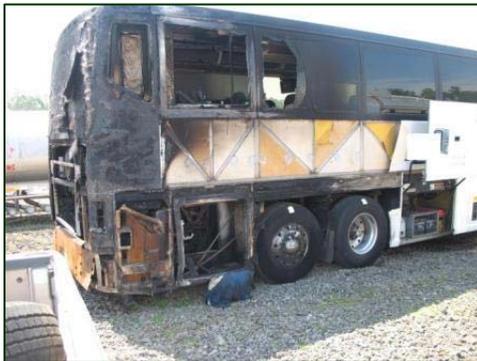
The fire damage to the right side of the motorcoach began at the drive axle location and extended rearward to the back corner (**Figure 10**). The body panel over the rear axles was burned at the rear aspect and was removed from the vehicle prior to the SCI inspection. The rigid insulation panels within the trussed frame remained intact. The most rearward panels were charred at the aft and upper aspects. Located immediately below these panels was a side mounted access door to the engine compartment. This forward hinged door was constructed of an extruded aluminum frame with a fiberglass panel that formed the cover of this door. This panel was completely consumed by the fire. The aluminum latch pocket that was mounted to the upper third on the trailing side of the door frame was 50 percent consumed by the fire. Firefighting personnel used a pry bar to open this door. The lower aft aspect of the frame was deformed forward by this activity. The top mid aspect of the door frame exhibited an area of high heat oxidation. This area appeared clean as the remaining area of the door was smoke and soot stained. This high heat oxidation continued vertically onto the vehicle frame immediately above this access door (**Figure 11**).

Figure 10. Fire damage to the right rear side area of the motorcoach.

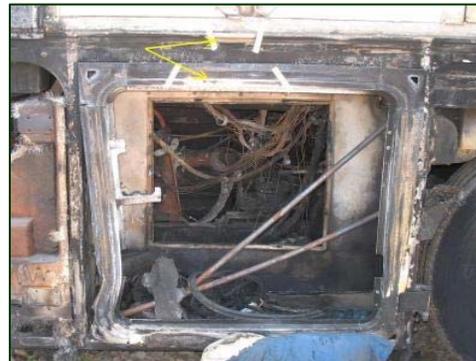
Figure 11. High heat oxidation to the area above the right side engine compartment door.

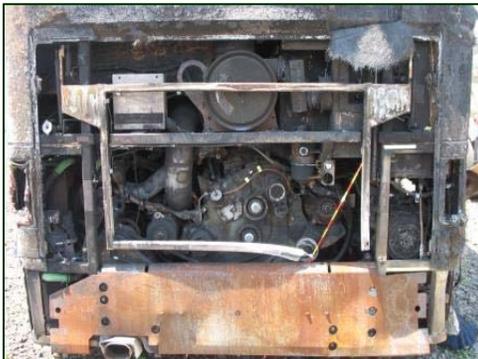
The engine compartment was visible through the rear door area and the right side area due to the complete burn of the fiberglass door panels. At the time of the SCI inspection, the compartment remained intact and undisturbed since the fire. **Figure 12** is an overall view of the engine compartment.

Figure 12. Overall view of the engine compartment.

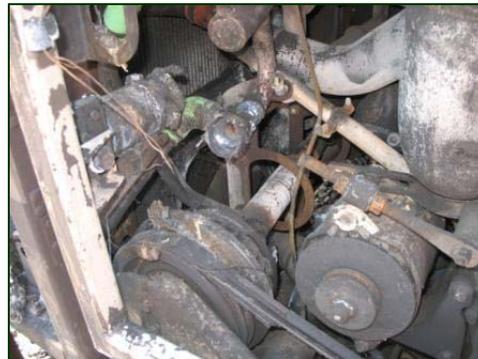
The left side of engine compartment contained the mechanical drive system for the AC condenser and radiator fan assembly. The V-belt that powered this unit was burned, but intact and in place around the pulleys. The assembly was blackened and exhibited smoke and heat damage. Located above this unit were the engine's turbocharger and the associated plumbing. The turbocharger and all connecting components were intact. Rubber connectors were burned; however, all components remained in position. The 12-volt alternator was mounted to the left of the engine block. This unit was intact with no evidence of high heat. The V-belt that powered this alternator was consumed by the fire. **Figure 13** is a view of the left side of the engine compartment.

Figure 13. Left side of the engine compartment.

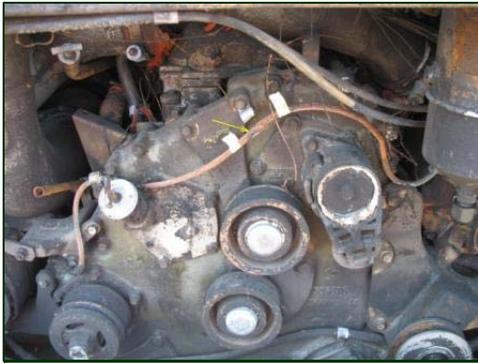
The engine block was blackened by the fire. The paint remained on the left side and mid area of the block (**Figure 14**). The 24-volt alternator was mounted to the right of the engine. This unit was blackened by the fire, but otherwise intact. The bottom aft aspect of the mounting bracket exhibited an area of high heat oxidation. A heavy gauge cable was routed across the engine to the alternators. This cable was braided copper wire with a plastic insulation and was secured to the block by two clips. The insulation was completely burned from the cable. The left clip remained intact with no evidence of damage. The cable arced due to electrical flow at the center mounted clip. The bottom of the clip that was in contact with the cable was melted and the copper cable was burned and melted from this arcing (**Figure 14**).

Figure 14. Engine and arced cable.

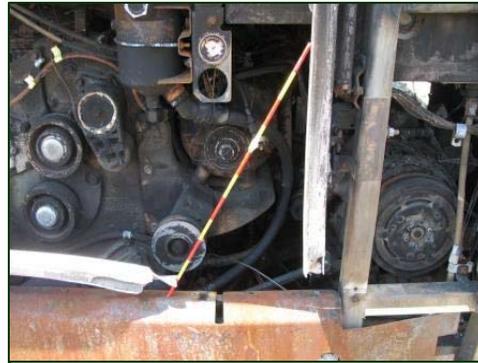
Figure 15. Right side of the engine compartment.

The air compressor was mounted to the lower right corner area of the engine compartment. This unit was intact with no evidence of high heat. All of the electrical wire insulation for the harness on the top of the compressor was burned. The V-belt that powered this unit was burned. **Figure 15** is a view of the right side of the engine compartment.

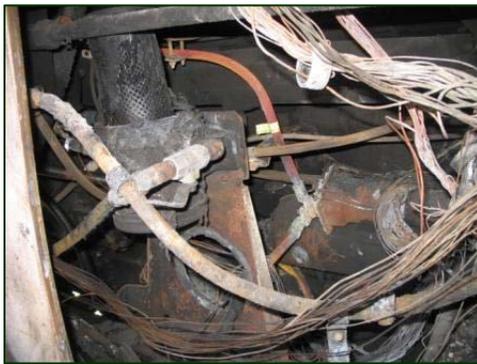
It was noted that an accumulation of oil and grease was present in this area of the engine compartment. The area immediately surrounding the starter cables and the solenoid exhibited evidence of high heat. The oil and grease accumulation surrounding those components was burned away. Larger diameter copper tubing located directly above the starter was burned clean.

The fuel filter consisted of two cartridge-type filters that were contained within composite or fiberglass canisters. This filter assembly was secured to a heavy-gauge mounting bracket located above the starter. The upper filter cartridge was burned and in place, with its outer canister completely consumed by the fire. The lower filter and canister were completely burned. The braided fuel line remained intact. The fuel filter bracket, the aft area of the starter and solenoid, starter cables and terminal connectors were burned clean, evidence of high heat. The insulation was burned from all the cabling.

Figure 16. Fuel filter, starter, and starter cables viewed through right side access door.

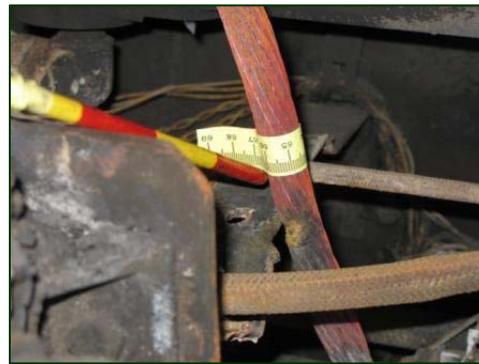
The upper power cable attached to the starter solenoid was routed horizontally through a clamp bracket, then dropped vertically and routed in a gradual 90 degree bend. This cable was routed adjacent to the fuel filter bracket located immediately above the starter. Inspection of the cable and bracket revealed evidence of arcing (**Figure 17**). This arcing resulted in a partial melting of the cable and the semi-circular erosion/burning of the heavy gauge steel bracket. The close proximity of the cable to the bracket suggests the possibility that the insulation of the cable was abraded over time due to vibration. The exposed energized cable contacted the bracket resulting in the arcing. This arcing was a possible source of the engine compartment fire.

Figure 17. Arced starter cable against bracket.

The arcing of the battery cable against the fuel filter bracket was determined to be the primary cause of the fire as the origin was located directly above the starter location. This area displayed the high heat commonly associated with origin.

Determination of Cause: Within this area of origin, a short circuit was identified between a positive battery cable and a steel fuel filter bracket. Since battery to starter circuits are not fused, short circuits are a competent heat source and can ignite the wire insulation, resulting in a fire. This evidence is consistent with electrical arcing being the most probable cause of the fire.
