CALSPAN ON-SITE AMBULANCE CRASH INVESTIGATION

SCI CASE NUMBER: CA09040

VEHICLE: 2009 FORD E450 CHASSIS / OSAGE TYPE III AMBULANCE BODY

CRASH DATE: JUNE 2009

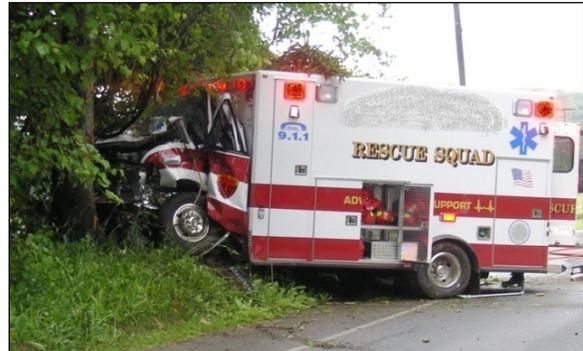
Figure 1: Final rest position of the ambulance.

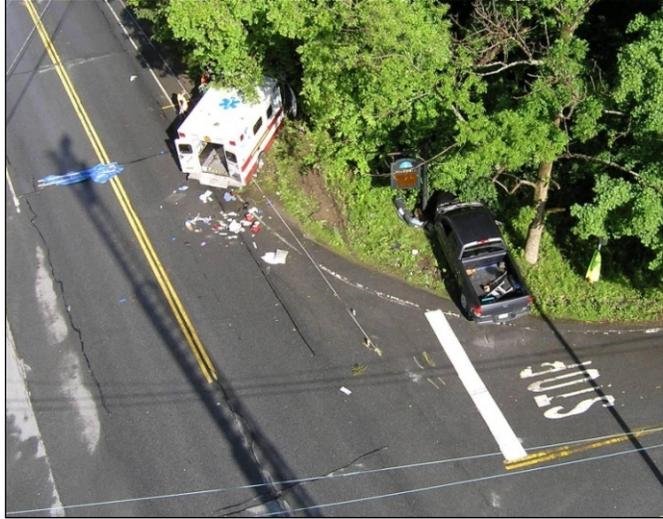
Figure 8: Aerial Image of Incident Scene. (On-scene local police image)

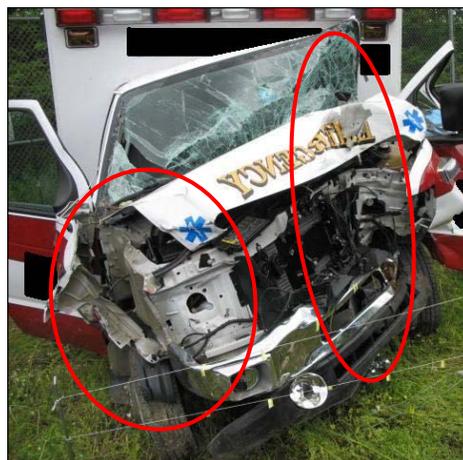
The front end of the ambulance had severe damage, with severe interior intrusion on the left side. The left front wheel and left side of the cab was significantly displaced rearward and vertically. There were two distinct areas of damage noted on either side of the frontal plane from the two separate impact events, as highlighted in **Figure 9**.

Direct contact damage from the impact with the Toyota began 65 cm (25.5 in) right of center line and extended 28 cm (11 in) to the corner. The corner impact resulted in engagement on the right side plane extending rearward to the right front axle area. The right front fender crushed rearward, was pulled right laterally, and folded back over itself. The right headlight assembly was disintegrated, and the front right corner of the hood was crushed rearward. Under hood components were subsequently damaged. The right front tire aired out as the wheel buckled and the tire debaded. The Collision Deformation Classification (CDC) was 12FREE3.

Figure 9: Frontal damage patterns to the ambulance.

The second impact caused severe damage to the chassis. Due to the inclined terrain and the angle at which the ambulance impacted the tree, the entire impact area was crushed rearward, and buckled vertically. Direct damage began on the hood 17 cm (6.5 in) left of center and extended 44 cm (17 in) to the left corner, and began at the bumper height 39 cm (15 in) left of center and extended 40 cm (16 in) to the left corner. The combined induced and direct damage extended from corner to corner across the 180 cm (71 in) end-width. The residual crush measured along the bumper was as follows: C1 = 115 cm (45 in), C2 = 86 cm (34 in), C3 = 55 cm (22 in), C4 = 27 cm (10.5 in), C5 = 9 cm (3.5 in), and C6 = 0 m (0 in). Maximum crush was located at the front left corner (C6). The CDC associated with this second damage pattern was 32FYEN05. The direction of force was incremented by a factor of 20 to account for vertical shift of the left frame rail, which was displaced upward approximately 15 cm (6 in).

Direct damage from the second impact included crush and displacement of the entire bumper, hood, grille, headlight assembly, radiator, fluid reservoirs, and other underhood components. The bumper was also separated from its left mount. The narrow impact caused distinct U-shaped damage in the hood, which matched the diameter of the tree. The crush extended to the inboard side of the left wheel and wheel opening, and reduced the left wheelbase by 64 cm (25 in) to 338 cm (133 in). Consequently, the right wheelbase was lengthened 1 cm (0.5 in) to 403 cm (158.5 in). The vertical displacement of the frame rail vertically upheaved the left sill and induced rearward crush, folding the left running board.

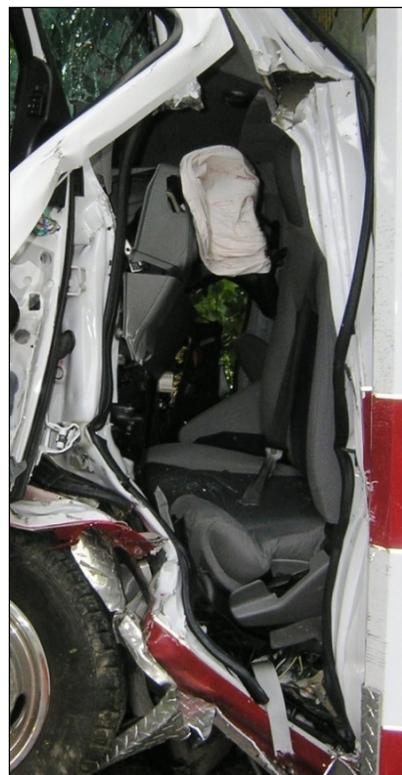
The severe interior intrusion of the ambulance cab was heavily biased to the left side. The entire instrument panel and steering column were intruded significantly. The steering wheel was displaced vertically and longitudinally and was engaged against the right side of the driver's head restraint. It was also displaced laterally to the right by 32 cm (12.5 in), measured at the 12 o'clock position with respect to the centerline of the head restraint. The severe deformation surrounding the driver's seat is shown in **Figure 10**. (Note the vertical and longitudinal displacements of the instrument panel, steering wheel, and left front tire.) Measurements of the longitudinal distance between the plane of the driver and passenger seatbacks (adjusted to the furthest rear position) and the aforementioned components are found in the following table, which compares the involved vehicle at the time of SCI inspection to an undeformed exemplar chassis:

Figure 10: Driver intrusion. (On-scene local police image)

POSITION	INTRUDED COMPONENT	DIRECTION	MAGNITUDE
LEFT	Mid-line of instrument panel	Longitudinal	50 cm (19.5 in)
	Steering wheel hub	Longitudinal	39 cm (15.5 in)
	Brake pedal	Longitudinal	51 cm (20 in)
	Toe pan at wheelwell	Longitudinal	39 cm (15 in)
CENTER	Mid-line of instrument panel	Longitudinal	36 cm (14 in)
	Engine cowl	Longitudinal	44 cm (17.5 in)
RIGHT	Outboard instrument panel	Longitudinal	3 cm (1 in)
	Inboard instrument panel	Longitudinal	15 cm (6 in)
	Engine cowl	Longitudinal	14 cm (5.5 in)

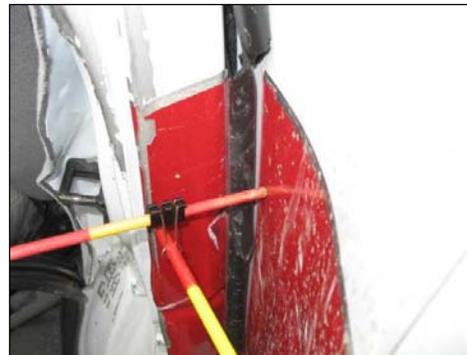
Overall rearward longitudinal displacement of the cab caused deformation to the frontal exterior area of the ambulance body, with a maximum rearward deflection of 6 cm (2.5 in) at sill level. There was 6 cm (2.25 in) of deflection at striker level on the B-pillar, as depicted in **Figure 11**. There was also 5 cm (2 in) of deflection at the belt line, though there was no deformation at the roofline.

Figure 11: Ambulance body crush.

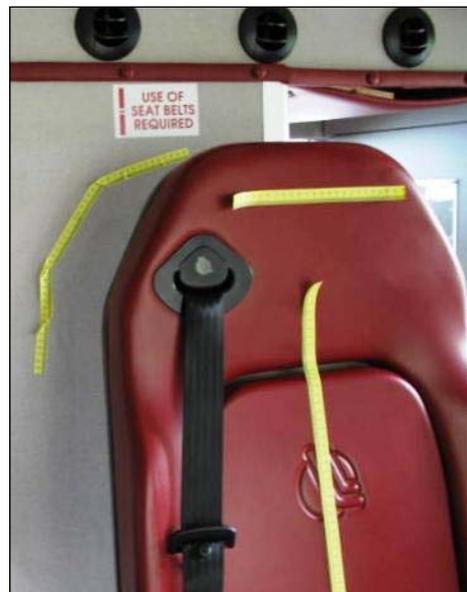
The wall behind the Captain's Chair had contact evidence from the upper seatback of the chair. This was located from 94-122 cm (37-48 in) above the floor, at 41-61 cm (16-24 in) left of centerline. The Captain's Chair was not deformed, and the integral CRS remained stowed within the seatback. This is depicted in **Figure 12**.

Figure 12: Captain's Chair contact evidence.

During the crash sequence, the AEMT-I loaded the seatback of the Captain's Chair. This resulted in contact damage to the front wall as the seatback deflected forward. As the vehicle engaged the tree, objects in the patient compartment became airborne. The AEMT-I was separated from the Captain's Chair and contacted the front wall and ceiling with his back and head. The unrestrained patient was ejected from the stretcher and contacted him in the chest. He was displaced to the right side as the vehicle rebounded, coming to rest on the floor in front of the right side passenger access door. This sequence caused abrasion and laceration injuries to his scalp. After the vehicle came to rest, he exited the vehicle without assistance. He was transported by EMS ground ambulance to a local hospital where he was treated for minor severity injuries and released the same day.

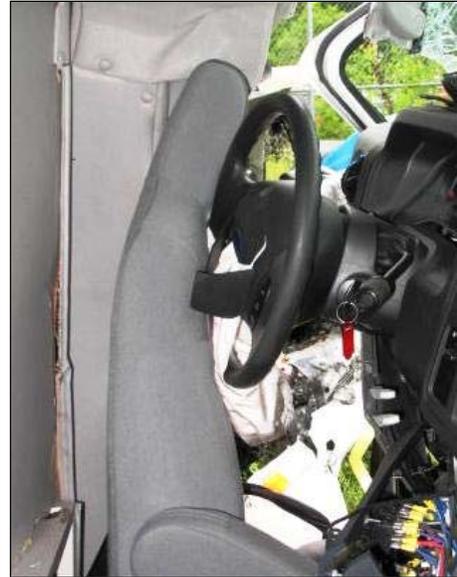
Figure 13: Driver air bag and displaced steering assembly of the ambulance.

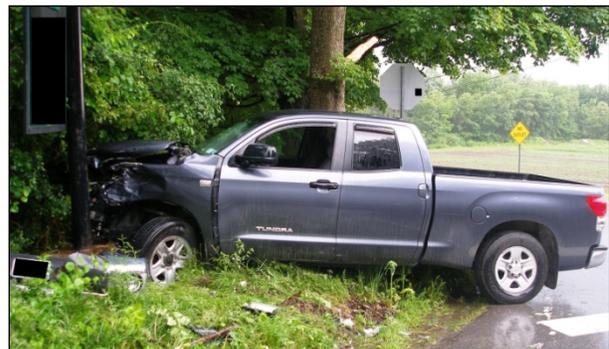
The stationary Toyota was impacted by the ambulance on the left front side (**Figure 14**). Direct contact damage from this impact began 61 cm (24 in) forward of the left A-pillar and extended 41 cm (16 in) to the left front bumper corner. The associated Field L was 102 cm (40 in), and began 7 cm (2.6 in) forward of the leading edge of the left front door and extended to the front corner. The accompanying crush profile included the following six equidistant values documented along the plane: C1 = 0 cm (0 in), C2 = 7 cm (3 in), C3 = 14 cm (5.5 in), C4 = 26 cm (10.5 in), C5 = 37 cm (15 in), and C6 = 44 cm (17 in). Maximum crush was located at the front left corner (C6). The CDC of this impact was 09LFEW3.

The initial impact caused moderate damage to the front of the vehicle, crushing the left front fender laterally into the hood and underhood components. This deformation damaged and displaced the battery, headlight assembly, hood, grille, and bumper. The left front tire lost air pressure as a result of the impact, though photographs taken on-scene by police officers show that the tire remained mounted on the wheel rim and did not debeat. As the ambulance engaged the Toyota, the front bumper of the pickup truck was separated from its mounts. Both the bumper and the pickup truck transitioned into eastward CW rotations. The bumper completed a full 360 degree lateral

Figure 14: Final rest position of the Toyota. (On-scene local police image)
