## ON-SITE ROLLOVER INVESTIGATION

CASE NUMBER - IN09040

LOCATION - MISSOURI

VEHICLE - 2008 MAZDA CX-7

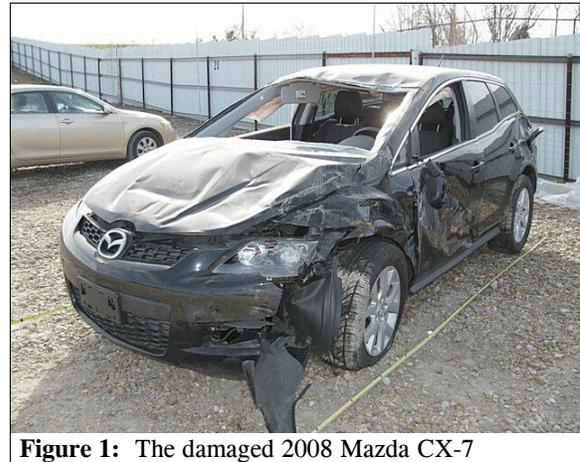
**Figure 1:** The damaged 2008 Mazda CX-7

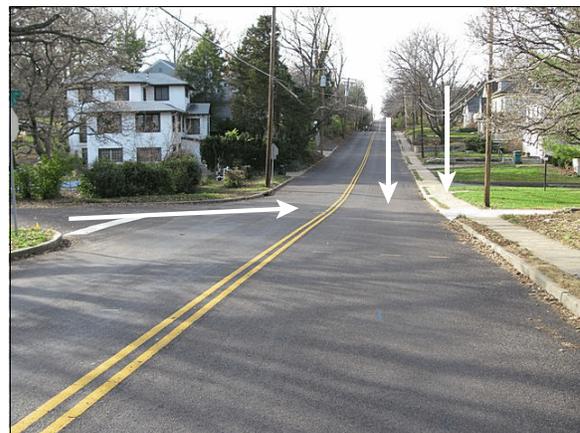
**Figure 2:** Approach of the Mazda; arrow on left shows approach of the Jeep; arrow in center shows area of impact with the Jeep; arrow on right shows location of the Mazda's rollover

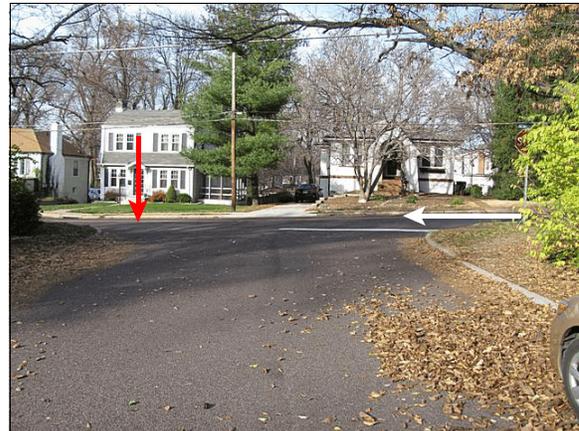
**Figure 3:** Approach of the Jeep to the intersection; arrow on right shows the approach of the Mazda; arrow on left shows the area of impact

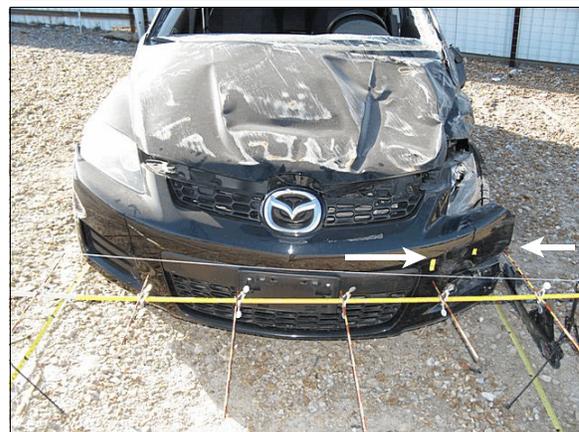
**Crash:** The driver of the Jeep accelerated into the intersection and initiated a left turn. The front plane of the Mazda (**Figure 4**) impacted the right side plane of the Jeep (event 1). The impact on the Mazda was within the 11 o'clock sector and the impact force was not sufficient to trigger deployment of the driver's frontal air bag. The impact redirected the Mazda northwest and the right front and right rear wheels (**Figure 5**) impacted a curb (events 2 and 3, **Figure 6**). The curb impacts tripped the Mazda and it rolled over (event 4, **Figure 7**) right side leading across the sidewalk and onto a residential driveway. The Mazda's rollover inflatable curtain (IC) air bags deployed during the rollover. The Mazda came to final rest on the driveway (**Figure 6**) on its left side heading southwest. The driver of the Jeep pulled his vehicle over to the north curb approximately 30.5 m (100 ft) west of the Mazda.

**Figure 4:** Arrows show the damage on the front bumper from the impact with the Jeep

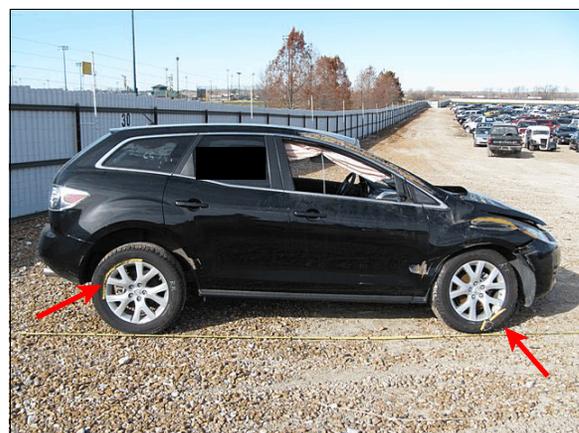
**Figure 5:** Arrows show the damage on the right front and right rear wheels from the curb impacts

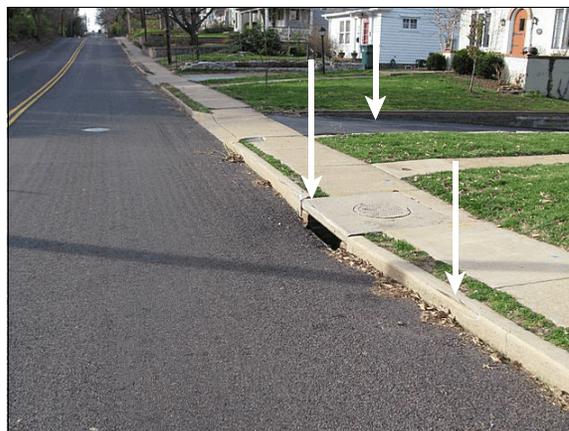
The rollover of the Mazda (event 4) was initiated when the Mazda's right side wheels impacted the curb. The curb impacts occurred near a storm water drain (**Figure 6**) and the curb was higher in this area due to the grade to the drain. The curb was 28 cm (11 in) high in the area where the right front wheel impacted and 18 cm (7.1 in) high where the right rear wheel impacted. The curb impacts tripped the vehicle and it rolled over right side leading 3 quarter turns across a distance of approximately 12 m (39.4 ft). The vehicle came to final rest on its left side heading southwest.

**Figure 6:** Arrows in foreground show marks on the curb from the impacts by the right front and right rear wheels of the Mazda; arrow in background show final rest position of the Mazda

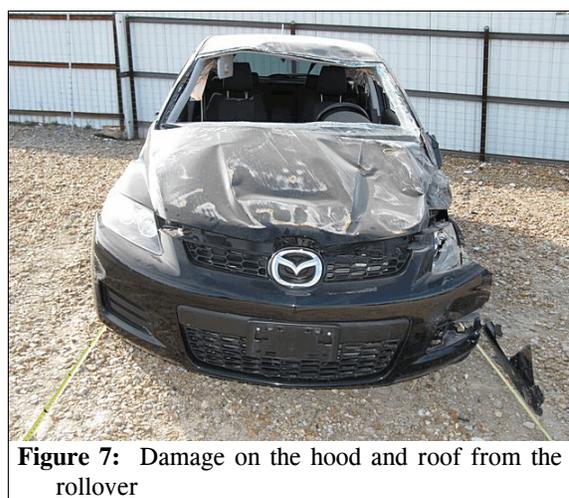
**Figure 7:** Damage on the hood and roof from the rollover

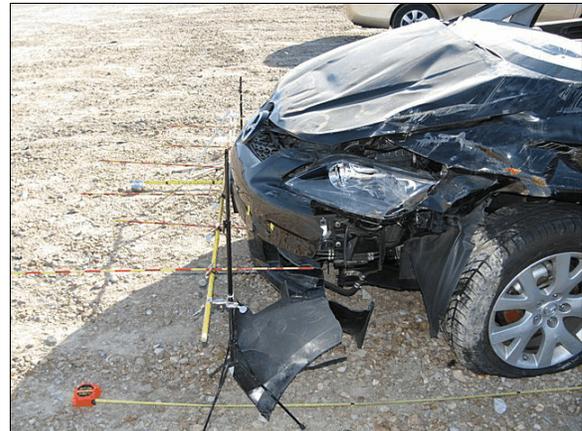
**Exterior Damage:** The impact with the Jeep (event 1) involved the front plane of the Mazda. The direct damage involved the left corner of the front bumper, left headlamp/turn signal assembly, and the left fender (**Figure 8**). The direct damage began at the front left bumper corner and extended 36 cm (14.2 in) across the bumper fascia. The crush measurements were taken on the bumper bar. The bumper bar did not extend beyond the left frame member (**Figure 9**) and due to the narrow end engagement, the only components of the bumper structure that were damaged were the plastic bumper fascia and a metal bracket on the outboard side of the left frame rail (**Figure 9**). The maximum crush was 3 cm (1.2 in) occurring at C<sub>1</sub>, which was measured on the metal bracket. The left fender was crushed rearward 8 cm (3.1 in). The left front wheel was also engaged during this impact and displaced rearward 14 cm (5.5 in). The induced damage involved the bumper fascia and the hood. The table below shows the vehicle’s front crush profile.

**Figure 8:** Left side view of the impact area on the left portion of the front bumper

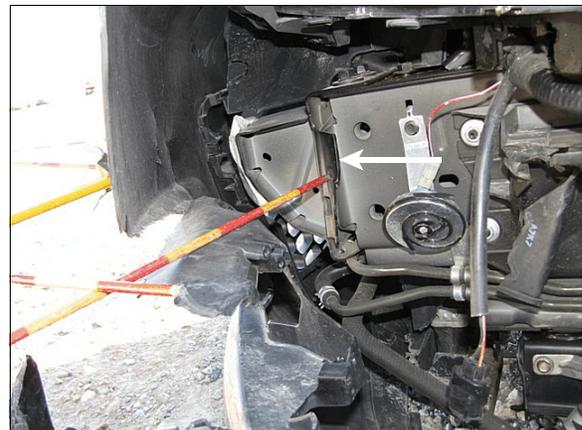
**Figure 9:** Close view of the left end of the bumper bar and left frame member; arrow shows the deformed metal bracket where C<sub>1</sub> was measured

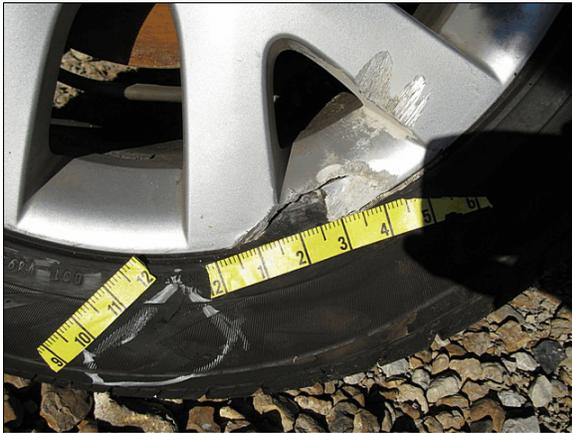
The curb impacts (events 2 and 3) involved the right front and right rear wheels. The right front rim and tire were damaged (**Figure 10**) and a piece of the rim 9 cm (3.5 in) in length was broken off. The sidewall of the tire was also cut and abraded. A heavy abrasion 53 cm (20.5 in) in length was present on the right rear wheel rim (**Figure 11**).

**Figure 10:** Damage to the right front rim and tire from the curb impact

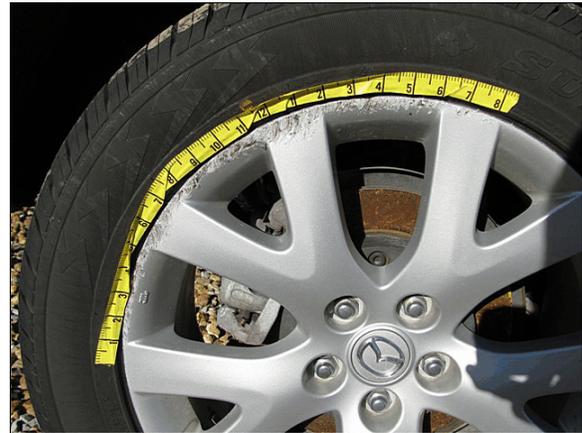
**Figure 11:** Damage on the right rear rim from the curb impact

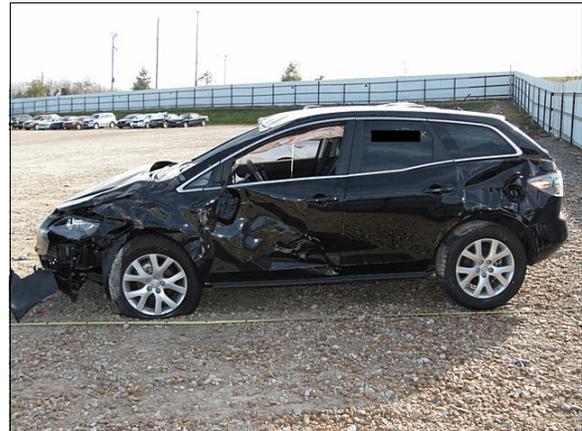
**Figure 13:** Damage from the rollover on the left side plane

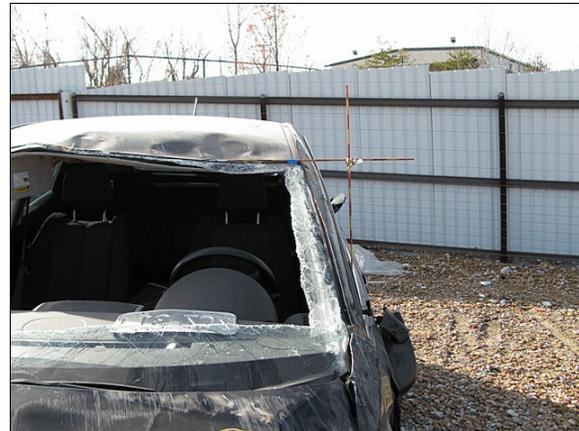
Figure 14: The maximum vertical crush occurred on the windshield header

The vehicle's passenger compartment sustained several minor intrusions due to the rollover. The most severe intrusions occurred in the driver's seating area and involved the roof and windshield header, which both intruded vertically 6 cm (2.4 in).

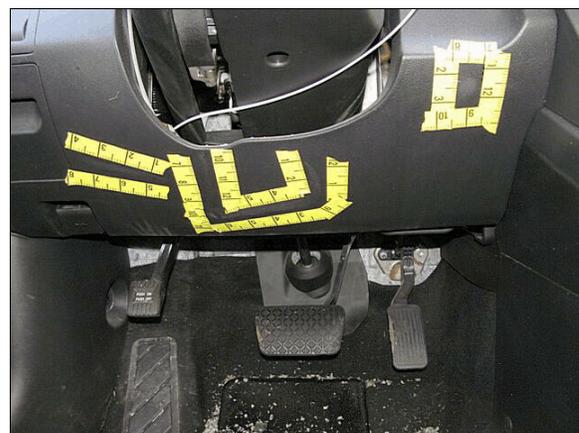
**Vehicle Interior:** The inspection of the Mazda’s interior revealed several areas of occupant contact evidence within the driver’s seating area. The lower middle and lower left instrument panel were scuffed due to knee contact (Figure 15). The left roof side rail and adjacent roof were lightly scuffed with a few hair transfers from head contact (Figure 16). The left front door arm rest (Figure 17) and the forward lower quadrant of the left front door were scuffed from contact by the driver’s left thigh and left lower leg. There was no deformation of the steering wheel and no compression of the energy absorbing steering column.

Figure 15: Scuff marks on the lower instrument panel of the Mazda

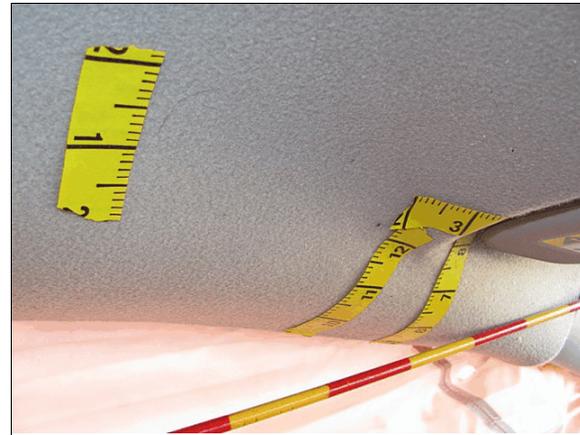
**Figure 16:** Scuff marks and a few hair transfers on the left roof side rail and adjacent roof

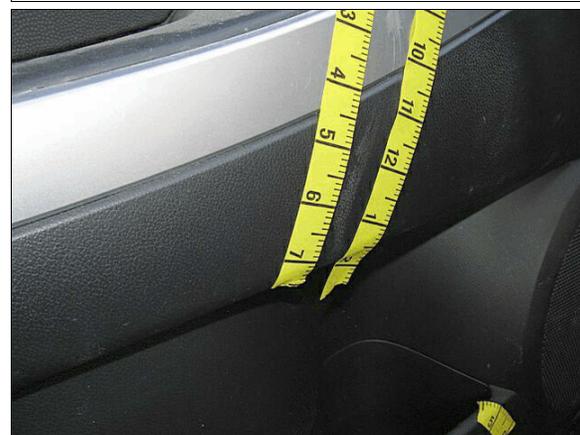
**Figure 17:** Scuff mark on the left front door arm rest

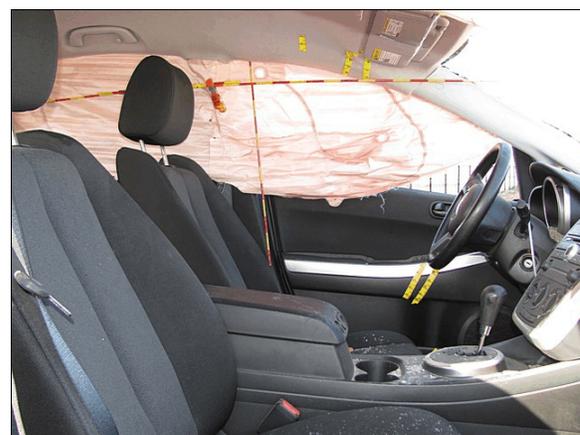
The IC air bags were located along the roof side rails inside the headliner (**Figure 18**) and extended from the A-pillar to the D-pillar. They were designed with inflation chambers adjacent to the outboard seat positions. The creases in the IC air bags indicated that they were folded accordion style within the module. Each deployed IC air bag was 206 cm (81.1 in) in width and 42 cm (16.5 inches) in height. There were no visible tethers that attached the IC air bag to the A-

**Figure 18:** The front portion of the left rollover/side impact IC air bag

or D-pillar and no visible vent ports. Each IC air bag extended 5 cm (2 in) below the beltline in the second row and 8 cm (3.1 in) in the front row. The gap between the front of the IC air bag and the front of the window frame at the beltline was 11 cm (4.3 in). Inspection of the IC air bags revealed no discernable evidence of occupant contact and no damage.
