ON-SITE CERTIFIED ADVANCED 208-COMPLIANT VEHICLE INVESTIGATION

CASE NUMBER - IN09041
LOCATION - MICHIGAN
VEHICLE - 2009 SMART FORTWO
PASSION CABRIOLET CONVERTIBLE
CRASH DATE - October 2009

Submitted:
May 13, 2010

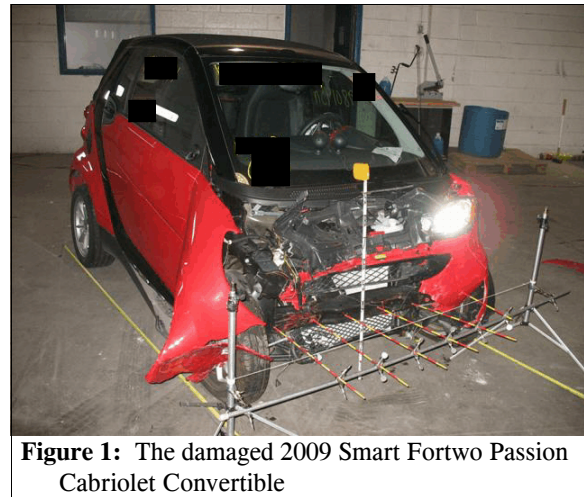
Figure 1: The damaged 2009 Smart Fortwo Passion Cabriolet Convertible

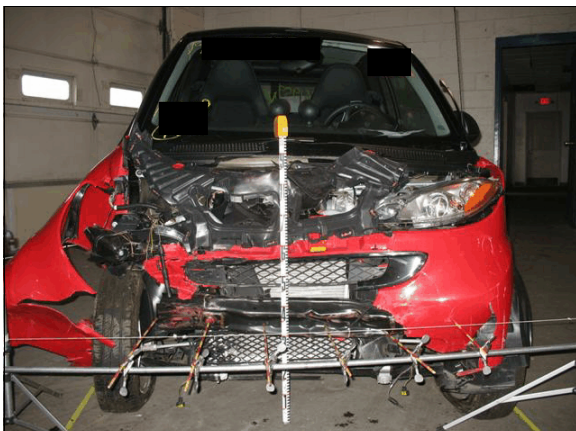
Crash: The front plane of the Smart (**Figure 4**) impacted the front plane of the Toyota (**Figure 5**). The direction of force on the Smart was within the 11 o'clock sector and the impact force was sufficient to trigger a deployment of the driver's frontal air bag. The Smart rotated clockwise approximately 90 degrees and came to final rest in the mouth of the driveway heading northwest. The Toyota came to final rest in the mouth of the driveway heading north.

Figure 4: Damage on the front plane of the Smart from the impact with the front plane of the Toyota

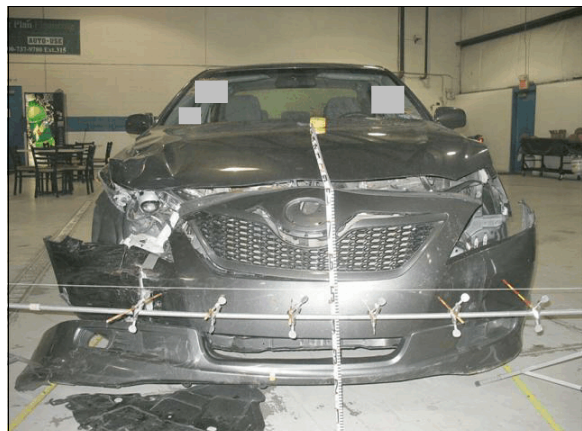
Figure 5: Damage to the front plane of the Toyota from the impact with the front plane of the Smart

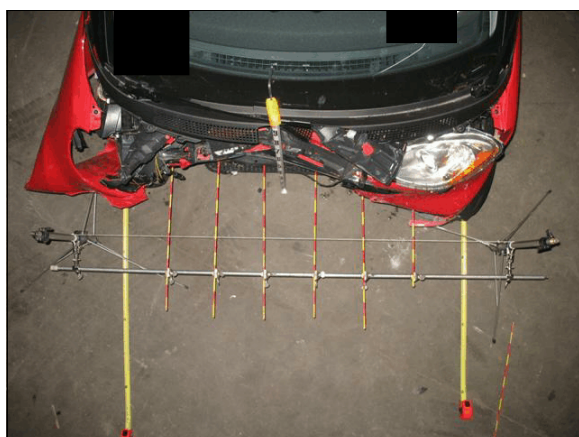
Exterior Damage: The impact with the Toyota involved the front plane of the Smart. The front bumper fascia, bumper bar, grille, right headlamp/turn signal assembly, hood, right fender, and the right front wheel were directly damaged. The direct damage began at the front right bumper corner and extended 110 cm (43 in) across the bumper. The crush measurements were taken on the bumper bar and the maximum residual crush was 30 cm (11.8 in) occurring at C₆ (**Figure 6**). The vehicle’s right side wheelbase (**Figure 7**) was reduced 11 cm (4.3 in) while the left side wheelbase was unchanged. Induced damage involved both fenders and the right sill trim cover. The table below shows the front crush profile.

Figure 6: Top view of the crush on the front plane of the Smart

Damage Classification: The Collision Deformation Classification (CDC) for the front impact was 11FDEW4 (340 degrees). The Damage algorithm of the WinSMASH program calculated the total Delta V for the Smart as 29 km/h (18 mph). The longitudinal and lateral velocity changes were -27.3 km/h (-17.0 mph) and 9.9 km/h (6.2 mph), respectively. Based in the damage to both vehicles, the results appeared reasonable.

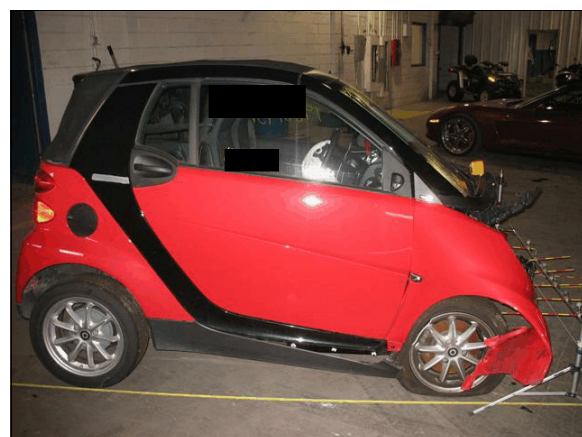
Figure 7: Shortened right side wheelbase and induced damage on the fender and sill trim cover of the Smart

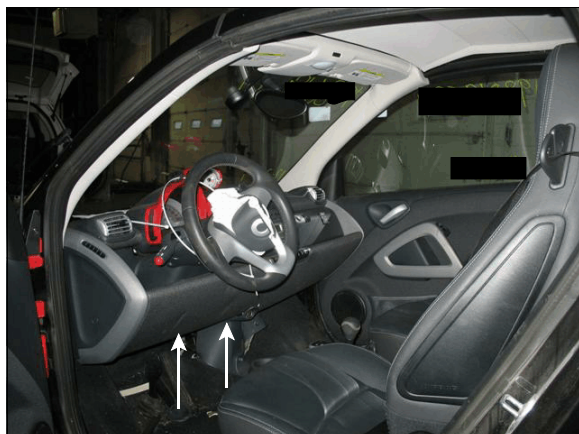
Vehicle Interior: The inspection of the Smart’s interior (**Figures 8**) revealed a broken windshield wiper lever (**Figure 9**) probably from contact by the driver’s right hand. The lower left instrument panel was lightly scuffed from contact by the driver’s knees. There was no deformation of the steering wheel or compression of the energy absorbing steering column.

Figure 8: Front row of the Smart viewed from left front door; arrows show scuffs on lower instrument panel

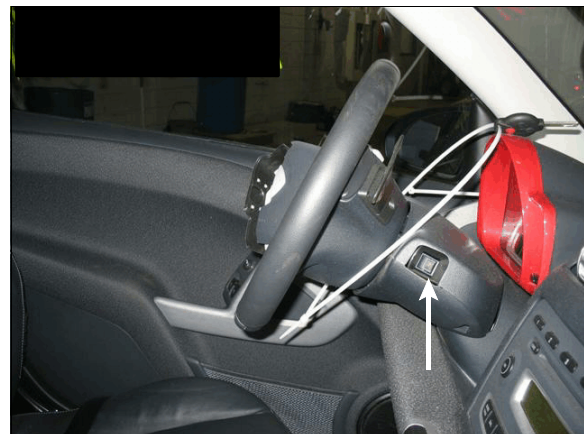
Figure 9: The windshield wiper lever was broken from occupant contact

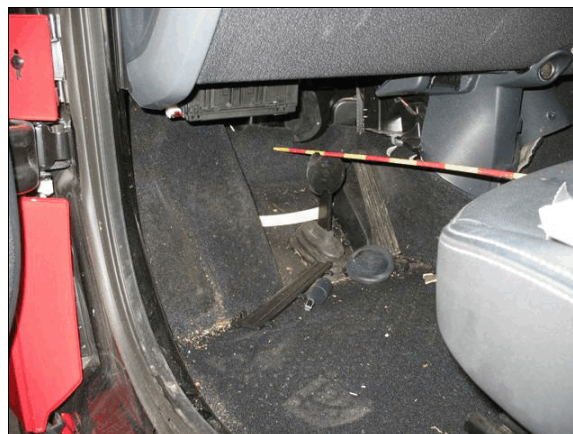
(3.5 in), while the left toe pan (Figure 10) intruded 6 cm (2.4 in).

Figure 10: The left toe pan of the Smart intruded 6 cm (2.4 in)

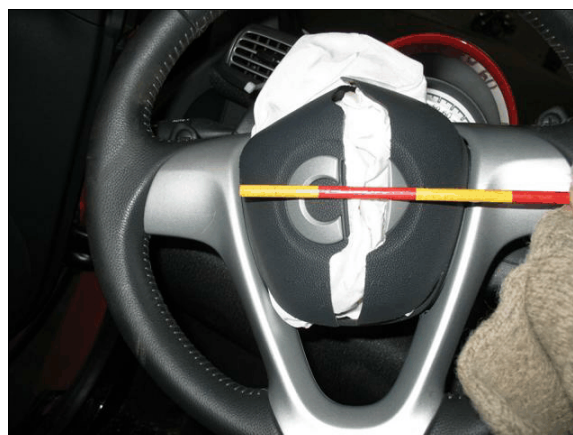
The driver's frontal air bag was located within the steering wheel hub. The module cover was a two flap configuration constructed of pliable vinyl (Figure 11). Each flap was 6.5 cm (2.6 in) wide at the top, 5 cm (2 in) wide at the bottom, and 13 cm (5.1 in) in height. An inspection of the cover flaps revealed that they opened at the designated tear points and were undamaged. The deployed air bag (Figure 12) was 60 cm (23.6 in) in diameter and had one 4 cm (1.6 in) diameter vent port and four 6 cm (2.4 in) tethers. The vent port (Figure 13) was located on the back of the air bag at the 12 o'clock position, near the hub. Inspection of the air bag revealed no discernable evidence of occupant contact and no damage.

Figure 11: Air bag module cover flaps

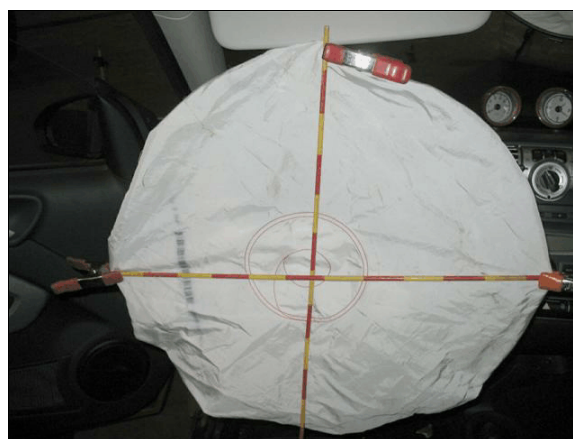
Figure 12: The driver's air bag

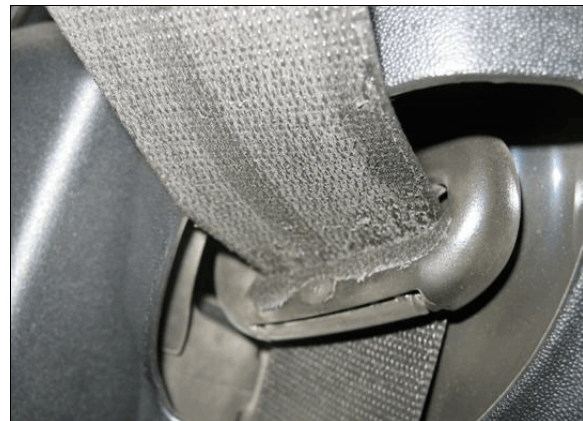
The inspection of the driver's safety belt assembly revealed load abrasions on the belt webbing and D-ring (**Figure 14**). The abrasions on the safety belt webbing were located 118 cm (46.5 in) above the stop button. Load abrasions were also present on the latch plate belt guide (**Figure 15**). This evidence indicated that the driver was restrained in this crash.

Figure 14: Load abrasion on driver's D-ring and belt webbing

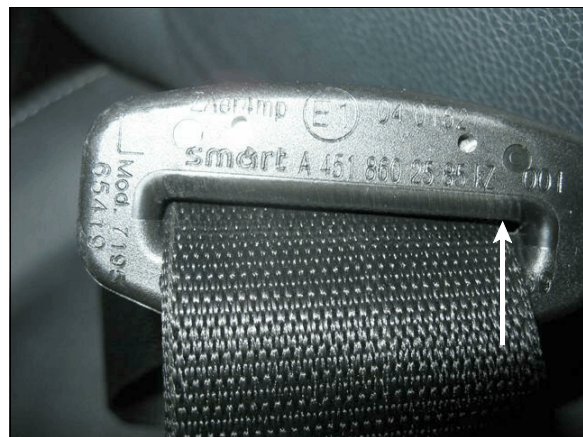
Figure 15: Load abrasions on driver's latch plate belt guide

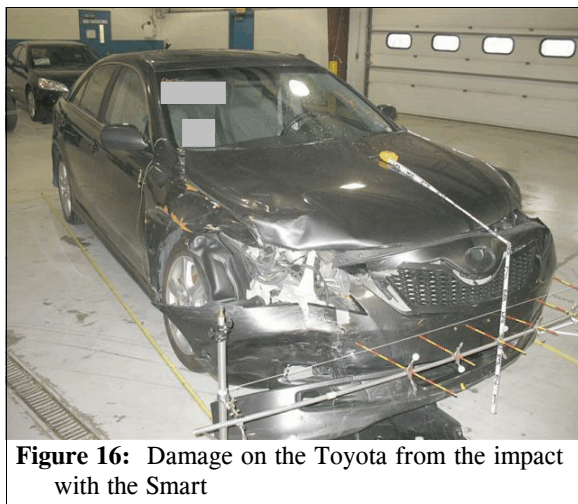
Exterior Damage: The impact with the Smart involved the front plane of the Toyota. The front bumper, bumper fascia, grille, hood, right fender, right headlamp/turn signal assembly, and right front wheel were directly damaged (**Figure 16**). The direct damage began at the front right bumper corner and extended 75 cm (29.5 in) along the front bumper. The crush measurements

Figure 16: Damage on the Toyota from the impact with the Smart

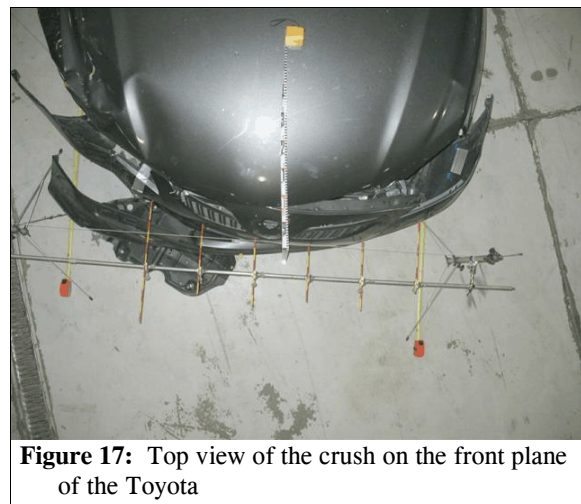
were taken at the bumper level and the maximum residual crush was 6 cm (2.4 in) occurring at C₆ (Figure 17). The right side wheelbase was reduced 6 cm (2.4 in), while the left side wheelbase was unchanged. The induced damage involved the hood and right front door. The table below shows the front crush profile.

Figure 17: Top view of the crush on the front plane of the Toyota

Damage Classification: The Toyota’s CDC for the front plane impact was 01FZEW1 (20 degrees). The Damage algorithm of the WinSMASH program calculated the Toyota’s total Delta-V as 17 km/h (10.6 mph). The longitudinal and lateral velocity changes were -16 km/h (-9.9 mph) and -5.8 km/h (3.6 mph), respectively. Based on the damage to both vehicles, the results appeared reasonable.
