**CALSPAN ON-SITE SIDE IMPACT INFLATABLE OCCUPANT
PROTECTION SYSTEM CRASH INVESTIGATION
SCI CASE NO.: CA09042**

VEHICLE: 2007 VOLKSWAGEN JETTA WOLFSBURG EDITION

LOCATION: NORTH CAROLINA

CRASH DATE: JUNE 2009

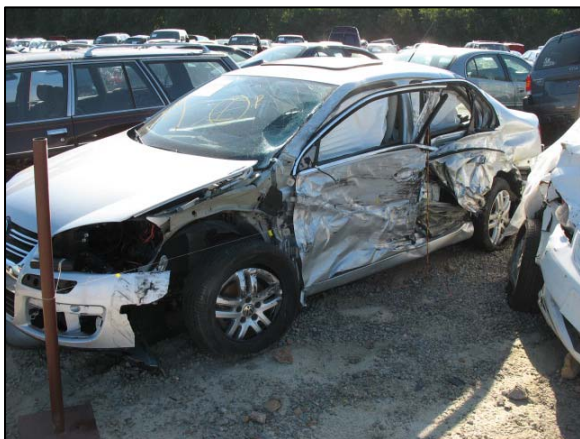
The left side and the right rear wheel of the Volkswagen were damaged in this multiple event crash. The initial impact (Event 1) involved moderate-severity damage to the left side of the Volkswagen (**Figure 3**). The direct contact damage began on the left side 66 cm (26 in) aft of the left rear axle and extended forward 390 cm (153.5 in) to slightly aft of the left front bumper corner. The combined direct and induced damage (Field L) began 84 cm (33.1 in) rear of the left rear axle and extended forward 408 cm (160.6 in). Lateral crush was present on the left doors, the A, the B and the C-pillars. The front and rear left door hinges were intact and remained attached to the A- and B-pillars, respectively. Both left side door latches remained engaged as

both side doors remained closed during the crash. The windshield was cracked but remained in place during the crash. The left side windows all disintegrated as a result of the impact with the Dodge. The right side windows, backlight and sunroof glazing were not damaged in this crash. The front and rear left wheels and tires were engaged by the Dodge Ram and were damaged but did not separate from the suspension components. Vertically, the direct damage extended from the sill level to the A- and B-pillars above the belt line. The residual crush profile was measured at the mid door elevation and was as follows: C1 = 0 cm, C2 = 15 cm (5.9 in), C3 = 6 cm (2.4 in), C4 = 9 cm (3.5 in), C5 = 13 cm (5.1 in), C6 = 7 cm (2.8 in). The maximum crush was located at C2, 10 cm (3.9 in) aft of the left rear axle and measured 15 cm (5.9 in). The elevation of the maximum crush was 66 cm (26 in), which was consistent with the front bumper height of the Dodge. The Door Sill Differential (DSD) was 12 cm (4.7 in). The left roof side rail deformed laterally and buckled the left side of the roof slightly upward. The Collision Deformation Classification (CDC) of this impact was 12LDAW2.

Figure 3: Impact damage to the left side of the Volkswagen.

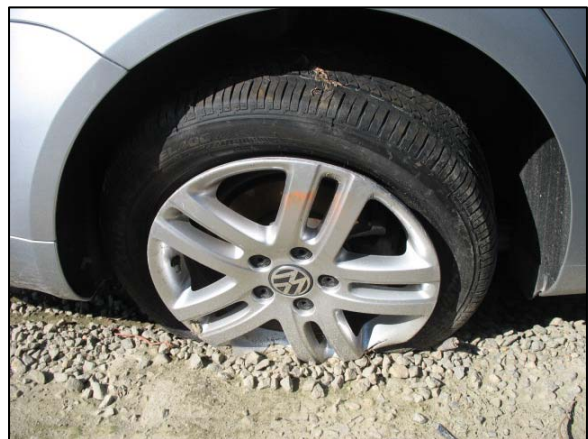
The secondary impact damage involved the right rear wheel of the Volkswagen (**Figure 4**). This component was damaged as the wheel impacted the east concrete curb (Event 3). The right rear tire was de-beaded and the wheel was deformed inboard. The plane wheel was canted approximately 15 degrees from its lower to upper aspect. The CDC assigned for this impact was 03RBWN1.

Figure 4: Secondary damage to right rear wheel and tire of the Volkswagen.

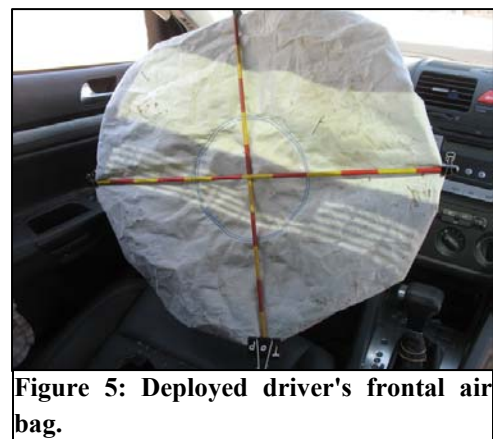
Figure 5: Deployed driver's frontal air bag.

There were no occupant contact points on the air bag; however, the face of the air bag was covered by small drops of body fluid and coffee. There were two 3 cm (1.2 in) cuts in the face of the air bag attributed to fragments of the tempered side glazing. The first cut was nearly horizontal and located 5 cm (2 in) below the center point of the face of the bag. The second cut was oriented diagonally up from left to right and was located 10 cm (3.9 in) below and 12 cm (4.7 in) to the right of the center point of the bag's face. There were three small holes less than 1 cm (0.4 in) in diameter located on the upper rear aspect of the air bag located 9 cm (3.5 in) above and 3 cm (1.2 in) to the left of the vent port.

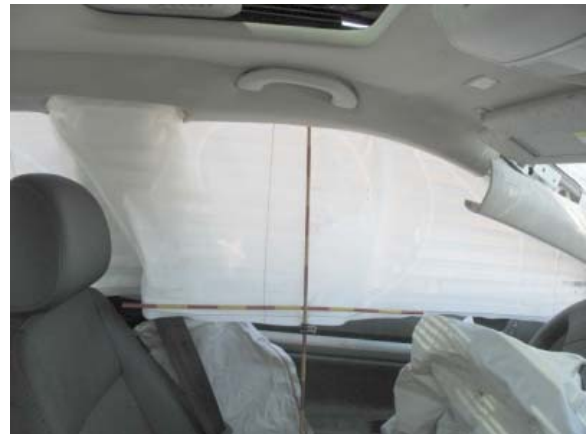
Figure 6: Left IC air bag at the driver's position.

The forward inboard aspect of the IC was covered with numerous small droplets of coffee but was free of occupant contact.

A 5 cm (1.2 in) cut was observed on the central aspect outboard surface of the IC air bag. The cut of the air bag's fabric was attributed to the front structure of the Dodge Ram. This cut was located 17 cm (6.7 in) below the roof side rail and extended from 57 to 62 cm (22.4 to 24.4 in) rear of the front edge of the IC.

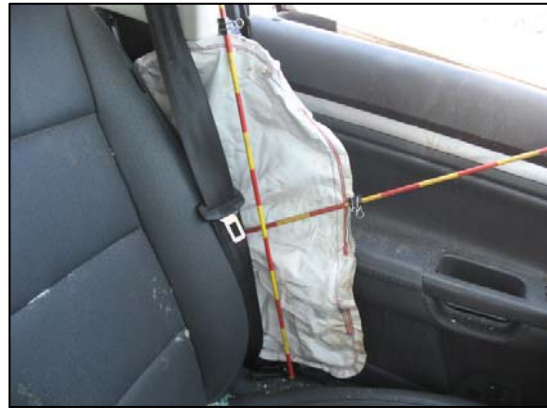
The left side impact air bag deployed from a panel in the outboard aspect of the left seat back. The air bag measured 20 cm (7.9 in) in width and 54 cm (21.3 in) in height. It contained one vent port at the three o'clock position and no tethers. There was smeared body fluid on the entire outboard aspect of the membrane. There was no damage to the membrane or contact evidence on the inboard side. **Figure 7** depicts the front left side air bag.

Figure 7: Left side impact air bag.

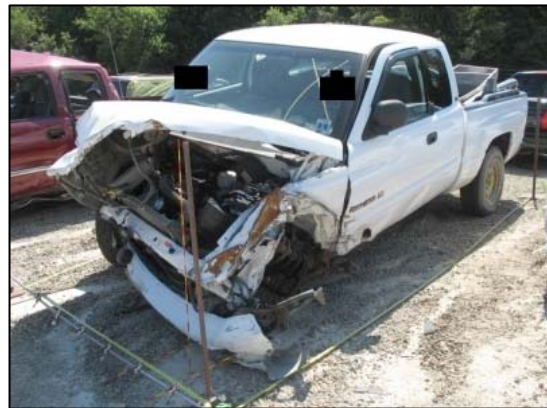
The front of the Dodge Ram sustained moderate severity damage as a result of the multiple impact crash. The front plane sustained two impacts with overlapping damage. The front plane sustained two impacts with overlapping damage. The first region of damage was located at the front left corner from the initial impact with the Volkswagen (**Figure 8**). This initial impact damage wrapped around the left corner and extended along the left plane to the left front door area. This damage pattern was overlapped by the damage from the Event 2 impact with the Buick. The partial CDC assigned for the Event 1 impact was 12FLEE6. The direction of force for the initial impact was within the 12 o'clock sector.

Figure 8: Left oblique view of the Dodge.

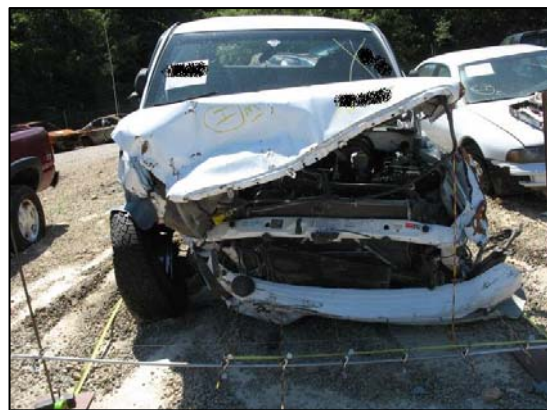
The secondary impact to the front right corner caused the bumper to shift downward and to the left (**Figure 9**). The direction of force for the secondary impact was within the 2 o'clock sector. The bumper was displaced 36 cm (14.2 in) to the left and 28 cm (11 in) downward. The direct damage was located from bumper corner to bumper corner and measured 133 cm (52.4 in). The maximum crush was located at C6, the front right bumper corner and measured 53 cm (20.9 in). A crush profile which combined the overall residual crush from the two impacts was documented along

Figure 9: Overall view of the frontal damage to the Dodge.

the width of the bumper. The crush profile was as follows: C1 = 25 cm (9.8 in), C2 = 37 cm (14.6 in), C3 = 46 cm (18.1 in), C4 = 50 cm (19.7 in), C5 = 53 cm (20.9 in), C6 = 53 cm (20.9 in). The CDC assigned for the secondary impact was 82FDEW3, considering the bumper shift to the left is greater than the vertical shift downward.

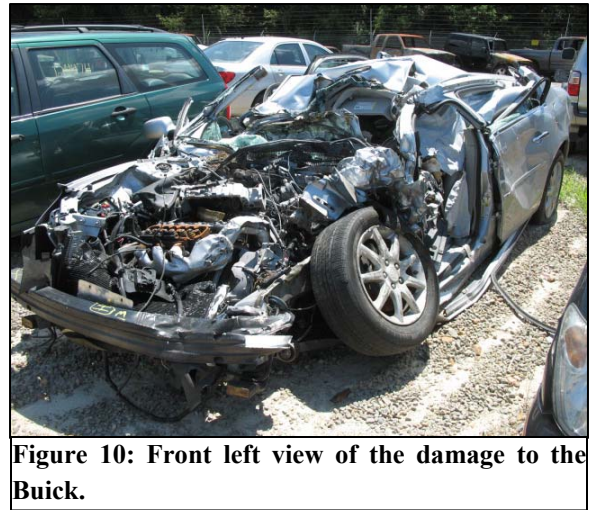
The front plane of the Buick sustained severe damage as a result of its impact with the Dodge. The direct contact damage at the bumper elevation began 38 cm (15 in) right of the centerline and extended left 112 cm (44.1 in) to the front left corner. The combined direct and induced damage (Field L) extended from bumper corner to bumper corner. The residual crush profile measured at the bumper level was as follows: C1 = 23 cm (9.1 in), C2 = 22 cm (8.7 in), C3 = 18 cm (7.1 in), C4 = 12 cm (4.7 in), C5 = 9 cm (3.5 in), C6 = 1 cm (0.4 in). The front bumper of the Dodge overrode the front bumper of the Buick and the direct damage to the Buick extended up the hood, over the top of the engine and ended at the A-pillars 167 cm (65.7 in) rearward of the front of the front bumper. The resultant deformation to the left A-pillar was 51 cm (20.1 in) longitudinally. The CDC assigned for this impact was 11FDAW7. **Figure 10** is an overall view of the damage to the Buick.

Figure 10: Front left view of the damage to the Buick.
