**CALSPAN ON-SITE BACK OVER INCIDENT INVESTIGATION**

**SCI CASE NO.: CA09043**

**VEHICLE: 2001 JEEP GRAND CHEROKEE**

**DATE OF INCIDENT: JUNE 2009**

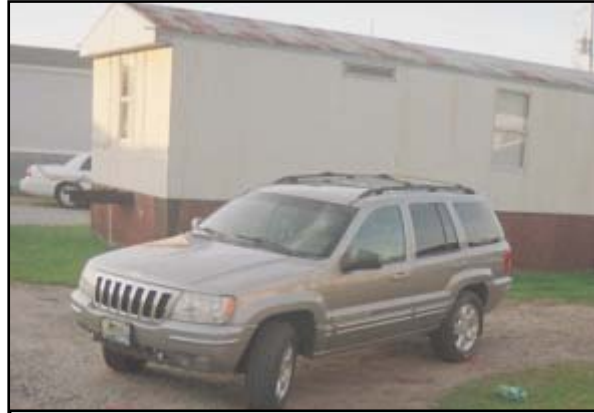
**Figure 1. Case vehicle, 2001 Jeep Grand Cherokee.**

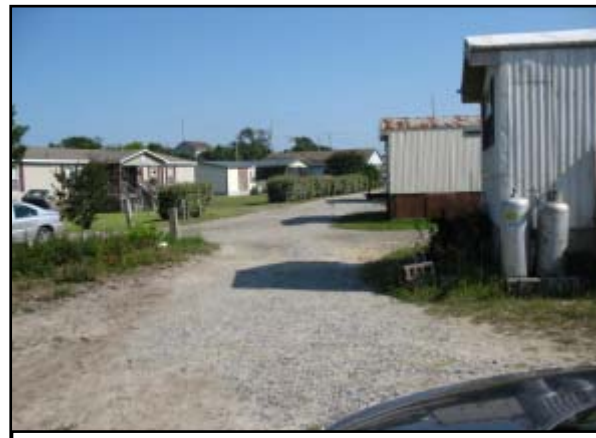
Prior to the incident, the driver of the Jeep exited his residence and proceeded to the southeast roadside where he dropped off a trash receptacle. The driver stated that he noted other children near the vicinity of the southeast roadside as he walked in a northeast direction toward the rear right of the vehicle. He walked to the left side of the Jeep, entered through the front left door and started the vehicle. The driver placed the transmission selector in reverse and began backing the vehicle in a westerly direction (**Figure 2**). The

**Figure 2. Pre-incident trajectory of the Jeep.**

driver stated during the SCI interview that he used the mirrors while backing with his primary attention focused in the left side mirror. As the vehicle neared the adjacent mobile home (west), the driver applied a left steering input in order to enter the driveway in a clockwise arc. His intention was to enter the adjacent driveway so he could turn the vehicle and proceed in a forward trajectory out of the mobile home park. During the backing maneuver, the 7-year-old non-motorist exited the adjacent mobile home from the west door and proceeded toward the driveway while bending at the waist and pushing a toy truck. The investigating police officer noted miniature tire tread marks from the toy truck in the area of the incident. The driver was unaware of the non-motorist on the driveway as he backed the Jeep. The driver stated that there were no exterior sightline obstructions.

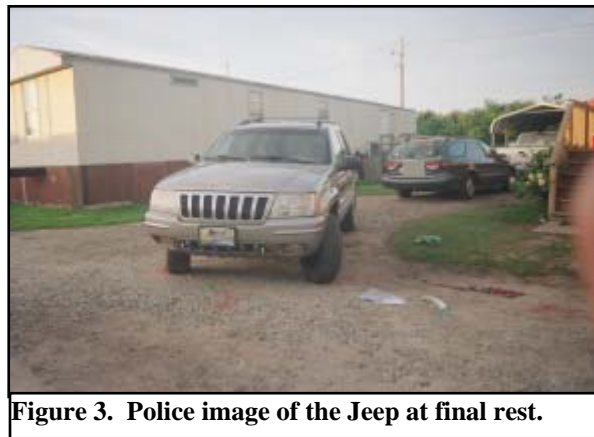
The Jeep traveled approximately 10-12 meters (33-39 feet) during this backing maneuver and struck the child with the rear bumper, knocking him to the ground. The driver was unaware of the incident and continued backing. The left side tires subsequently ran over the child's lower torso. The Jeep traveled approximately 1.2 meters (4 feet) where the driver stopped the vehicle and observed the child on the driveway. **Figure 3** is an on-scene view of the final rest position of the Jeep.

**Figure 3. Police image of the Jeep at final rest.**

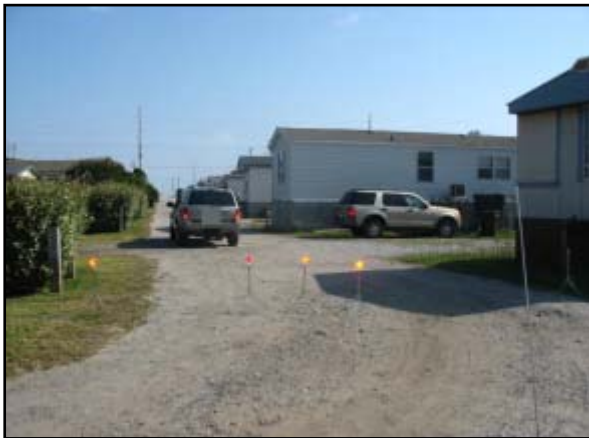
The rear visibility was measured using an 8 cm (3 in) diameter reflective red marker that was positioned in a stand and set 71 cm (28 in) above the ground. The driver was asked to locate the reflective marker looking into the rearview mirror as it cleared the backlight at the centerline.

The driver detected the reflective marker in the rear view mirror 9 m (29.5 feet) aft of the rear bumper. The driver continued a straight line of sight that intersected the ground at a point that was 18.1 m (59.4 feet) aft of the rear bumper. Lateral cones of visibility were established at 9 meters (29.5 feet) aft of the rear bumper with the driver looking into the rearview mirrors. The left cone began 0.7 meters (2.3 feet) left of the centerline and extended 4 meters (13 feet) to the left. The right cone consisted of the target detected at 0.6 meters (1.9 feet) right of the centerline and extended 2.5 meters (8.2 feet) to the right. Based on the visibility study and the bent over position of the non-motorist, the driver should have been able to detect the non-motorist in the left rearview mirror as he emerged from behind the mobile home. Given the height of the beltline, the non-motorist would not have been visible through the backlight. **Figures 4 and 5** depict the rear visibility study.

**Figure 4.** Targets positioned at the rear of the Jeep.

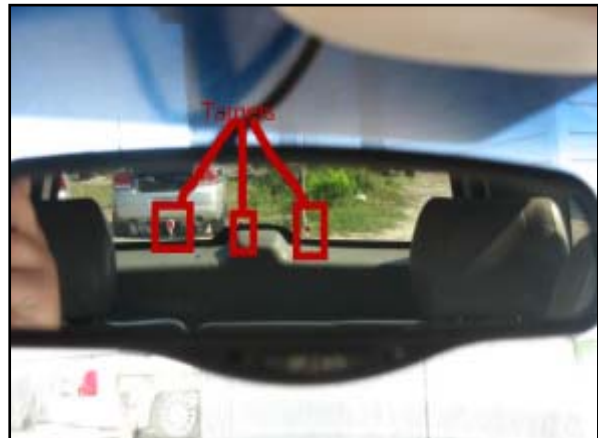
**Figure 5.** Targets located using rearview mirror.

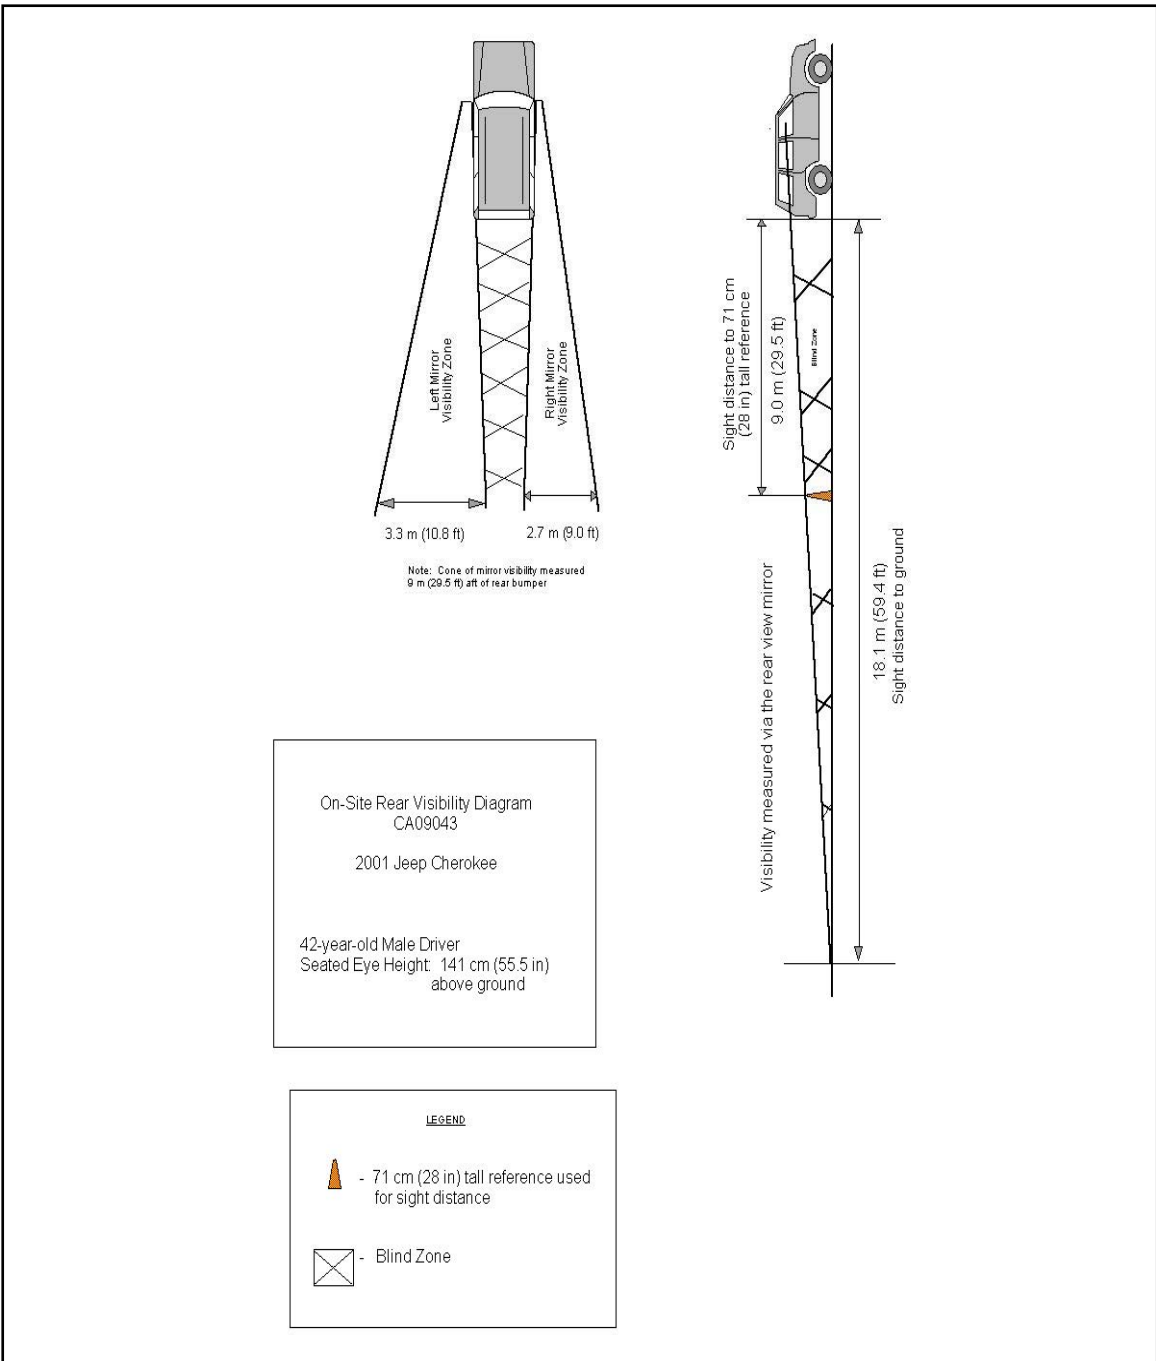
**Figure 6. Rear Visibility Diagram**

During the on-site investigation, a rear visibility study was conducted with the driver positioned in the Jeep. The Jeep was parked on the level section of the access road. Seated within the left front seat in a driving posture, the driver's eye height measured 140 cm (55.5 in) above the ground. At the time of the SCI inspection, the seat track was

The driver stated that he was looking in the rearview mirrors with the left mirror being the primary focus while backing. The driver noted that while looking through the center rearview mirror he had to look over the rear wiper motor that was mounted at the base of the backlight.

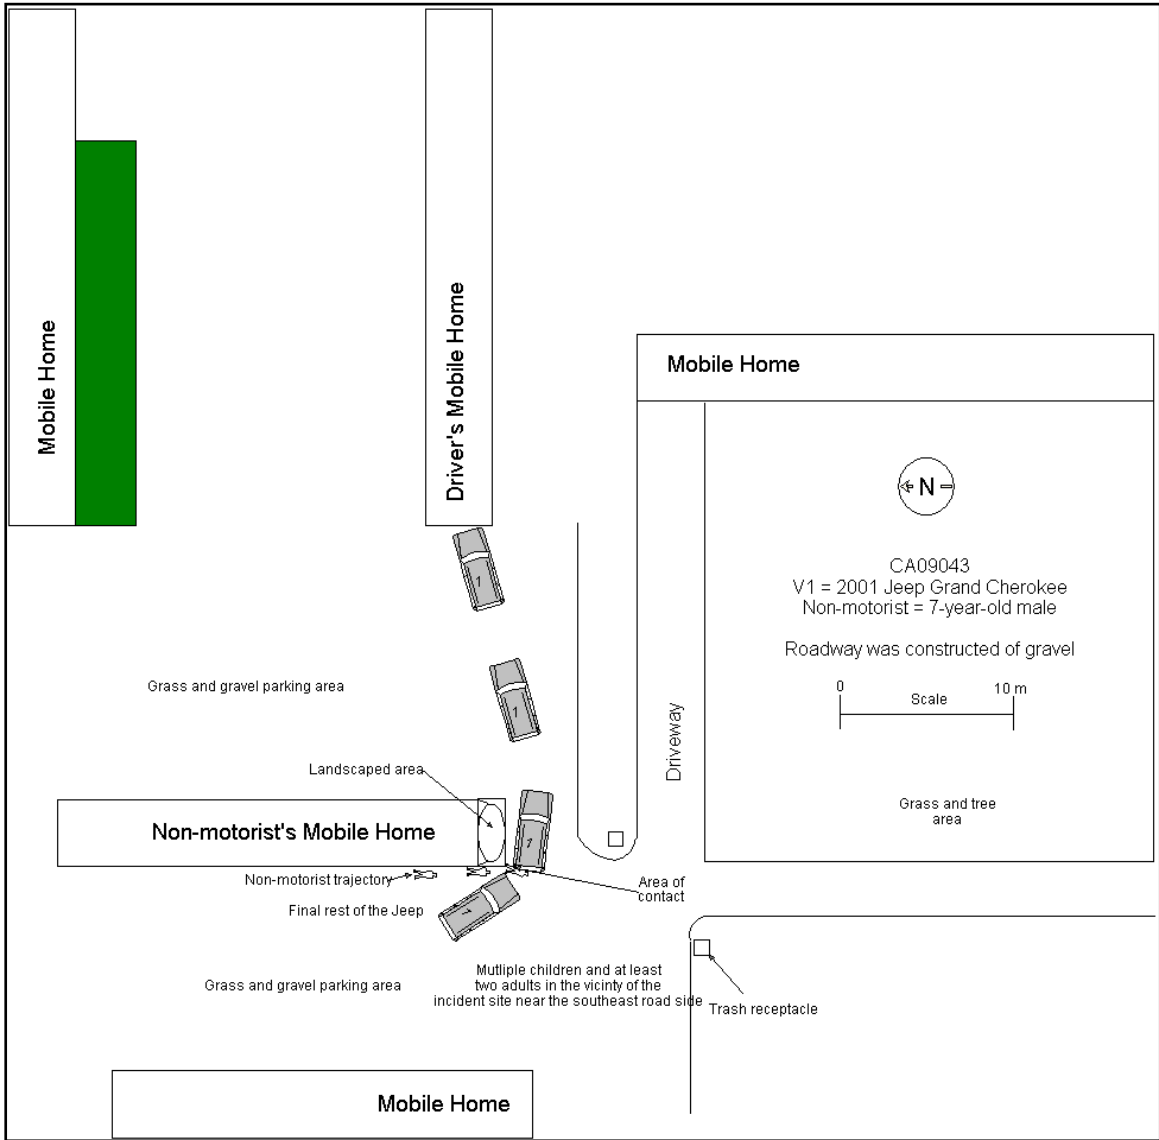
**Figure 7. Incident Schematic**

This incident occurred during the daytime hours of June 2009. At the time of the incident, the weather was not a factor. The incident occurred on the gravel surfaced driveway of a mobile home park. The driveway was located at the end of an east/west access road and was shared by a cluster of mobile homes. The mobile homes were dispersed over a 50 x 50 meter area (165 x 165 feet). The driver's mobile home was located 20 meters (66 feet) east of the access road and was oriented east to west. The non-motorist's mobile home was located 8 meters (26.2 feet) north of the access road and was oriented in a north/south direction. The gravel driveway had a positive two-percent grade leading to the driver's mobile home. The surface of the driveway was rough with dispersed potholes. **Figure 7** is a schematic of the incident site.
