**CALSPAN ON-SITE SIDE IMPACT INFLATABLE
OCCUPANT PROTECTION SYSTEM CRASH INVESTIGATION
SCI CASE NO: CA09044**

VEHICLE: 2007 GMC YUKON

LOCATION: TENNESSEE

CRASH DATE: APRIL, 2009

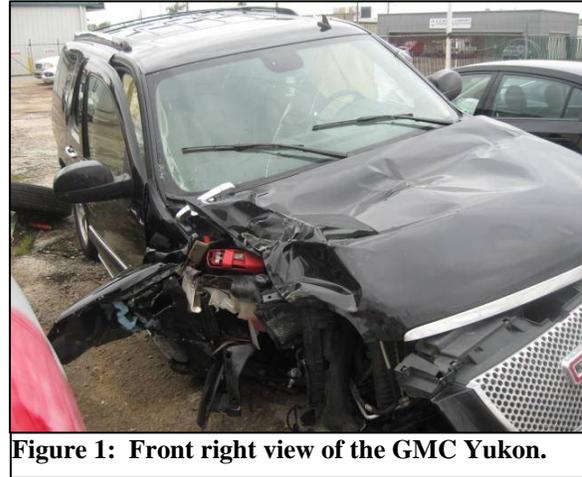
Figure 1: Front right view of the GMC Yukon.

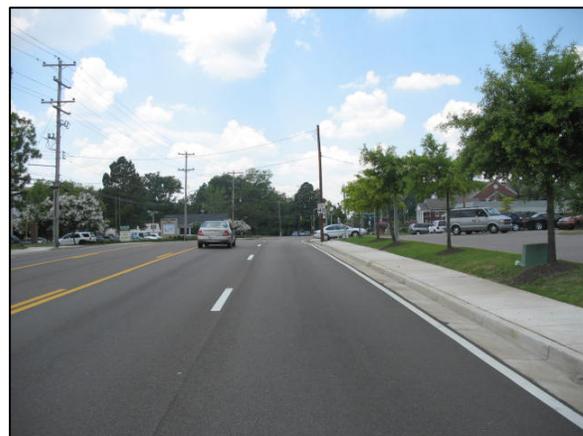
The GMC was westbound (**Figure 2**) in the outboard travel lane, driven by the 31-year-old unrestrained female. The EDR reported speed of the GMC was 66 km/h (41 mph) 2.5 seconds prior to Algorithm Enable (AE). The EDR also reported that the vehicle's brakes were not being applied during the recorded pre-crash travel of the vehicle. The recorded throttle position was fluctuating between 32 and 24 percent during the 2.5 second pre-crash recording. The driver relinquished directional control of the GMC and the vehicle departed the right road edge. The

Figure 2: Westbound view of the GMC's pre-crash path of travel

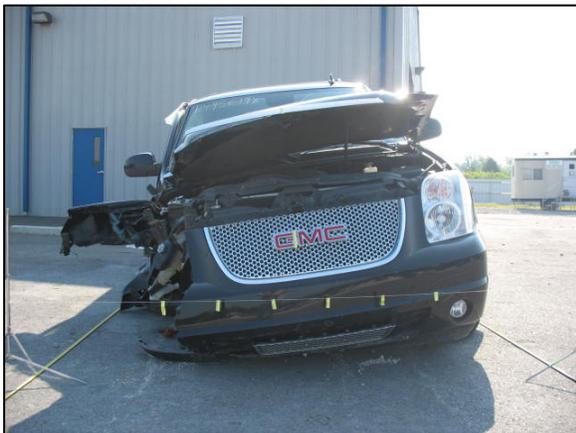
The exterior of the GMC sustained two separate areas of direct contact damage during the vehicle-to-object crash sequence. **Figure 3** is a view of the damage to the frontal plane of the GMC that occurred from the initial event with the utility pole. The direct contact damage was measured laterally along the front bumper fascia. It began 46 cm (18.1 in) right of center and extended 34 cm (13.4 in) to the projected front right bumper corner. The impact resulted in deformation to the front bumper fascia, radiator, bumper beam, right front axle and suspension, and right/front fender. The right side wheelbase was reduced in length by 15 cm (5.9 in). The combined induced and direct contact damage length was 122 cm (48 in) and involved the full width of the bumper beam. The front crush profile was measured at the bumper elevation and

was as follows: C1 = 1 cm (0.4 in), C2 = 4 cm (1.6 in), C3 = 3 cm (1.2 in), C4 = 3 cm (1.2 in), C5 = 3 cm (1.2 in), C6 = 7 cm (2.8 in). The direct contact wrapped around the corner and extended along the right side to the right A-pillar area. The Collision Deformation Classification (CDC) for this impact event was 12FREE5.

Figure 3: The GMC's crush profile of the front plane damage

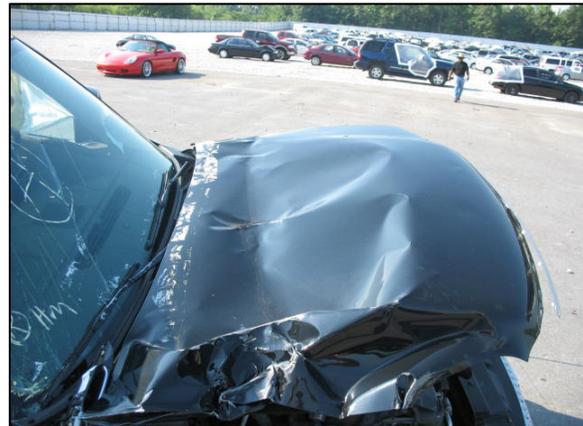
The secondary event produced a vertical crush pattern that extended laterally across the top of the GMC's hood, forward of the windshield. This damage resulted from the fractured pole as it fell on top of the GMC. **Figure 4** is a right side view of the damage caused by the secondary impact. The direct contact damage began 114 cm (44.9 in) rearward of the front reference line that was established to represent the original length of the vehicle and extended 11 cm (4.3 in) rearward. The damage also extended 140 cm (55 in) laterally across the width of the vehicle. The residual crush profile was not measured due to the non-horizontal impact force associated with this event. The assigned CDC was 00TFDW6.

Figure 4: Right side view of the damage to the GMC's hood from the falling utility pole

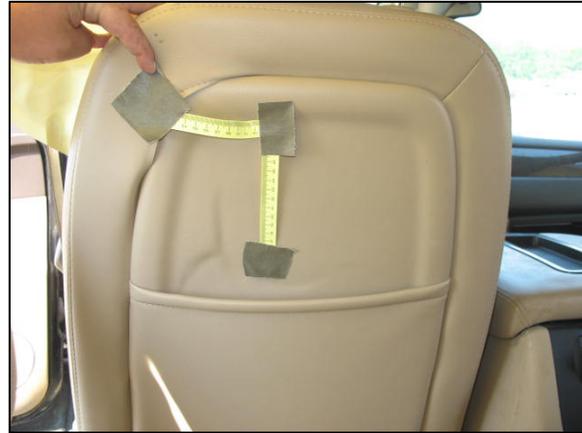
The interior damage to the GMC consisted of intrusion of the passenger compartment, the deployment of the vehicle's air bag systems, actuation of the pretensioners, and an interior occupant contact point. The intrusions were limited to 14 cm (5.5 in) of rearward displacement of the right toe pan and 4 cm (1.6 in) of right instrument panel displacement. An occupant contact was identified on the aft surface of the driver's seatback (**Figure 5**) which consisted of deformation to the original contour of this component. The area of direct contact measured 8 cm x 15 cm (3.1 in x 5.9 in) width x height and was located 12 cm (4.7 in) inboard of the left side and 15cm (5.9 in) below the top of the of the seatback. The driver's rigid plastic knee bolster was soiled with dirt and grease. Further examination of this component revealed no discernable contact points.

Figure 5: View of the contact point on the back of the driver seatback

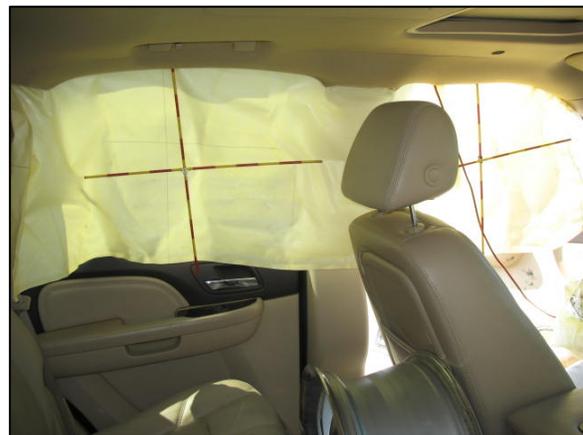
The GMC was equipped with dual-purpose side impact/rollover IC air bags mounted to the roof side rails. The IC air bag system consisted of a large rectangular curtain that provided coverage for the first two rows and a separate smaller curtain, connected by a common tether, which covered the third row. All four curtains deployed as a result of the crash. The forward IC air bags (**Figure 6**) measured 155 cm x 48 cm (61.0 in x 18.9 in) length x height in overall dimensions and provided coverage from the upper aspect of the A-pillar to the C-pillar area. A 26 cm (10.2 in) long triangular shaped sail-panel filled the void at the area of the A-pillars. The vertical coverage of this curtain extended 4 cm (1.6 in) below the beltline in the first row and 5 cm (2 in) below the beltline in the second seating row. The right IC air bag was cut by the first responders to provide greater access to the rear seat of the vehicle. The cut line was below the roof side rail, starting at the B-pillar and extending 83 cm (32.7 in) rearward.

Figure 6: View of the left side forward IC air bag located in the first two seating rows

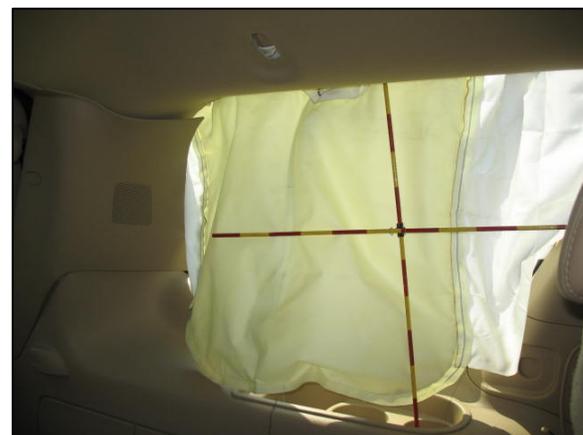
The third row IC air bags (**Figure 7**) measured 55 cm x 47 cm (21.7 in x 18.5 in) length x height in overall dimensions and provided coverage from the rear aspect of the C-pillar to the forward aspect of the D-pillar area. The vertical

Figure 7: View of the left rearward IC airbag located in the third seating row

coverage of this curtain extended 12 cm (4.7 in) below the beltline in the third seating row. This IC contained two rectangular tether panels which extended to their respectively adjacent pillars. The forward tether panel measured 22 cm x 47 cm (8.7 in x 21.7 in) length x height and the rear tether panel measured 11 cm x 47 (4.3 in x 21.7 in) length x height. There were no discernable contact points to any of the deployed IC air bags.

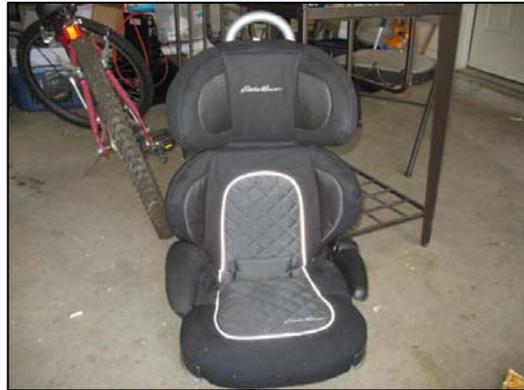
The CRS was identified as a Cosco/Dorel Eddie Bauer Auto Booster Seat (**Figure 8**), with a Model Number of 22888-SDU. The date of manufacture was August 02, 2007. The high back belt positioning booster seat was inspected at the GMC driver's residence. The driver's husband stated that the CRS had been purchased new by the family. The CRS was constructed of a 3-piece molded plastic shell with foam padding and a polyester cloth lining with integrated armrests.

Figure 8: Front view of the Forward-facing Child Safety Seat.

The 7-year old female was sitting within the CRS; however, she was not restrained by the vehicle's safety belt system. The CRS was not secured to the vehicle. The manufacturer of the CRS rated the booster seat in the high back mode for use by children within 13.6-45.4 kg (30-100 lb) with a height range of 110.1-144.8 cm (43-57 in). The CRS was appropriate for the child based on her 20 kg (44 lb) weight. The inspection of this CRS revealed indications of historical use; however, no discernable loading evidence or damage was observed on the CRS.

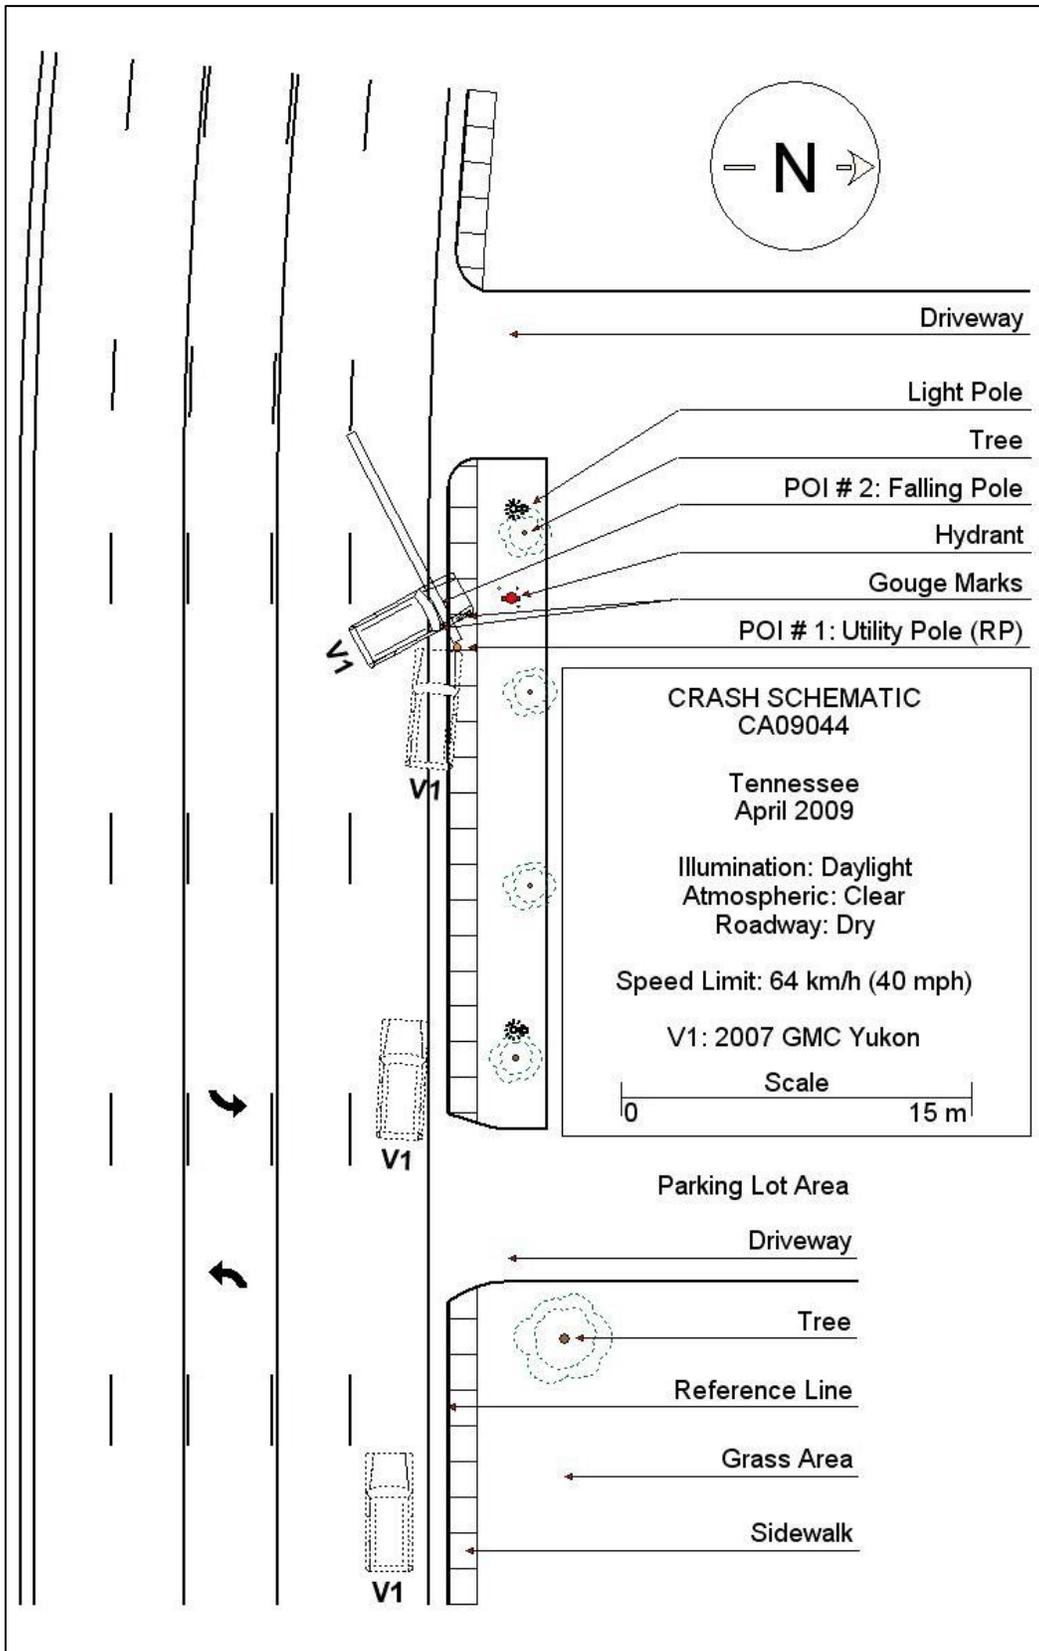
Figure 9: Crash schematic.

The crash occurred during the daylight hours in April 2009. At the time of the crash, the weather was clear and the bituminous roadway was dry. The crash sequence occurred within an undivided section of roadway that consisted of two westbound travel lanes, two eastbound travel lanes and a dual direction center left turn lane. The outboard westbound travel lane measured 3.4 m (11.2 ft) in width. The inside westbound travel lane measured 3.2 m (10.5 ft) and the left turn lane measured 3.8 m (12.5 ft) in width. The north side of the roadway was bordered by a 15 cm (6 in) raised concrete curb that extended the length of the roadway. A concrete sidewalk measuring 1.2 m (4.0 ft) wide was located directly north of the curb line. A 3.0 m (9.8 ft) wide grass area separated the sidewalk from an asphalt parking lot that was located on the north side of the road. The grass area measured 28.7 m (94.2 ft) in length and contained two light poles eight trees and one fire hydrant. The north side parking lot contained two driveways located at opposite ends of the grass median. The wooden utility pole was located within the width of the sidewalk and was centered 0.4 m (1.3 ft) outboard of the curb line. The posted speed limit was 64 km/h (40 mph). A schematic of the crash is included at the end of this report as **Figure 9**.
