**CALSPAN ON-SITE MOTORCOACH FIRE INVESTIGATION**

**SCI CASE NO.: CA09049**

**VEHICLE: 2003 MCI MODEL G4500 MOTORCOACH**

**INCIDENT DATE: JULY 2009**

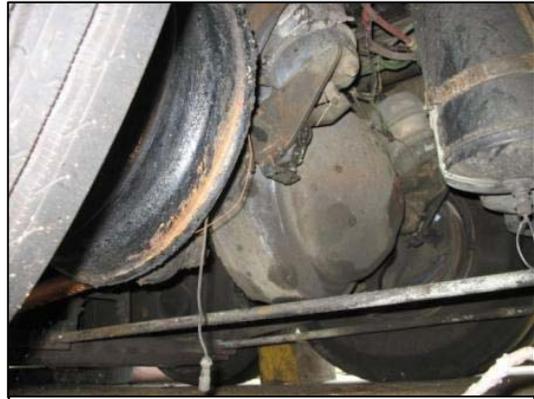
The driver was traveling on the outboard travel lane during the clear and dry daylight conditions. He checked his right outside mirror and observed smoke emanating from the right rear axle area of the motorcoach. The driver slowed the motorcoach and brought the vehicle to a controlled stop on the right shoulder. The driver turned-off the engine and applied the emergency brake. He retrieved the onboard ABC fire extinguisher, exited the motorcoach, and proceeded to the right rear axle location (**Figure 5**). The driver contained the fire with the dry-chemical extinguisher and called the emergency response system to report the fire and request police and firefighting assistance. The driver returned to the motorcoach and ordered the evacuation of all passengers. The passengers exited the motorcoach and proceeded to the grass roadside, a safe distance from the motorcoach. There were no injuries associated with this fire.

**Figure 5. Fire area the involved the right driver axle undercarriage.**

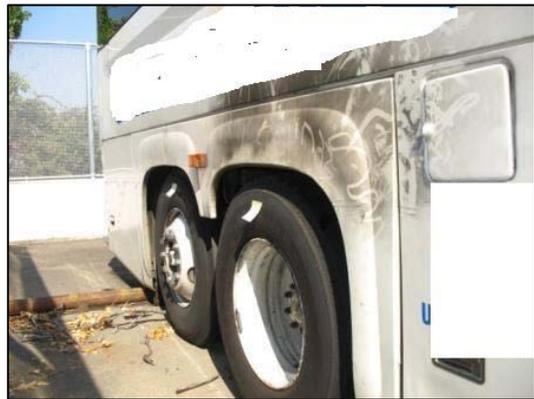
The exterior body panels of the motorcoach were fiberglass composite and were not damaged by the undercarriage-related fire. Smoke and soot deposits were present on the axle skirting over the right drive axle and the side body panel above the drive axle position. In addition to the smoke deposits, the painted surface at the bottom edge of the skirt was blistered by heat with an orange-peel like

**Figure 6. Heat damage and smoke staining to the right drive axle skirt and body panels.**

appearance (**Figure 6**). The smoke deposits continued in a forward direction from the axle position and were present to the area of the fuel filler door and above, immediately forward of the drive axle. This pattern indicated a forward direction of the smoke. The smoke/soot deposits to the painted body panels were not a permanent discoloration as the blackened deposits could easily be removed.

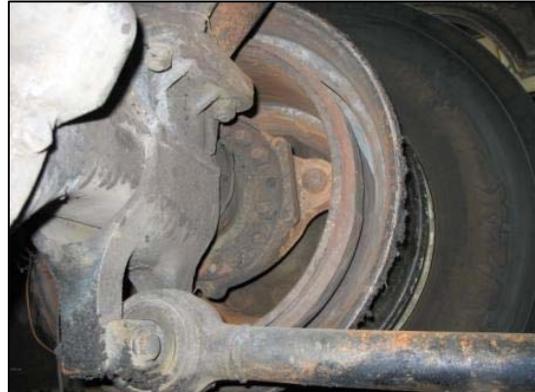
The undercarriage of the motorcoach sustained minor severity damage that involved the inner tire of the right drive axle, the right drive axle brakes, with minor fire damage to the adjacent air suspension bladder and air lines to the air brake chamber. The specific components and the related damage are described in detail below. **Figure 7** is an undercarriage view of the right drive axle area.

**Figure 7. Overall view of the undercarriage components at the right drive axle area.**

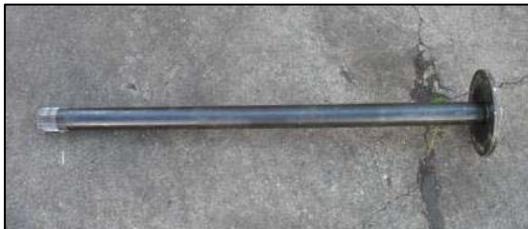
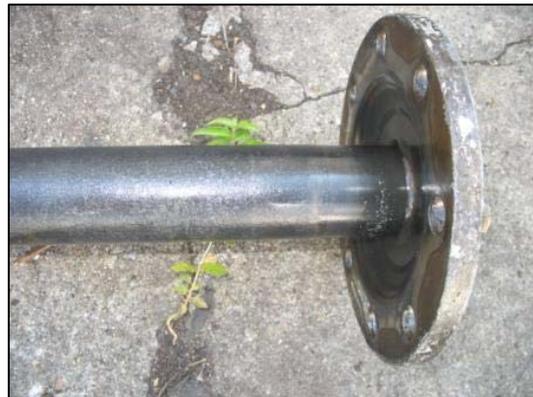
The SCI inspection of the drive axles revealed no evidence of damage, or damage incurred by a potential wheel bearing failure. The axle was wet with oil and was not damaged. **Figures 8 and 9** are views of the right drive axle that was removed from the motorcoach prior to towing transfer to the repair facility.

**Figure 8. Removed right drive axle.**

**Figure 9. Close-up view of the outboard end of the axle and the axle flange.**

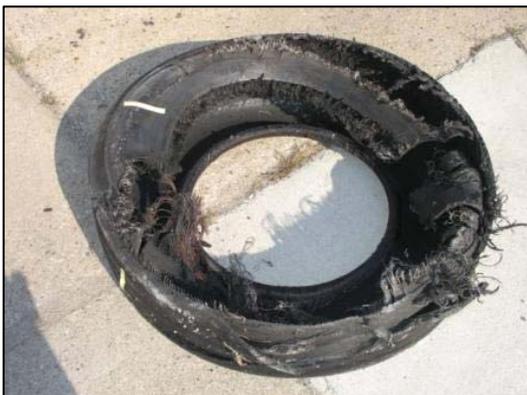
The inner sidewall of the inboard drive axle tire was shredded with separation from the tread and bead areas (**Figure 10**). The steel belts of the sidewall were exposed with a 69 cm (27 in) section of the sidewall completely separated from the tire. This damage was typical of a tire that was run flat.

A portion of the sidewall of the inner drive axle tire was charred by fire. This fire damage extended onto the tread area of the tire. The burn pattern appeared to be vertically oriented, indicative of the burn pattern at the top position of the tire when the motorcoach was stopped.

**Figure 10. Inboard sidewall damage to the right inner drive axle tire.**

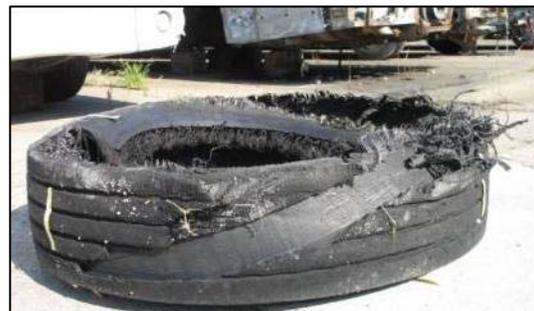
A section of the tire tread separated. A narrow band of tread separated on a diagonal pattern across the full-width of the tread pattern of the tire (**Figure 11**). The length of the separation was 94 cm (37 in). The burn pattern extended over this area. The underlying belts of the tire were not subjected to fire damage, suggesting this tread section was removed from the tire post-incident.

**Figure 11. Partial post-incident tread separation with fire damage across the tire tread.**

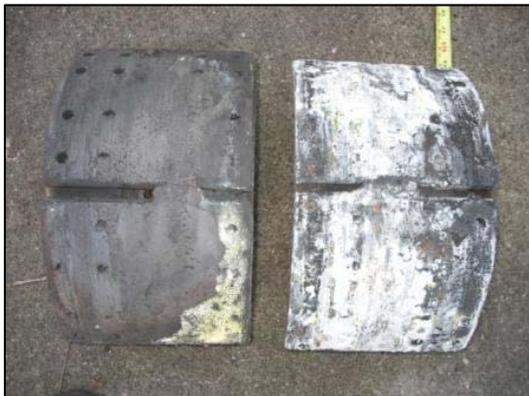
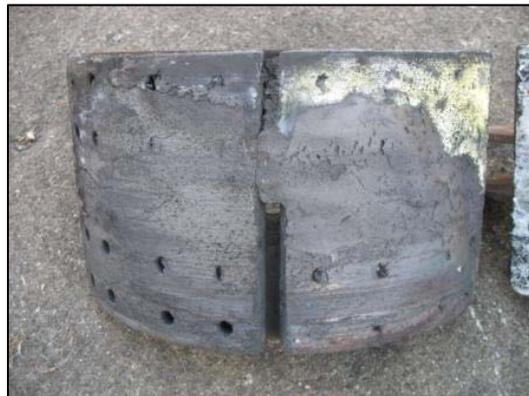
Both brake linings exhibited evidence of high heat, presumed to have resulted from prolonged engagement with the brake drum. Material from the linings had eroded from the lining surfaces and was deposited and fused in the center groove of the shoes. The lining material also filled the majority of the rivet holes in the lining.

One of the brake shoes was whitish in color, indicating higher heat, or exposure to fire. A narrow band of the white discoloration was present on the outer surface of the other shoe. **Figures 12 and 13** depict the damage and discoloration to the brake shoe linings.

**Figure 12. Heat damage/erosion of the right drive axle brake shoe linings.**

**Figure 13. Close-up view of the damage to the brake shoe lining.**

Based on the high-heat evidence to the right drive axle brake shoes and the eroding of lining material, it is believed that this brake partially applied while the motorcoach was traveling at highway speeds. The heat generated by the brake extended inboard in relation to the motorcoach and involved the inner drive axle tire. The tire subsequently aired out as the motorcoach continued en route to its destination. The tire debanded, self-destructed and self-combusted. The resulting fire, although minor in severity, spread to the undercarriage components and involved the air suspension bladder and the air lines adjacent to the brake chamber.
