CALSPAN ON-SITE FRONT OVER INCIDENT INVESTIGATION

SCI CASE NO.: CA09052

VEHICLE: 2003 FORD EXPEDITION

DATE OF INCIDENT: JULY 2009

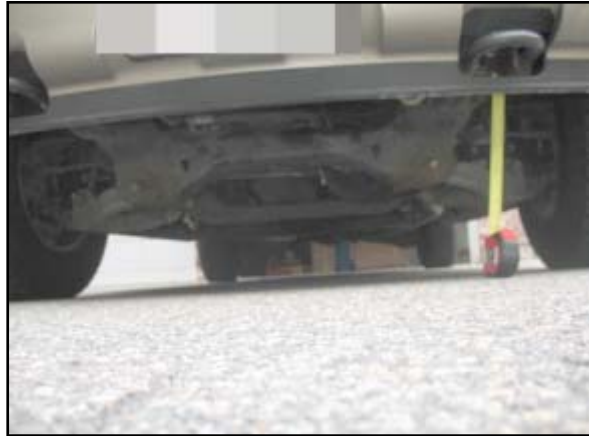
Figure 3 is an overall view of the front undercarriage components. The vertical clearance heights of the front components of the Ford were measured from the paved surface of the driveway in front of the residence and are listed in the following table:

Figure 3. Front undercarriage components.

Component	Clearance Height
Beltline	124 cm (48.8 in)
Top of hood	112 cm (44 in)
Top of bumper	77 cm (30.5 in)
Base of bumper	41 cm (16 in)
Valance	31 cm (12.3 in)
Tow hooks	37 cm (14.5 in)
Cross member	31 cm (12 in)
Cross members mounts	23 cm (9 in)
Frame rails	41 cm (16.3 in)
Lower control arms	24 cm (9.3 in)

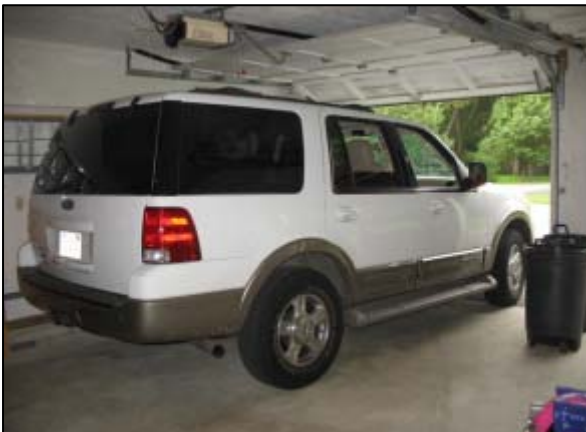
While the driver was moving the vehicle, the 22-month-old female exited the residence through the same door and approached the Ford from the vehicle's rear right. The non-motorist walked along the right side of the vehicle between the storage items and the vehicle (**Figure 4**). As the non-motorist reached the front right corner, she turned to the left and was struck by the front right corner of the vehicle and was knocked to the ground. The non-motorist was on her back with her head extending through the garage door opening (**Figure 5**). The vehicle continued forward and ran over her left leg and onto her abdomen. The Ford traveled approximately 0.6-0.9 meters (2-3 feet) where the driver stopped the vehicle with the front left door immediately inboard of the exterior wall. The driver stated that she did not see the non-motorist and was unaware of the incident. **Figures 4 and 5** depict the travel directions of the vehicle and the non-motorist.

Figure 4. Non-motorist approach to the right side of the Ford.

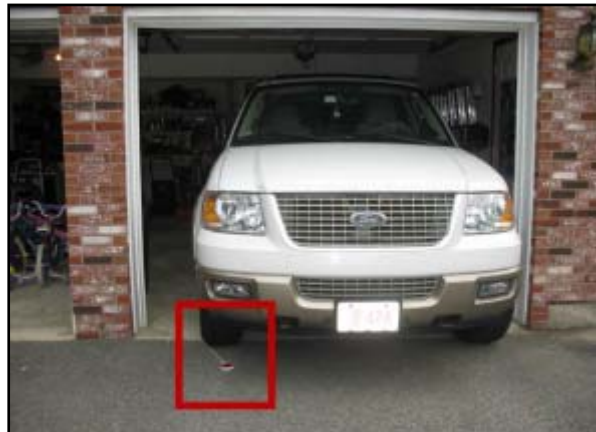
Figure 5. Area of contact between the front right tire and the non-motorist.

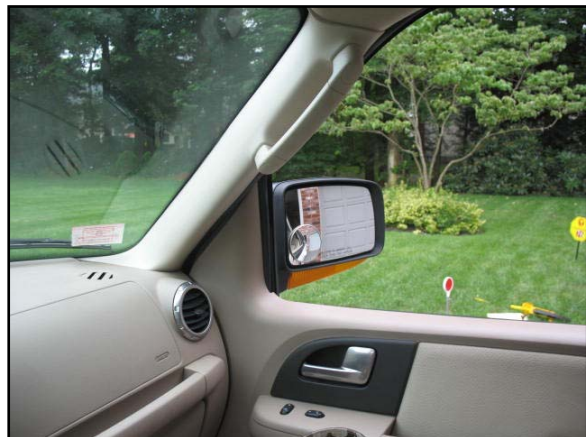
Figure 6. Driver's view out of the front right window.

seated eye height was 156 cm (61.5 in) above the ground. **Figure 6** is a driver view through the front right window to the right target. **Figures 7 and 8** are exterior views depicting the blind zone along the right side of the Ford. The target locations were then measured with respect to the vehicle. The lateral distance from the right plane to the target measured 2.3 m (7.5 ft). **Figure 9**, attached to the end of this report, is a scaled overhead visibility schematic depicting the blind zone forward of the vehicle.

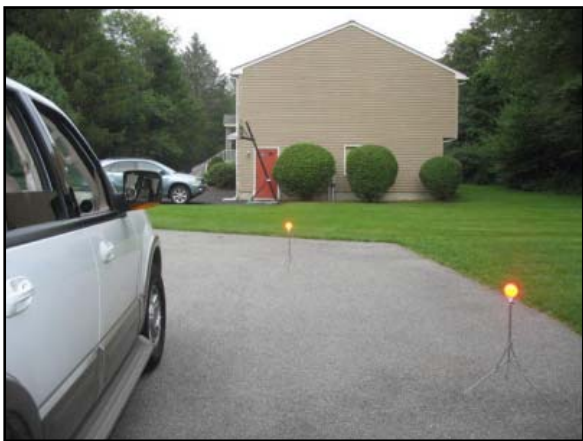
It should be noted that although the non-motorist was walking within the blind zone on the right side of the vehicle, it would have been possible to observe the non-motorist during her initial approach to the vehicle by the use of the right mirror. The driver did not observe the non-motorist, as her attention was focused to the front left door and front of the vehicle throughout the entire maneuver of driving the vehicle forward.

Figure 7. Right side blind zone.

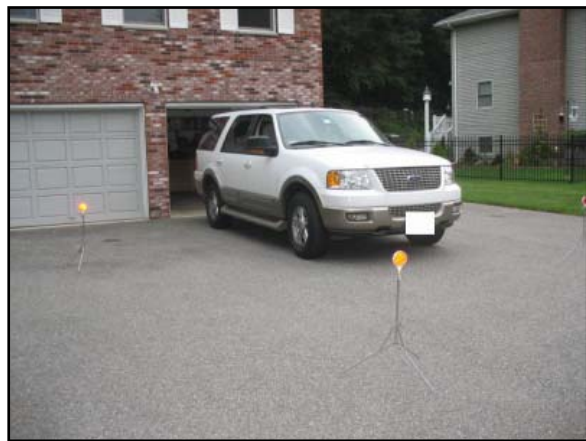
Figure 8. Front oblique view of the blind zone.
