**CALSPAN ON-SITE SIDE IMPACT INFLATIBLE OCCUPANT  
PROTECTION SYSTEM CRASH INVESTIGATION  
SCI CASE NO.: CA09055**

**VEHICLE: 2009 HONDA FIT SPORT**

**LOCATION: NORTH CAROLINA**

**CRASH DATE: AUGUST 2009**

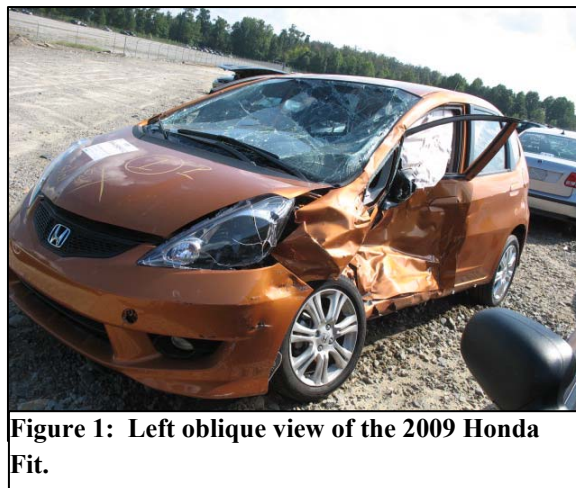
This on-site investigation focused on the side impact inflatable occupant protection system in a 2009 Honda Fit (**Figure 1**) that was involved in an intersection crash. The vehicle was equipped with four-wheel anti-lock brakes, a Certified Advanced 208-Compliant frontal air bag system (CAC), front seat-mounted side impact air bags and roof side rail-mounted side impact Inflatable Curtain (IC) air bags. The manufacturer of the Honda has certified that the vehicle is compliant to the advanced air bag portion of Federal Motor Vehicle Safety Standard (FMVSS) No. 208.

**Figure 1: Left oblique view of the 2009 Honda Fit.**

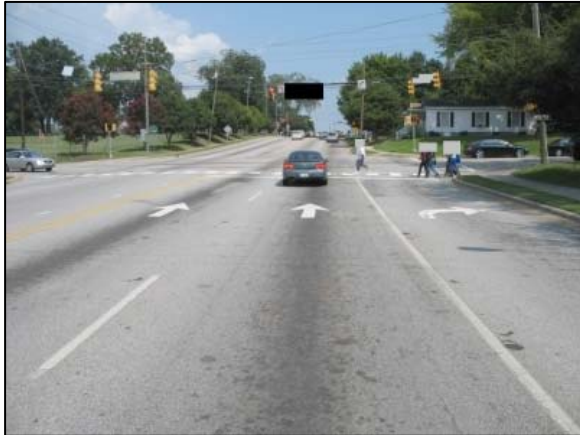
This crash occurred during daylight hours at the urban four-leg intersection of a two-way east/west road and a one-way southbound road. **Figure 2 and 3** are the eastbound and southbound approach views to the intersection, respectively. The intersection was controlled by overhead traffic signals. The environmental conditions were clear and dry at the time of the crash. The east/west road consisted of five lanes; three eastbound lanes and two westbound lanes. The travel directions were separated by a double yellow line. Each lane measured were 3.9 m (12.8 ft) in width. This roadway contained a shallow right curve on the approach to the intersection. The one-way southbound approach to the intersection consisted of three travel lanes. Each lane measured 4 m (13.1 ft) in width. Both roadways were surfaced with asphalt. The southbound approach had a negative grade of 1.6 percent. The eastbound approach was level. The intersection was bordered on all sides by concrete curbs 16 cm (6.3 in) in height. Beyond the curbs there was a grass strip and concrete sidewalks. A metal pole supporting the crosswalk signal was located on the southeast corner of the intersection and was involved in a secondary impact with the Chevrolet. The speed limit for both roadways was 72 km/h (45 mph). The Crash Schematic is included as **Figure 10** of this report.

**Figure 2: Eastbound trajectory view of the Honda into the intersection**

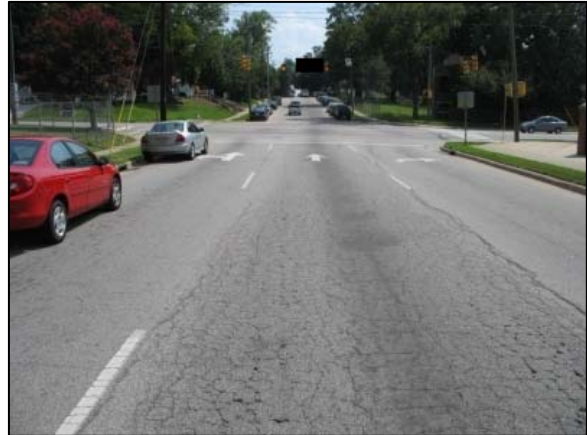
**Figure 3: Southbound trajectory view of the Chevrolet into the intersection.**

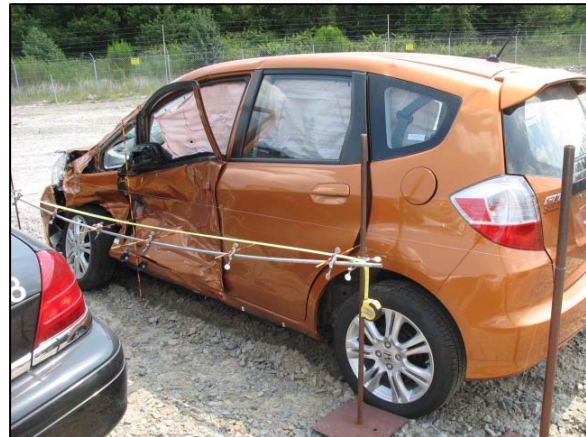
The left plane of the Honda Fit sustained moderate-severity damage in this intersection crash. **Figures 4 and 5** depict the left side damage to the Honda. The combined direct and induced damage (Field L) began 13 cm (5.1 in) forward of the left rear axle and extended forward 291 cm (114.6 in). The direct contact damage began 105 cm (41.3 in) forward of the left rear axle and extended forward 179 cm (70 in) to the left front bumper corner. Lateral crush was present to the left front fender, left A-pillar, left front door, and left B-pillar. The maximum crush measured 32 cm (12.6 in) and was located at C4, 187 cm (73.6 in) forward of the left rear axle. The elevation of the maximum crush measured 61 cm (24 in) above ground level. The Door Sill Differential (DSD) was 21 cm (8.3 in) and was located at the forward aspect of the left front door. A residual crush profile was measured at the mid door level and was as follows: C1 = 0 cm, C2 = 0 cm, C3 = 23 cm (9.1 in), C4 = 32 cm (12.6 in), C5 = 17 cm (6.7 in), C6 = 1 cm (0.4 in). The left front and rear door hinges were intact and remained attached to

**Figure 4: Overall view of the left side damage to the Honda.**

the A- and B-pillars, respectively. Both left side doors remained closed during the crash. The left front door was jammed shut post-crash. The windshield was completely fractured by the impact forces; no laminate tears were present. The left side quarter glass at the A-pillar and the left front door glazing disintegrated. The left rear door glazing, left rear glazing adjacent to the cargo area, backlight and all right side glazing were undamaged. The Collision Deformation Classification (CDC) assigned for this impact was 10LYEW3.

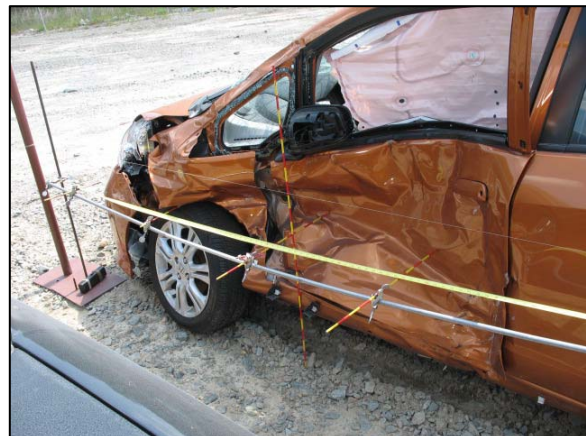
**Figure 5: Image depicting the direct contact damage to the left side of the Honda.**

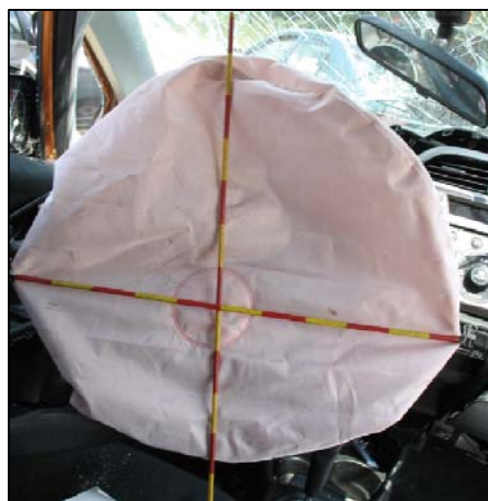
The driver's air bag was concealed within the center hub of a three-spoke steering wheel by a tri-flap design. The upper flap measured 13 cm (5.1 in) in width at the horizontal tear seam and 7 cm (2.8 in) in height. The dimensions of the two lower flaps were symmetrical. The upper aspects measured 8 cm (3.1 in) in width at the horizontal tear seam, the sides measured 7 cm (2.8 in) in height at the vertical tear seam and the lower aspects measured 3 cm (1.2 in) horizontally. The air bag (**Figure 6**) measured 50 cm (19.7 in) in diameter in its deflated state. It was vented by two ports located at the eleven and one o'clock positions on the rear of the air bag and was tethered by two straps located at the twelve and six o'clock positions on a 15 cm (5.9 in) circular seam sewn to the center of the face of the air bag. There were no occupant contacts to the driver's frontal air bag. The left half of the face of the air bag contained multiple deployment transfers and there were small droplets of body fluid on the face of the air bag at the 6 o'clock position.

**Figure 6: Deployed driver's frontal air bag.**

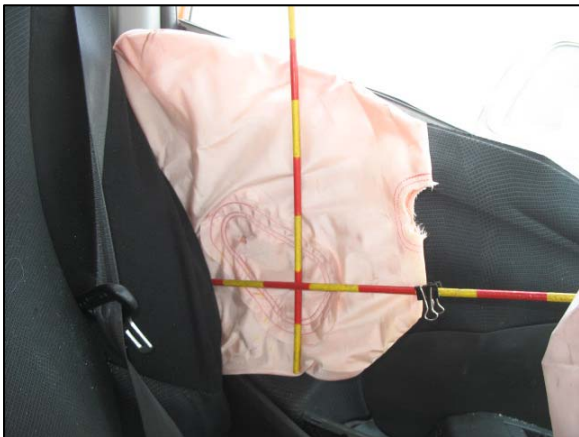
The Honda was equipped with front seat-mounted side impact air bags and roof side rail-mounted side impact IC air bags. The left seat-mounted side impact air bag and the left IC air bag deployed during this crash. The left seat-mounted air bag (**Figure 7**) deployed from a 30 cm (11.8 in) long seam in the outboard aspect of the front left seat back. The air bag measured 30

cm (11.8 in) in height and 25 cm (9.8 in) in width. The air bag had one vent port on the outboard aspect at the three o'clock position. There were small droplets of body fluid on the outboard side of the air bag located 9 to 15 cm (3.5 to 5.9 in) below the upper edge of the air bag and 7 to 11 cm (2.8 to 4.3 in) aft of the front edge of the air bag.

**Figure 7: Deployed left side impact air bag.**

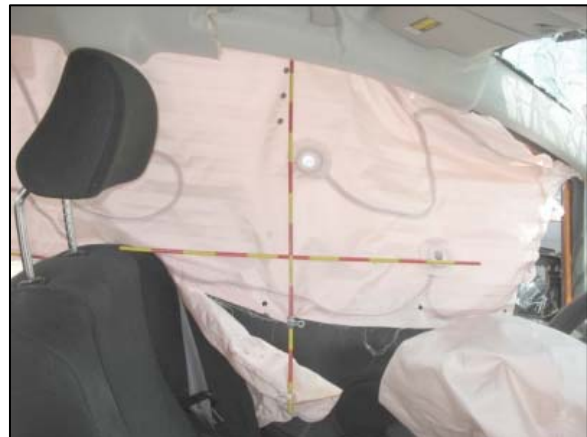
The left IC deployed from the left roof side rail (**Figure 8**). The air bag measured 176 cm (69.3 in) in length. The IC measured 50 cm (19.7 in) in height at the front and rear seating positions. Vertically, the IC extended below the belt line at the front and rear outboard positions. The air bag provided full-coverage head protection from the roof side rail to the belt line and from the A-pillar to the C-pillar. The inboard side of the left curtain air bag was free from occupant contact points and damage. The outboard side contained a scuff mark attributed to contact with the front of the Chevrolet. This scuff mark was located 6 to 18 cm (2.4 to 7.1 in) above the lower edge of the air bag and 30 to 46 cm (11.8 to 18.1 in) aft of the front edge of the airbag. The following identification number was stamped onto the IC: *1066953 46T08913LF20 031008-P >PA66,VMQ<*

**Figure 8: Deployed left IC air bag.**

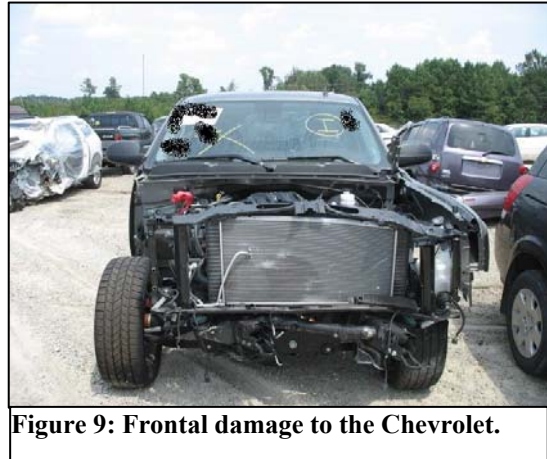
The front plane of the Chevrolet Silverado (**Figure 9**) sustained moderate-severity damage in the impact with the Honda. The front bumper, hood, right front fender and multiple engine compartment components were disassembled and removed from the Chevrolet prior to the inspection. The hood, fender and engine compartment components were in the cargo bed of the Chevrolet. The front bumper was missing and not available for inspection. The initial impact damage was estimated to extend from the front left bumper corner to the front right bumper corner. The frame rail ends were shifted to the left. The right frame rail shift measured 26 cm

(10.2 in); the left frame rail shift measured 31 cm (12.2 in). The Event 1 frontal damage was overlapped by the secondary impact damage with the signal pole. Due to the missing components and the overlapping damage, only a partial CDC could be assigned to the damage. The CDC assigned to the Event 1 damage was 81F99999. The Event 2 CDC was 99F99999.

**Figure 9: Frontal damage to the Chevrolet.**
