**CALSPAN ON-SITE ROLLOVER CRASH INVESTIGATION
SCI CASE NO.: CA09056**

VEHICLE: 2007 JEEP PATRIOT LIMITED 4WD

LOCATION: NORTH CAROLINA

CRASH DATE: JULY 2009

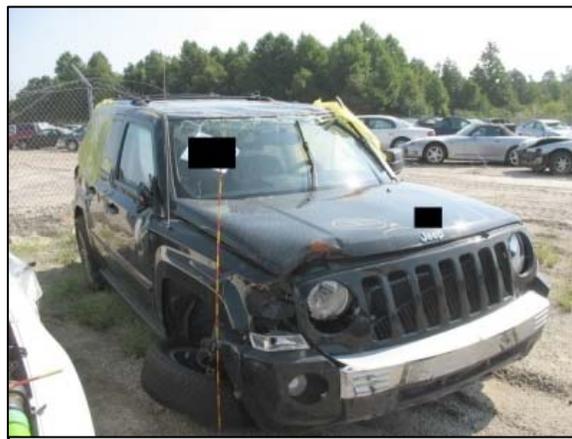
Figure 1: Front right oblique view of the 2007 Jeep Patriot.

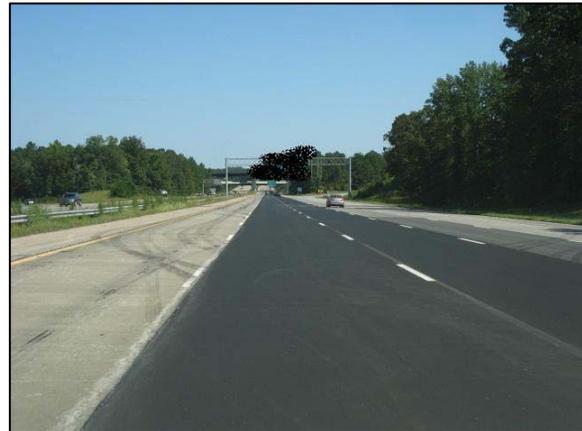
This crash occurred during daylight hours on a 5-lane divided north/south interstate highway (**Figure 2**). The environmental conditions were dry and cloudy. The roadway consisted of five travel lanes that were an estimated 4 m (13.1 ft) in width and bordered by asphalt shoulders. The outboard sides of the shoulders were bordered by W-beam guardrails. The speed limit in the area of the crash was 97 km/h (60 mph). A construction project to resurface the asphalt roadway had started during the time between the date of the crash and the SCI investigation, the number three and four lanes had been resurfaced at the time of the scene inspection. Due to heavy traffic volume and the high travel speed of vehicles on the interstate, the SCI investigator was unable to enter the roadway and conduct a thorough inspection of the crash site. The Crash Schematic is included as **Figure 11** of this report.

Figure 2: Northbound approach to the crash site.

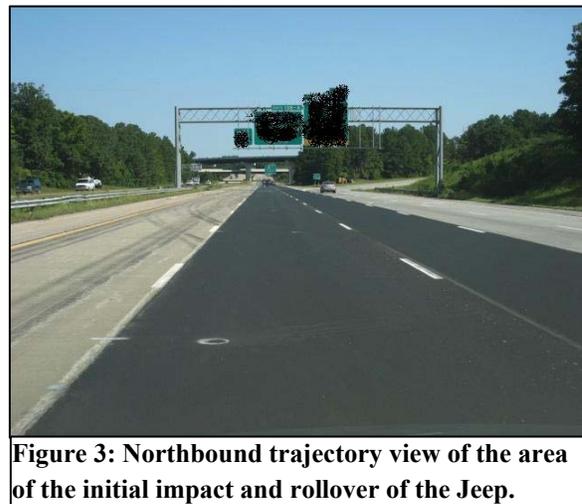
The offset impact and lateral momentum of the GMC induced a CCW yaw to the Jeep on the roadway. **Figure 3** is a northbound trajectory view of the area of the crash. The Jeep rotated approximately 100 degrees CCW and tripped into a right side leading rollover on the roadway. The Jeep rolled two-quarter turns to the right and slid to rest on its roof. The rollover was uninterrupted. The roll distance was unknown. The Jeep came to rest inverted facing south straddling the number four and five lanes on the northbound roadway. The GMC came to rest on the inboard shoulder facing southwestward.

Figure 3: Northbound trajectory view of the area of the initial impact and rollover of the Jeep.

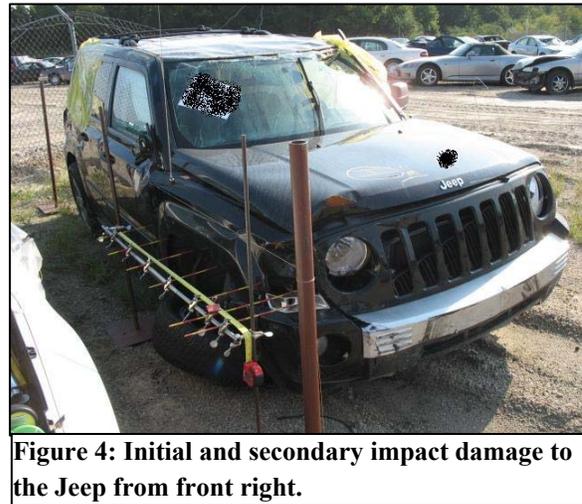
The exterior of the Jeep sustained moderate-severity damage to the right and top planes as a result of this multiple impact crash. The forward aspect of the right plane sustained damage as a result of Events 1 and 2 (**Figure 4**). A crush profile combining the overall residual crush from the overlapping impacts was documented along the length of the right front fender. The direct damage length measured 23 cm (9.1 in) and began 310 cm (122 in) forward of the right rear axle, ending at the right front bumper corner. The maximum crush measured 24 cm (9.4 in) and was located 324 cm (127.5 in) forward of the right rear axle. The combined direct and induced damage length began 216 cm (85 in) forward of the right rear axle and extended forward 117 cm (46.1 in). The crush profile was as follows: C1 = 0 cm, C2 = 1 cm (0.4 in), C3 = 4 cm (1.6 in), C4 = 7 cm (2.8 in), C5 = 13 cm (5.1 in), C6 = 10 cm (3.9 in). The Collision Deformation Classification (CDC) assigned for the Event 1 was 05RFEE2. The estimated CDC of Event 2 was 02RF9999.

Figure 4: Initial and secondary impact damage to the Jeep from front right.

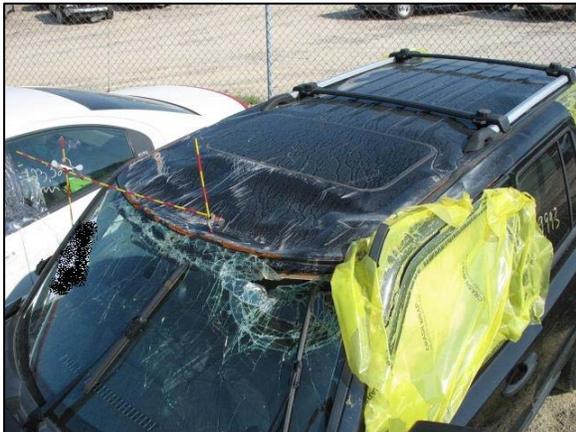
As a result of the rollover event, the Jeep sustained moderate-severity damage to the right and top planes. **Figures 5 and 6** depict the rollover damage sustained by the Jeep. The body panels of the right and top planes were abraded by ground contact plane. The abrasions on the roof were oriented longitudinally, indicating the vehicle had continued slid on its top northward after rolling over. The direct contact damage to the roof extended 116 cm (45.7 in) laterally from roof side rail to roof side rail. The longitudinal direct contact damage extended 190 cm (74.8 in) from the windshield header to near the backlight header. The maximum vertical crush was located on the roof, 71 cm (28 in) inboard of the right A-pillar and 6 cm (2.4 in) aft of the windshield header. The maximum vertical crush measured 7 cm (2.8 in). The maximum lateral crush was located on the right roof side rail 8 cm (3.1 in) aft of the windshield header. The maximum lateral crush was 2 cm (0.8 in). The CDC assigned to the rollover was 00TZDO2.

Figure 5: Overall view of the damage to the Jeep's top plane.

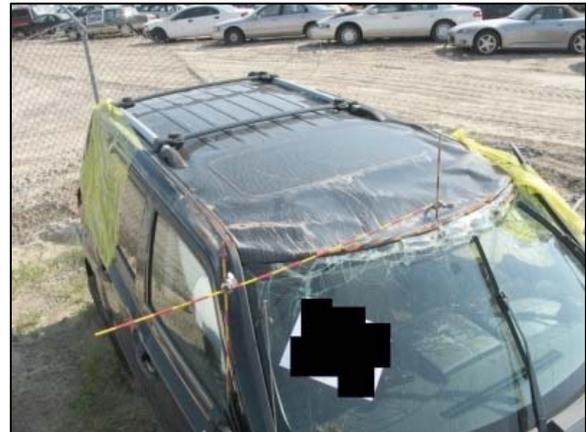
Figure 6: Rollover damage to the right side of the Jeep from front right.

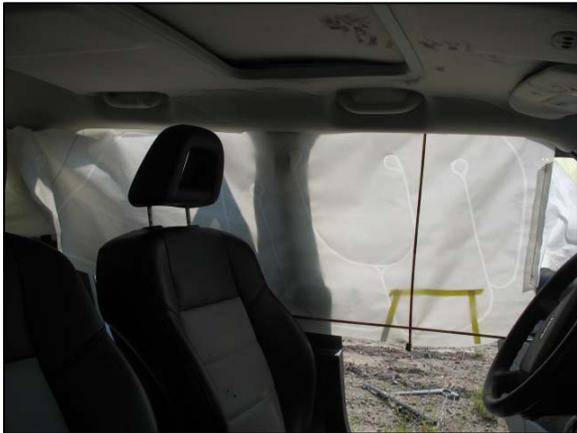
The front aspect of the outboard side of the left curtain air bag contained a scuff mark attributed to contact with the front left door. This scuff mark was located 8-20 cm (3.1-7.9 in) above the lower edge of the air bag and 18-38 cm (7.1-15 in) aft of the front edge of the air bag. This was

consistent with a scuff on the upper aspect of the driver's door panel located 4-11 cm (1.6-4.3 in) below the window sill and 14-34 cm (5.5-13.4 in) forward of the rear of the door. The left curtain was free from damage.

Figure 7: View of the Jeep's left curtain air bag.

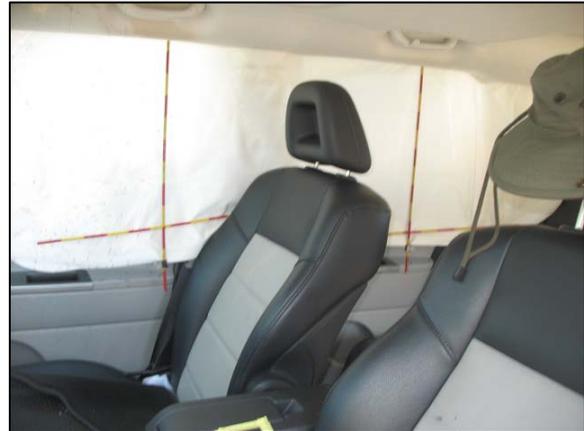
The front aspect of the inboard side of the right curtain air bag was covered with numerous drops of soda from an open container at the time of the crash. The residue was located from the front edge of the air bag extending rearward 47 cm (18.5 in). The right curtain was free from occupant contacts or damage.

Figure 8: View of the Jeep's right curtain air bag.

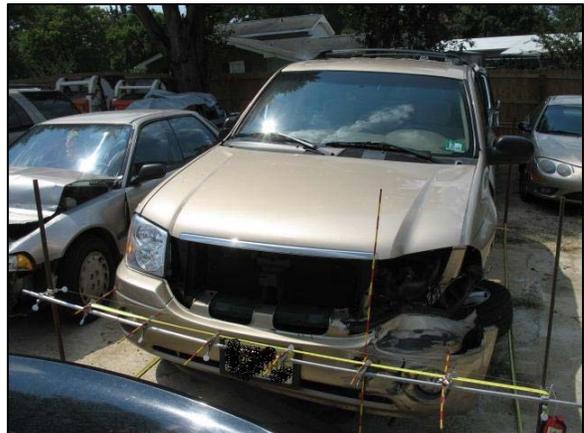
The front and left side of the GMC sustained moderate-severity damage in this multiple impact crash. The direct contact damage from the initial impact measured 44 cm (17.3 in) in width and began 32 cm (12.6 in) left of the vehicle centerline and extended left. The combined direct and induced damage (field L) from the initial impact extended the full width of the front bumper. The maximum crush measured 7 cm (2.8 in) and was located at the front left bumper corner. A crush profile was documented across the front bumper and was as follows: C1 = 7 cm (2.8 in), C2 = 6 cm (2.4 in), C3 = 3 cm (1.2 in), C4 = 1 cm (0.4 in), C5 = 0 cm, C6 = 0 cm. The CDC assigned for this impact was 12FLEW1. The initial impact damage to the GMC is depicted in **Figure 9**.

Figure 9: Initial impact damage to the GMC.

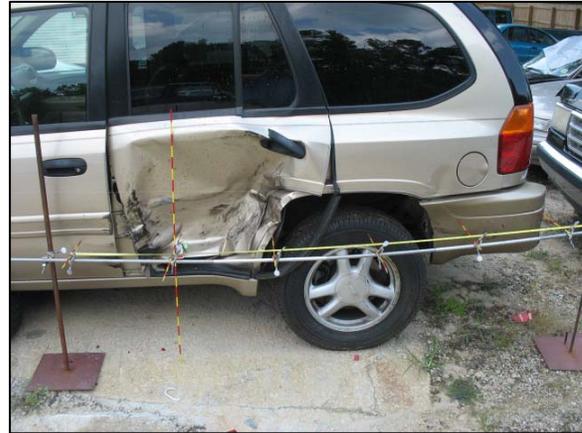
The left side of the GMC sustained moderate damage in the secondary impact. The damaged area began 125 cm (49.2 in) forward of the left rear axle and extended rearward a distance of 219 cm (86.2 in) to the left rear bumper corner (**Figure 10**). The maximum crush measured 18 cm (7.1 in) and was located at C5, 81 cm (31.9 in) forward of the left rear axle. A crush profile was taken at the lower door level of the GMC and was as follows: C1 = 0 cm, C2 = 6 cm (2.4 in), C3 = 0 cm, C4 = 4 cm (1.6 in), C5 = 18 cm (7.1 in), C6 = 0 cm. The CDC assigned for the secondary impact was 10LZEW2.

Figure 10: Secondary impact damage to the left side of the GMC.
