CALSPAN ON-SITE HYBRID VEHICLE CRASH INVESTIGATION
SCI CASE NO: CA09057

VEHICLE: 2007 TOYOTA PRIUS

LOCATION: PENNSYLVANIA

CRASH DATE: JULY, 2009

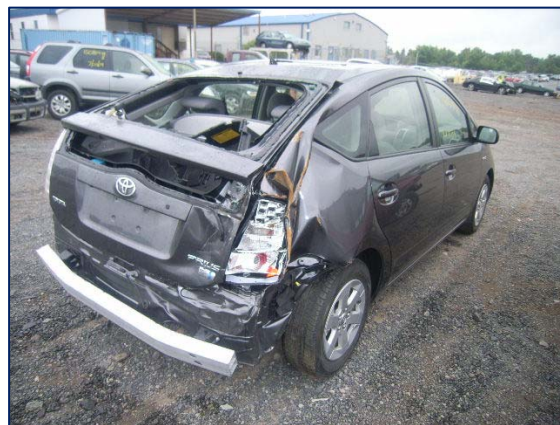
The crash occurred on a two-lane east/west road in a suburban setting. The Toyota was westbound driven by a 41-year-old male. A 23-year-old female was the front right passenger. The Toyota came to a complete stop behind a westbound non-contact vehicle. The non-contact vehicle was stopped and intended to turn left. The Ford F150 was westbound driven by a 71-year-old male. The left aspect of the Ford's front plane impacted the right aspect of the Toyota's back plane. **Figure 1** is an oblique view of the right rear damage. The driver and front passenger of the Toyota were transported with minor injuries.

Figure 1: Right rear oblique view of the Toyota.

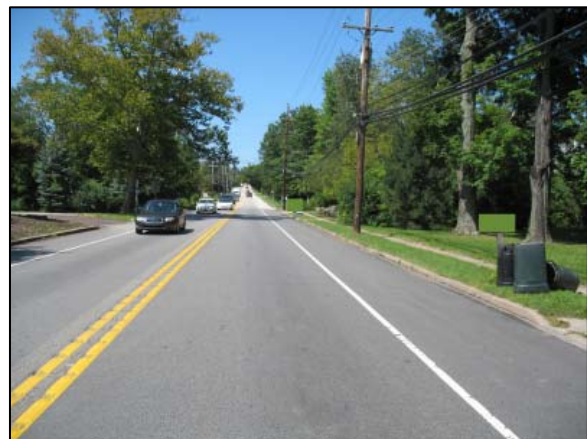
The crash occurred during the daylight hours in July 2009. At the time of the crash, the weather was clear and the asphalt road surface was dry. The crash occurred on a straight and level, two-lane east/west road in a suburban setting. The traffic lanes were separated by a double-yellow center line and each lane measured 3.5 m (11.5 ft) in width. The traffic lanes were bordered by asphalt shoulders. The north shoulder measured 2.6 m (8.5 ft) in width. The south shoulder measured 2.2 m (7.2 ft) wide. A restaurant was located on the south side of the road. Two driveways for traffic entering/exiting the parking area of the business intersected the road from the south. The speed limit in the area of the crash was 64 km/h (40 mph).

Figure 2: Westbound view at the crash site.

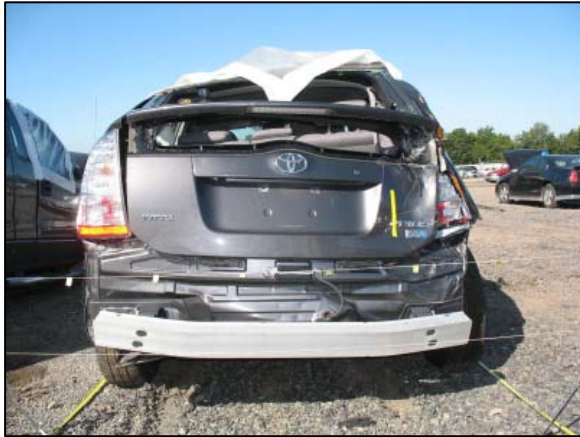
The Toyota Prius sustained moderate severity damage to its back plane as a result of the impact. **Figure 3** is a rear view of the Toyota's back plane damage. **Figure 4** is a lateral view at the back plane depicting the extent of crush. The direct contact damage began 41 cm (16 in) right of center and extended 25 cm (10 in) to the right rear bumper corner. The combined width of the direct and induced damage extended across the full 132 cm (52 in) end width of the vehicle. The rear bumper fascia separated during the impact and was not available for inspection. The exposed rear bumper reinforcement beam was a 6 cm x 10 cm (2.5 in x 4 in) aluminum box section 132 cm (52 in) in length. The reinforcement beam was mounted to the chassis by two 6 cm (2.5 in) stand-offs mounted 97 cm (38 in) apart. The reinforcement beam was not deformed by the corner impact. Rather, the force of the impact was distributed through the beam and into the frame and floor pan of the Toyota. The right rear body structure was crushed which buckled

the floor pan. The reinforcement beam was displaced forward and down. The crush profile at the bumper elevation was as follows: C1 = 1 cm (0.4 in), C2 = 0, C3 = 5 cm (2 in), C4 = 8 cm (3.1 in), C5 = 10 cm (3.9 in), C6 = 13 cm (5.1 cm). The maximum crush was located above the rear bumper elevation at the right rear corner of the Toyota. The maximum crush measured 16 cm (6.3 in). The right rear wheelhouse crushed forward and was in contact with the right rear tire. The right wheelbase was shortened 3 cm (1.2 in). The rear hatch was jammed shut. The backlight glazing was fractured. The Collision Deformation Classification (CDC) was 06-BRAE3.

Figure 3: Rear view of the damage to the Toyota's back plane.

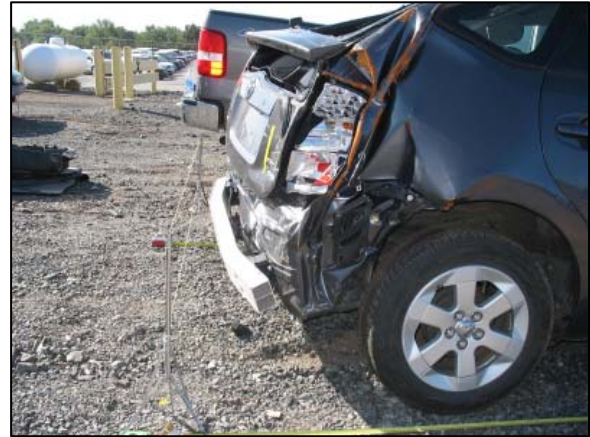
Figure 4: Right lateral view of the depicting the extent of crush at the rear corner.

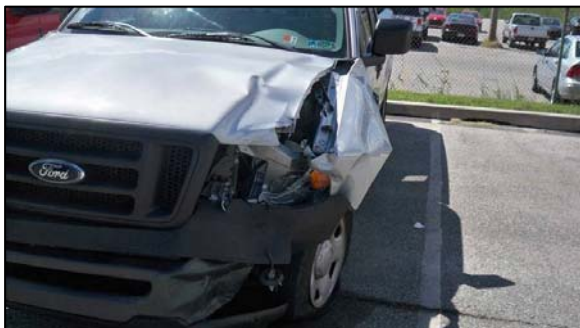
The Ford F150 was repaired prior to SCI's involvement in this investigation. Digital images of the frontal damage were obtained from its insurance carrier and were used to evaluate the vehicle's damage. **Figures 5 and 6** are the front and left oblique views of the Ford. The frontal damage was confined to the front left corner. The damaged components included the front bumper, left fender, hood and left headlamp assembly. The direct contact damage began an estimated 52 cm (21 in) left of center and extended left 30 cm (12 in). The estimated crush profile at the bumper elevation was as follows: C1 = 15 cm (6 in), C2 = 5 cm (2 in), C3 = 0, C4 = 0, C5 = 0, C6 = 0. There was no reduction in left wheelbase. The CDC of the damage was 12-FLEE1.

Figure 5: View of the Ford's frontal damage. Image obtained from the insurance carrier.

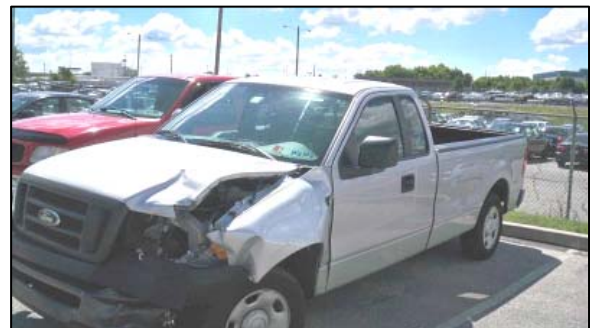
Figure 6: Front left oblique view of the Ford. Image obtained from the insurance company.

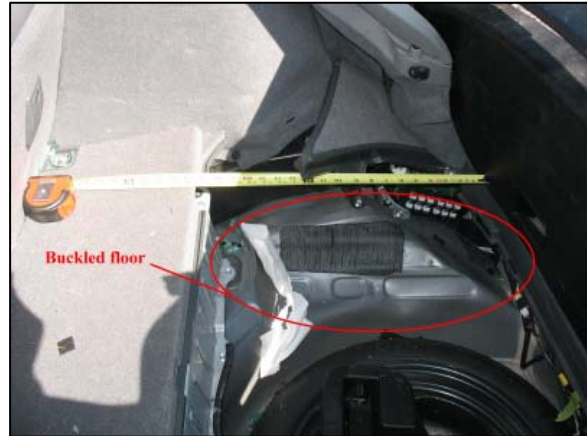
There was no damage or intrusion to the vehicle's occupant compartment. Minor intrusion was identified to the right rear aspect of the cargo area, **Figure 7**. The longitudinal dimension from the row 2 seat back to the back wall of the cargo area was reduced 11 cm (4.5 in) on the right. The right floor was deformed over a 48 cm x 20 cm (19 in x 8 in) area and buckled vertically approximately 5 cm (1.8 in).

Figure 7: Left lateral view into the cargo area.

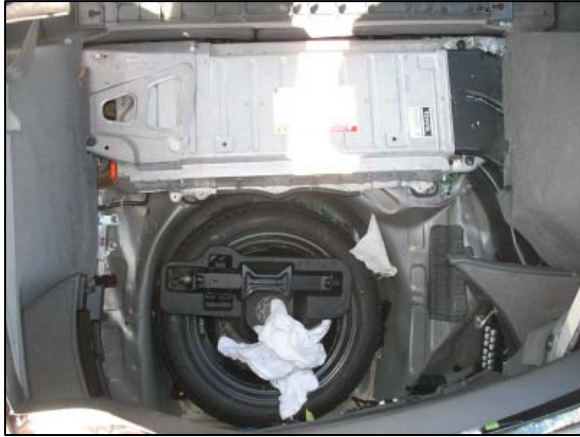
The hybrid battery stack was housed in an aluminum compartment that measured 30 cm x 76 cm x 15 cm (12 in x 30 in x 6 in) length x width x height.. The battery compartment was located behind the second row seat backs 58 cm (23.5 in) forward of the hatch opening [81 cm (32 in) forward of the rear bumper]. It was mounted to the floor of the cargo space, forward and above the 66 cm (26 in) diameter spare tire well. **Figures 8** is an overhead view into the cargo area depicting the deformation and the hybrid location behind the second row seat backs. **Figure 9** is a view of the hybrid battery and the buckled right aspect of the floor. Heating, ventilation, and cooling (HVAC) duct work was located along the right side of the cargo area. There was no damage to, or leakage from, the hybrid battery compartment. The battery appeared to be in compliance with Federal Motor Vehicle Safety Standard (FMVSS) No: 305.

Figure 8: Overhead view into the cargo area depicting the hybrid battery location.

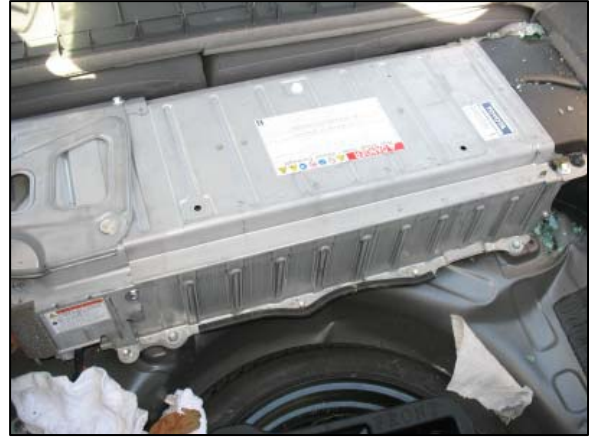
Figure 9: View of the hybrid battery and the buckled floor on right.

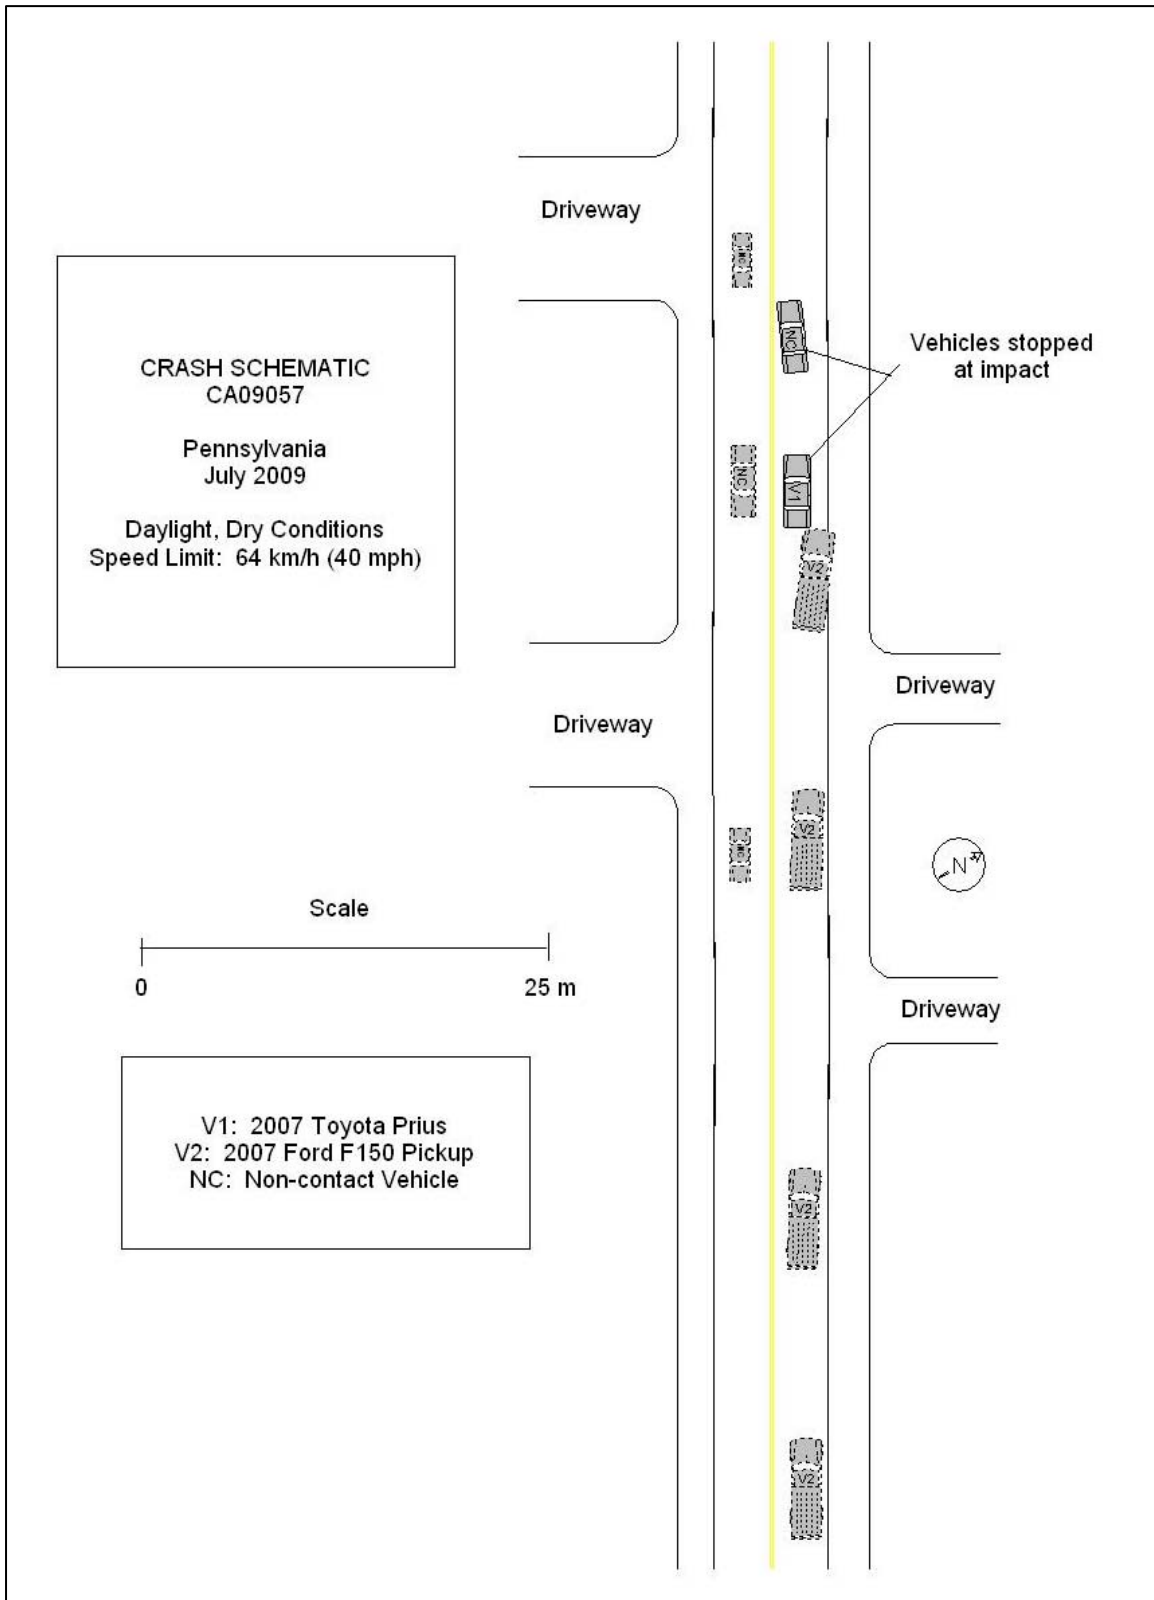
The Toyota Prius was driven by a 41-year-old male and occupied by a 23-year-old female front right passenger. The westbound Toyota came to a complete stop behind a westbound non-contact vehicle. The non-contact vehicle was stopped, waiting for opposing traffic to clear and intended to turn left into the intersecting driveway of the restaurant. The Ford F150 was also westbound, driven by a 71-year-old male. The driver of the Ford braked and steered his vehicle to the right in an attempt to avoid the stopped Toyota. A schematic of the crash is attached to the end of this report as **Figure 10**.

The left aspect of the Ford's frontal plane struck the right aspect of the Toyota's back plane in a 12/6 o'clock impact configuration. The momentum of the Ford displaced the Toyota forward approximately 1 m (3 ft) and both vehicles came to rest facing west. The severity of the impact (delta-V) was calculated by the Damage Algorithm of the WinSMASH program. The total delta-V of the Toyota was 16.0 km/h (9.9 mph). The longitudinal and lateral components of the delta-V were 15.8 km/h (9.8 mph) and 2.8 km/h (1.7 mph), respectively. The total delta V of the Ford was 11.0 km/h (6.8 mph) with the longitudinal and lateral delta-V components of -11.0 km/h (-6.8 mph) and 0 km/h (0 mph), respectively.

Figure 10: Crash schematic.
