CALSPAN REMOTE ROLLOVER CRASH INVESTIGATION

SCI CASE NO.: CA09061

VEHICLE: 2004 LINCOLN AVIATOR

CRASH DATE: JUNE 2005

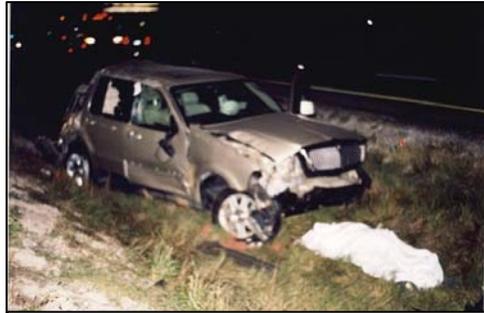
Figure 1. Image of the Lincoln at final rest. (Image courtesy of the investigating police department.)

into a right side leading rollover event. The frontal air bags deployed during the rollover event; however, the IC air bags did not deploy. The unrestrained 68-year-old female driver of the Lincoln was completely ejected from the vehicle and expired at the crash site. **Figure 1** is an overall view of the Lincoln at final rest.

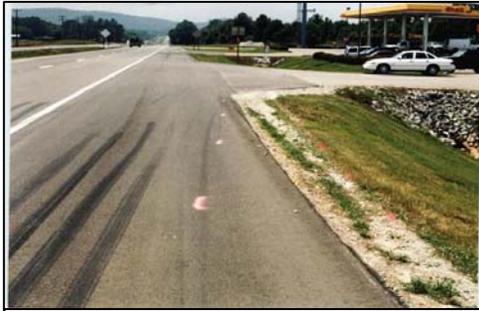
Prior to the crash, the Lincoln was traveling in a westerly direction on the outboard travel lane at a police estimated speed that was above the posted speed limit of 72 km/h (45 mph). The driver allowed the vehicle to drift to its right onto the paved shoulder (**Figure 2**). The Lincoln traversed the right shoulder at a shallow angle and the right side tires departed the paved surface onto the roadside. The driver initiated a counterclockwise (CCW) steering input in an attempt to regain the travel lane. The Lincoln initiated a CCW yaw as the right side tires remained on the roadside. The steering input redirected the vehicle back toward the travel lanes as it continued to yaw in a CCW direction. Based on the photographic documentation of the yaw marks, the left rear tire mark crossed the right front mark at the mid-point of the north shoulder, indicating the Lincoln had rotated approximately 30 degrees CCW prior to re-entering the westbound travel lanes.

Figure 2. Point of departure from the north shoulder.

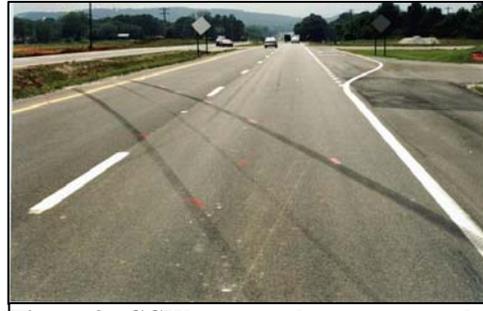
Figure 3. CCW yaw marks across travel lanes.

The Lincoln crossed both westbound travel lanes (**Figure 3**) and exited the south shoulder onto the stone at the edge of the median. The investigating officer (IO) documented a length of 101.8 m (334.0 ft) for the right rear yaw mark, 37.2 m (122.0 ft) of the left rear yaw mark, and 67.1 (220.0 ft) of the right front yaw mark. The left front yaw mark originated in the middle of the outboard travel lane and was not documented by the IO. All four tire marks ended on the stone shoulder at the north edge of the grass median. The right side tires apparently aired out as the Lincoln exited the paved shoulder onto the stone (**Figure 4**). The alloy wheels engaged the dirt and stone surface and tripped the Lincoln into a right side leading rollover. At the trip point, the vehicle had rotated approximately 80 degrees CCW with respect to its path of travel and was rolling about its longitudinal axis. The Lincoln traveled over the depressed grass center median as the tires lost ground contact. At this early stage of the rollover, the front end of the Lincoln pitched downward.

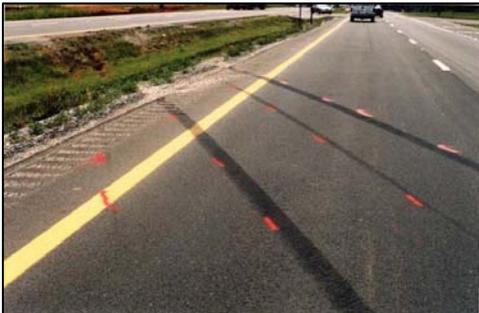
Figure 4. CCW rotation of the Lincoln off the south shoulder to the trip point.

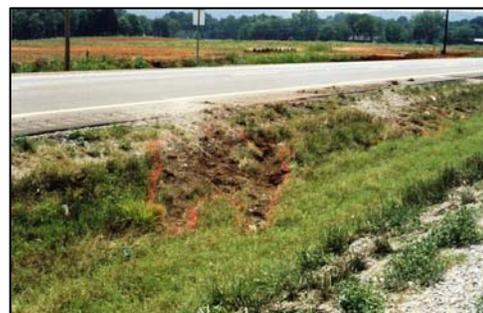
Figure 5. Initial contact with the median slope.

The initial contact with the positive sloped embankment at the south side of the median (**Figure 5**) involved the right front tire and wheel, the right front bumper corner and the undercarriage of the Lincoln. Three distinct gouge patterns originated in the grass and dirt surface and continued into the stone shoulder. This non-horizontal impact deflected the frontal structure laterally left and separated the front bumper fascia. The bumper beam and the radiator support were buckled from the lateral forces. The lateral deformation of the frontal structure resulted in a partial separation of the right front

fender. The initial ground impact probably deployed the frontal air bag system. There was no EDR data available to support the deployment time of the frontal air bags.

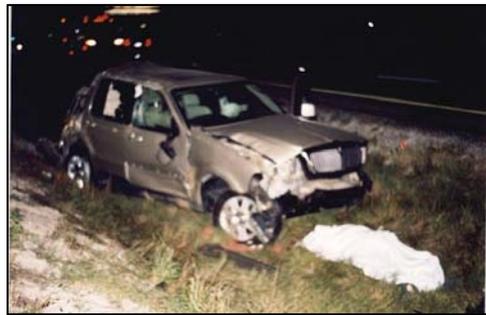
The Lincoln rolled clockwise from the back plane contact and about its longitudinal axis and impacted the median with its right side, completing its third-quarter turn. This contact point was supported by abrasions to the right roof side rail area, the lower aspect of the right front door, and the right side of the hood. The right front fender, although displaced outboard of its original position, was not damaged by the ground contact. The Lincoln subsequently returned to its wheels (4th-quarter turn) and came to rest approximately 24 m (80 ft) from the initial contact point with the median and traveled an estimated distance of 30 m (100 ft) from the trip point to final rest. At rest, the Lincoln was facing in a west, southwesterly direction (**Figure 6**). The rollover was classified as an uninterrupted event.

Figure 6. Final rest position of the Lincoln and the ejected driver.

The unrestrained driver was redirected rearward by the back plane contact and was subsequently ejected through the left rear quarter window opening, presumably during the second to third quarter turns of the rollover event. She came to rest forward of the Lincoln and was pronounced deceased at the scene of unknown injuries.

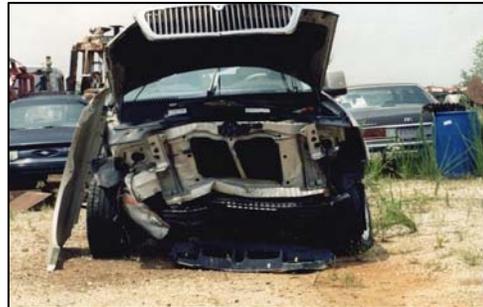
The frontal structure of the Lincoln was displaced laterally left as a result of the initial right front corner impact with the median embankment. The impact buckled the radiator support and the bumper beam right of the vehicle's centerline (**Figure 7**). The inner structure of the right front fender was displaced laterally. The right front fender was

minimally damaged and had partially separated from the inner structure. The top mounted bolts pulled through the fender without causing induced damage to the fender. The impact separated the bumper fascia and the headlamp assemblies. The right edge of the hood was deflected downward and laterally left from ground contact.

Figure 7. Left lateral displacement of the frontal structure.

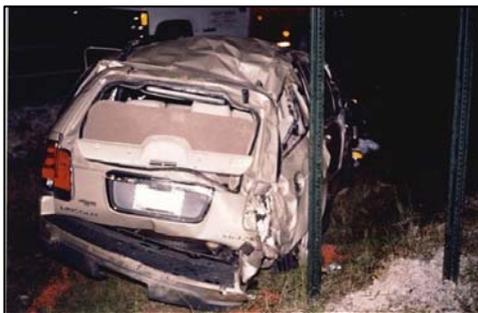
The back of the Lincoln sustained severe damage that was biased to the upper right aspect of the D-pillar/backlight header juncture. The direct contact damage that consisted of abrasions and dirt and grass debris extended the full width of the rear bumper fascia and the backlight header. The upper right D-pillar was displaced forward and downward. The roof side rail between the C- and D-pillar was buckled and displaced downward from the back plane engagement. The right rear quarter panel was compressed forward and downward as a result of the back plane contact. The maximum vertical roof crush was located at the right D-pillar and was estimated at 20-25 cm (8-10 in). The upper D-pillar was displaced approximately 20 cm (8 in) forward. **Figures 8 and 9** are images of the damage to the back plane of the Lincoln.

Figure 8. Damage to the back plane of the Lincoln.

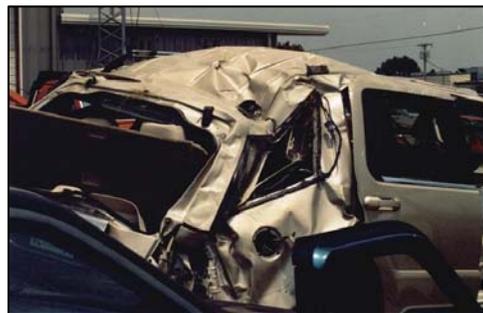
Figure 9. Close-up view of the crush to the right D-pillar area.

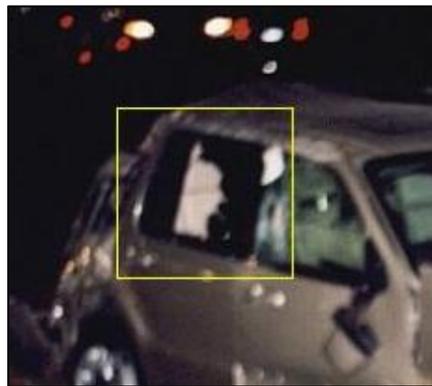
An aftermarket deep window tint film was applied to the rear door glazing and possibly the rear quarter windows and backlight glazing. The left rear door glazing was closed and remained intact post-crash. The left rear quarter window, backlight, and right rear quarter window glazing was disintegrated during the crash. It is unknown if the left rear quarter window was disintegrated by body deformation or by the driver as she was ejected through this opening. The on-scene image of the Lincoln showed that the right rear door glazing was shattered and holed at the scene of the crash with the forward third portion of the glazing held in place by the aftermarket tint film

Figure 10. On-scene image of the status of the right rear door glazing.

(**Figure 10**). The glass fragments were held in place by the aftermarket film. Follow-up images of the vehicle at the tow yard showed that the entire door glazing had separated from the window frame. The Lincoln was not equipped with a roof window.

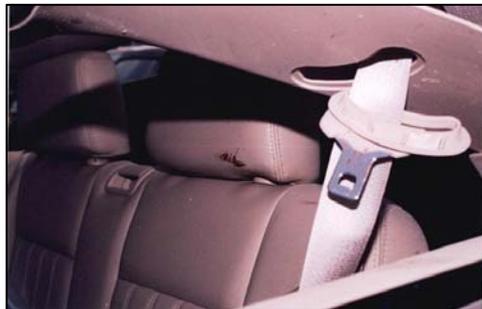
The back plane of the Lincoln impacted the median resulting in a forward crush pattern across the backlight header. The driver responded to this impact by initialing a rearward trajectory. She loaded the front left seat back, deforming the seat back rearward. The driver traveled between the seat backs of the first and second rows and contacted the third row left head restraint and safety belt buckle. Blood evidence was present on these components (**Figure 12**).

Figure 12. Body fluid evidence of the third row left head restraint and latch plate.
