**CALSPAN REMOTE ROLLOVER CRASH INVESTIGATION**

**SCI CASE NO.: CA09063**

**VEHICLE: 2003 LINCOLN AVIATOR**

**CRASH DATE: AUGUST 2007**

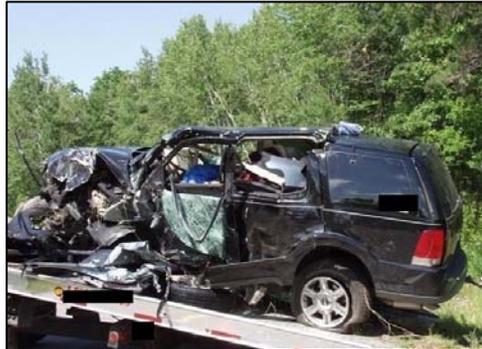
**Figure 1. Left side view of the 2003 Lincoln Aviator. (Images courtesy of the police department.)**

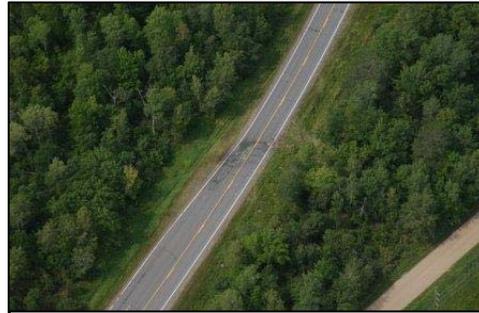
**Figure 2. Aerial view of the crash site.**

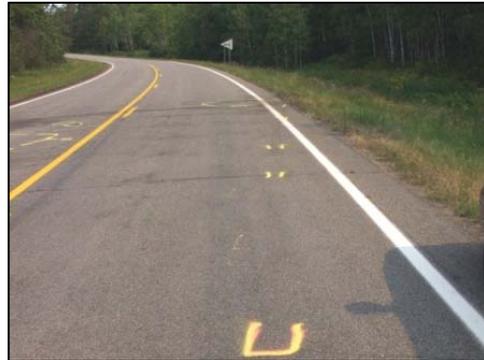
The driver of the Lincoln was northbound in the appropriate travel lane at a speed consistent with the posted speed limit of 89 km/h (55 mph). The Lincoln driver maintained his lane of travel as he negotiated the left curve. The driver of the Toyota was traveling southbound as he entered the right curve for his direction of travel. For an unknown reason, the driver of the Toyota allowed the vehicle to drift to the left and cross the centerline into the northbound travel lane. There were no known avoidance actions initiated by the driver of the Toyota. The driver of the Lincoln braked and steered right onto the east shoulder in an attempt to avoid the impending crash. A right front skid mark from the Lincoln arced from the travel lane onto the asphalt shoulder, ending at the edge of the pavement. A subtle left front skid mark was present on the travel lane. This evidence marked the trajectory of the Lincoln and supported the pre-crash avoidance actions by the driver (**Figure 3**).

**Figure 3. Pre-crash avoidance actions and resultant skid marks from the Lincoln.**

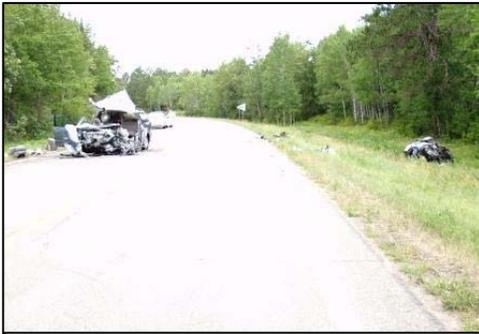
**Figure 4. Final rest positions of the involved vehicles.**

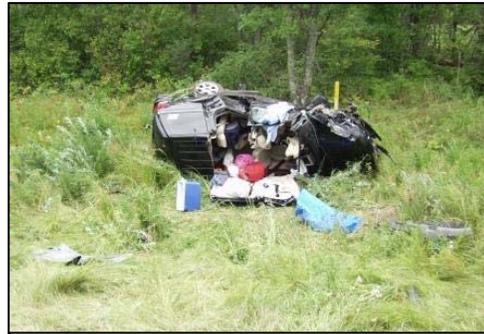
**Figure 5. Final rest position of the Lincoln Aviator.**

*Secondary* – The secondary event for this crash involved the rollover of the Lincoln following its separation from the Toyota. The Lincoln initiated a lateral rollover to the left as it rotated 180 degrees CCW down the embankment onto the roadside, completing three-quarter turns. The rescue personnel cut the left A- and B-pillars and the roof at the location of the left C-pillar to remove the occupants. Although the roof was repositioned during the towing process, the specific vertical and lateral crush of the roof could not be determined. The front laminated side glazing remained intact, but cracked and fell from the window frames. The left rear door glazing was disintegrated. The right rear door, rear quarter windows and the backlight glazing remained intact. The Lincoln was

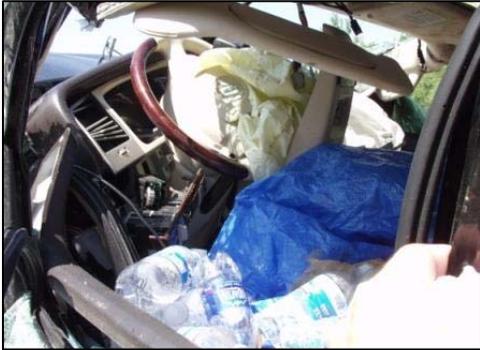
The interior of the Lincoln was reduced in size by longitudinal intrusion of the frontal components into the driver's position. The intrusion buckled the instrument panel upward and displaced the steering column rearward and vertically. The left B-pillar appeared to have been displaced laterally right into the driver's seat back. The interior images did not provide the detail required to determine specific occupant contact points.

**Figure 6. Intrusion into the driver's position.**

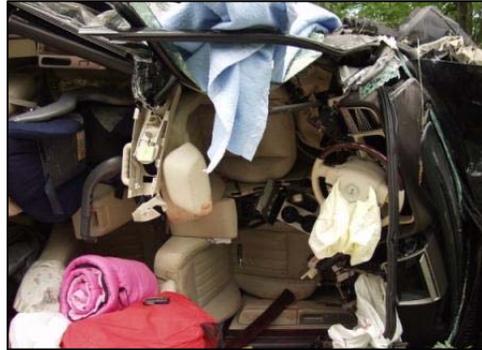
**Figure 7. Interior view of the Lincoln at final rest.**

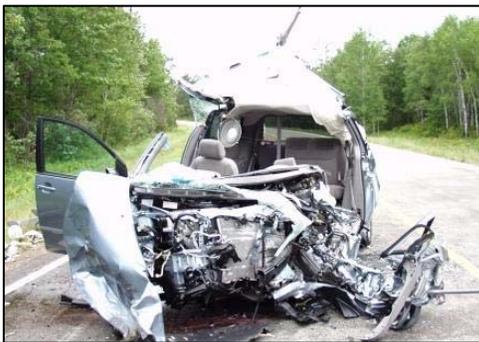
The Toyota Sienna minivan sustained severe frontal crush that was associated with the frontal engagement with Lincoln. The direct contact damage began near the centerline of the frontal plane and extended to the front left corner. As the frontal structure of the Toyota crushed rearward, the left side engaged with the Lincoln. Based on the available images, the direct damage extended to the left B-pillar area as evidenced on the sill of the Toyota. The combination of the severe frontal impact and the post-crash altering of the vehicle by the fire department precluded an estimated crush profile. The bumper fascia was separated from the vehicle and the bumper beam was exposed. The right mounting point of the bumper beam separated as it was displaced laterally left. The left frame rail and bumper beam appeared to have crush to the original position of the left A-pillar. The left front tire and wheel assembly separated from the suspension and steering systems.

**Figure 8. Frontal view of the Toyota Sienna.**

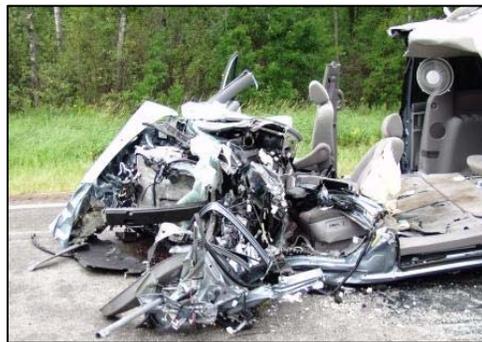
**Figure 9. Left lateral view of the frontal deformation to the Toyota.**

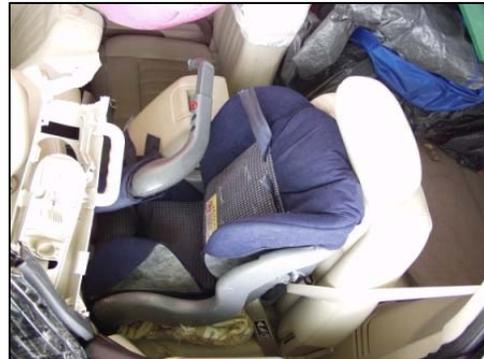
**Figure 10. View of the CRS in the rear left position of the Lincoln.**

Damage to the CRS involved the separation of the tray shield from the pivot points. The left aspect of the CRS shell appeared to be fractured as visible lateral compression of the upper aspect of the CRS was present.
