**CALSPAN ON-SITE SIDE IMPACT INFLATABLE OCCUPANT  
PROTECTION SYSTEM CRASH INVESTIGATION  
SCI CASE NO.: CA09067**

**VEHICLE: 2007 BMW 525i SEDAN**

**LOCATION: NORTH CAROLINA**

**CRASH DATE: SEPTEMBER 2009**

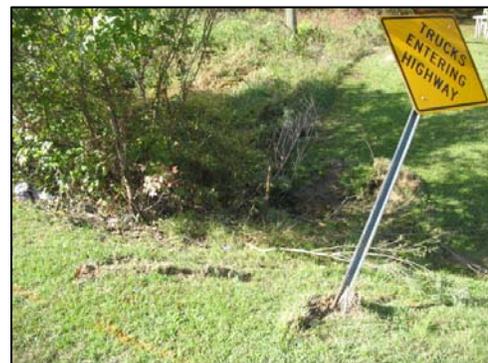
The impact force redirected the BMW to its right. A 16.7 m (54.8 ft) left rear tire mark evidenced the BMW's post-crash trajectory. The BMW departed the roadway to the right where it impacted and overrode a highway sign (Event 2). The BMW traversed the steep embankment, rotated clockwise and traveled to the bottom where the front plane of the vehicle impacted the back side of the ditch. **Figure 3** depicts the impact locations with the sign and the embankment. The Barrier Algorithm of the WinSMASH program calculated a total delta-V of 17 km/h (10.6 mph) for the embankment impact. The longitudinal and lateral components of the delta-V were -16.7 km/h (10.4 mph) and 3 km/h (1.9 mph), respectively. The BMW came to rest against the west ditch embankment, facing west 21 m (69 ft) from the initial

**Figure 3: Location of impacts with the sign (Event 2) and the embankment (Event 3).**

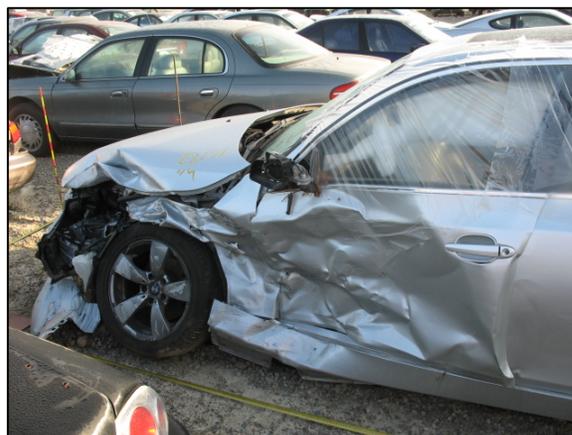
The left side and frontal areas of the BMW sustained moderate damage as a result of this multiple event crash sequence. The primary damage was located on the left side of the BMW. The direct contact damage began 159 cm forward of the left rear axle and extended forward 174 cm (68.5 in) to the left front bumper corner (**Figure 4**). The combined direct and induced damage (Field L) began 116 cm (45.7 in) forward of the left rear axle and extended forward 217 cm (85.4 in). Lateral crush was present to the left front fender, left A-pillar and left front door. The maximum crush measured 26 cm (10.2 in) and was located at C3, 202 cm

**Figure 4: Left side damage sustained by the BMW in the initial impact.**

(79.5 in) forward of the left rear axle. A residual crush profile was measured at the lower door level and was as follows: C1 = 0 cm, C2 = 13 cm (5.1 in), C3 = 26 cm (10.2 in), C4 = 21 cm (8.3 in), C5 = 19 cm (7.5 in), C6 = 20 cm (7.9 in). The height of the maximum crush was 41 cm (16.1 in) above the ground and the BMW's door sill height was 28 cm (11 in). The Door Sill Differential (DSD) was measured at 17 cm (6.7 in). The Collision Deformation Classification (CDC) assigned for the Event 1 impact was 11LYEW2. The front doors and rear right door were jammed closed post-crash. The front right door had been pried open by EMS to allow the driver to exit the vehicle. The left rear door remained closed during the crash and was operational post-crash. The windshield was fractured and the left front and left rear window glazing were

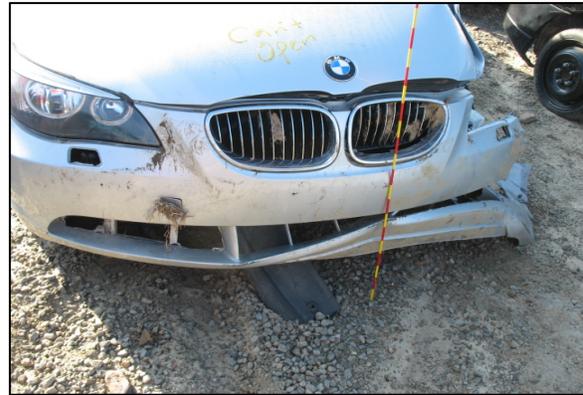
The direct and induced damage resulting from the impact with the ditch bank (Event 3) extended across the full width of the front plane. **Figure 5** depicts the frontal damage. The maximum crush was located at C1, the front left bumper corner. A residual crush profile was measured at the level of the bumper and was as follows: C1 = 13 cm (5.1 in), C2 = 2 cm (0.8 in), C3 = 3 cm (1.2 in), C4 = 3 cm (1.2 in), C5 = 5 cm (2 in), C6 = 2 cm (0.8 in). The CDC assigned for this impact was 12FDEW1.

**Figure 5: Frontal damage to the BMW resultant to Event 3.**

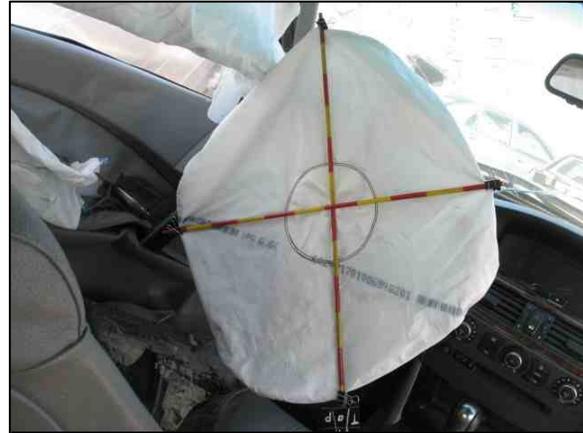
The BMW was equipped with a CAC frontal air bag system. The CAC system consisted of dual-stage frontal air bags for the driver and right front passenger positions, seat track positioning and buckle switch sensors, retractor pretensioners, and a front right occupant presence sensor. The driver's air bag was concealed within the center hub of the 3-spoke steering wheel by a quad-flap. The upper flaps measured 5 cm (2 in) in width at the upper side, 5 cm (2 in) in height, and 7 cm (2.8 in) in width at the horizontal tear seam. The lower flaps were triangular in shape and were 7 cm (2.8 in) in width and 9 cm (3.5 in) in height at the vertical tear seam. The driver's air bag (**Figure 6**) measured 56 cm (22 in) in diameter in its deflated state. The air bag was vented by two circular ports located on the upper rear aspect of the air bag at the 11 and 1 o'clock positions. The front left air bag was tethered by two straps attached to the face of the air bag at the 12 and 6 o'clock positions on a 14 cm (5.5 in) tether circle sewn to the face of the air bag. No contact evidence or crash-related damage was present on the driver's air bag. The air bag was labeled with the following nomenclature: >PA 6.6< 602491701006940201.

**Figure 6: Driver's frontal air bag.**

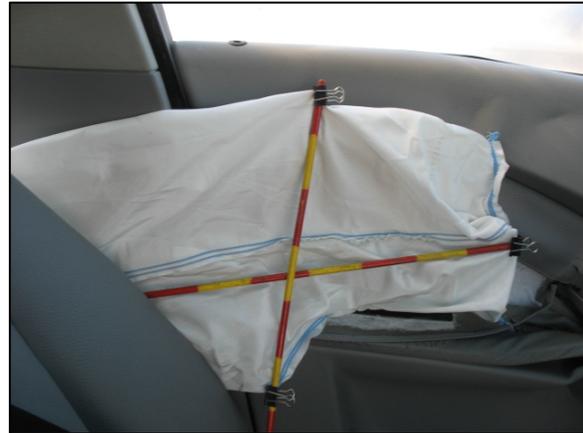
The left side impact air bag deployed from the rear aspect of the left front door panel. The H-configuration cover flaps measured 17 cm (6.7 in) in width and 8 cm (3.1 in) in height. The air bag measured 50 cm (19.7 in) in width and 20 cm (7.9 in) in height (**Figure 7**). There were no vent ports and the air bag was tethered by a horizontal panel that extended the length of the air bag 9 cm (3.5 in) above the bottom edge. There was no contact evidence or damage to the left side air bag.

**Figure 7: Left side impact air bag.**

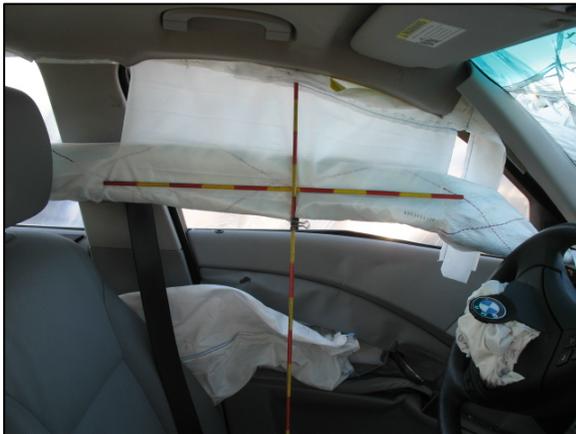
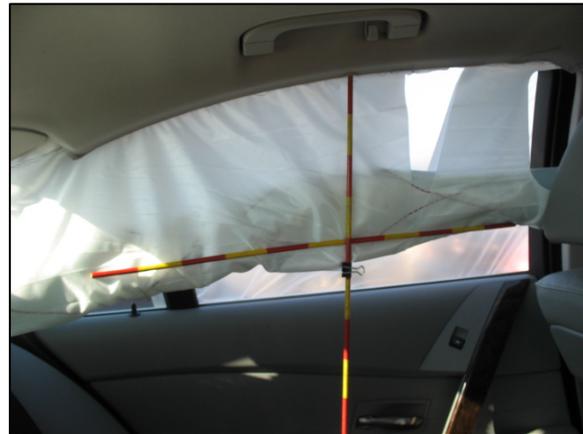
The left IC air bag deployed from the left roof side rail. The IC consisted of a tubular air bag contained in a sling, forming a curtain type air bag. The IC air bag measured 198 cm (78 in) in length and 10 cm (3.9 in) in diameter and was attached to the A- and C-pillars providing complete longitudinal coverage across the length of the left side glazing. The sling held the air bag 14 cm (5.5 in) above the belt line at the front and rear seating positions. The air bag was located 24 cm (9.4 in) below the roof side rail at the front seating position and 22 cm (8.7 in) below the roof side rail at the rear seating position. The IC air bag was labeled with the number - 06063806. There was no occupant contact or damage to the left IC air bag. **Figures 8 and 9** depict the left IC air bag.

**Figure 8: Left IC air bag at front left seating position.**

**Figure 9: Left IC air bag at the rear left seating position.**

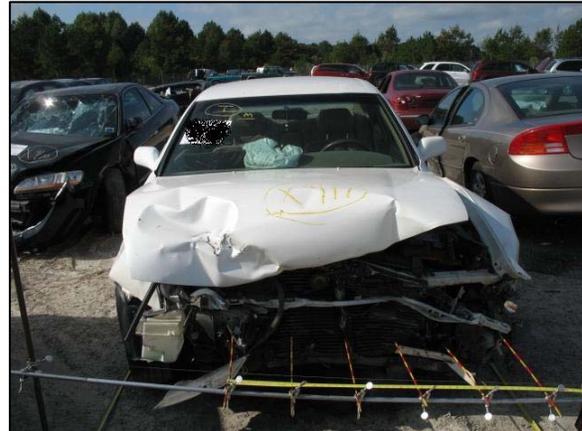
The front plane of the Toyota Avalon sustained moderate-severity damage from the impact with the BMW. The direct contact damage extended the full width of the front bumper. The front bumper fascia and bumper beam separated from the vehicle and were unavailable for inspection. A crush profile estimated from the location of the bumper mounting brackets and the damage to the chassis and radiator was documented along the full width of the front of the Toyota.

**Figure 10: Frontal damage to the Toyota.**

**Figure 10** depicts this crush profile. The maximum crush measured 37 cm (14.6 in) and was located at C3, 45 cm (17.7 in) inboard of the left front bumper corner. The estimated crush profile was as follows: C1 = 22 cm (8.7 in), C2 = 34 cm (13.4 in), C3 = 37 cm (14.6 in), C4 = 33 cm (13 in), C5 = 28 cm (11 in), C6 = 19 cm (7.5 in). The CDC assigned for this impact was 01FDEW2.
