**CALSPAN ON-SITE HEAVY TRUCK REAR IMPACT GUARD CRASH INVESTIGATION  
SCI CASE NO.: CA09070**

**VEHICLE: FREIGHTLINER TRACTOR W/ 2009 UTILITY FLATBED TRAILER  
LOCATION: NEW JERSEY**

**CRASH DATE: OCTOBER, 2009**

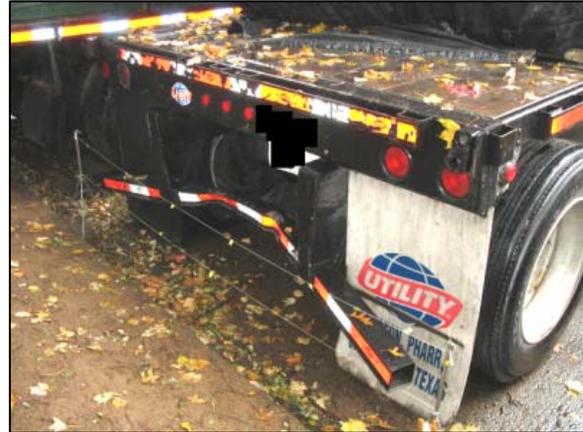
This on-site investigation focused on the rear impact guard that was installed on a 2009 Utility flatbed trailer (**Figure 1**) that was involved in a front-to-rear crash with a 2006 Ford Taurus. The crash occurred on an interstate highway. The tractor trailer was westbound in the left lane moving at a slow rate of speed. The Ford Taurus was also westbound and was traveling at or near the 105 km/h (65 mph) speed limit. The front plane of the Ford sustained severe impact damage that extended rearward to the front axle location. The unrestrained 52-year-old male driver of the Ford sustained fatal blunt force traumatic injuries and was pronounced deceased at the scene.

**Figure 1: Rear oblique view of the Utility trailer and the deformed rear impact guard.**

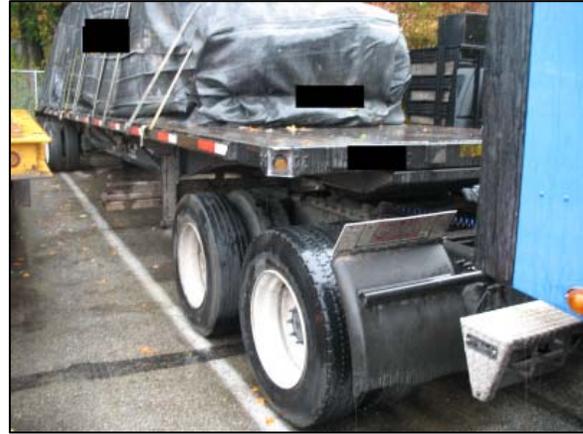
The Utility flatbed trailer (**Figure 2**) was 14.6 m (48 ft) in length, 257 cm (101 in) in width, and had a measured (loaded) deck height of 127 cm (49.8 in). The trailer was manufactured with a steel frame, oak decking and was configured with a spread dual-axle rear suspension. The distance between the axles measured 3 m (10 ft). The trailer's rear overhang (distance from the center of the rear most axle to the back plane) measured 0.7 m (2.3 ft). The longitudinal frame rails of the trailer were constructed from 41 x 10 cm (16 x 4 in) steel I-beams. The thickness of the beams measured 13 mm (0.5 in). The width between the frame rails of the trailer measured 112 cm (44 in).

**Figure 2: Front right oblique view of the trailer.**

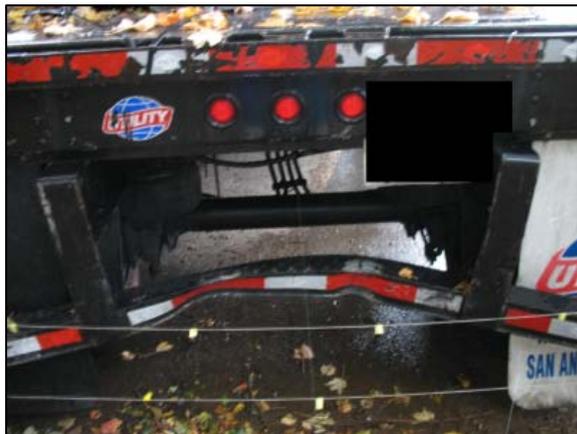
The rear impact guard (**Figure 3**) was constructed by the Utility Trailer Manufacturing Company in January 2008. A manufacturer's label was attached to the forward aspect of the guard. The guard was a steel weldment that was joined directly to the ends of the trailer's longitudinal frame rails. The two vertical support sections of the guard were comprised of 41 cm x 10 cm (16 in x 4 in), length by width, plates welded to the frame rails. Each vertical support was reinforced by a tapered I-beam section that formed a gusset welded to the lower surface of the frame rail. **Figure 4** is a left lateral view of the inboard aspect of the right vertical support gusset. The I-beam gusset measured 28 cm x 10 cm (11 in x 4 in), width by depth, and tapered to 10 cm (4 in) in depth over a length of 20 cm (8 in). The thickness of the material measured 13 mm (0.5 in). The lower end of each I-beam gusset was welded to a horizontal box-beam bumper that measured 244 cm (96 in) in length. The box-beam was comprised of a U-shaped channel that was welded closed into a rectangular cross-section by a steel plate. The beam measured 10 cm x 11 cm (4 in x 4.3 in), width by height. The height (above the ground) of the bumper's top surface measured 50 cm (20 in). **Figure 5** is a diagram of the trailer depicting the pre-crash configuration of the rear impact guard (end-view and side-view).

**Figure 3: Rear view of the center aspect of the deformed rear impact guard.**

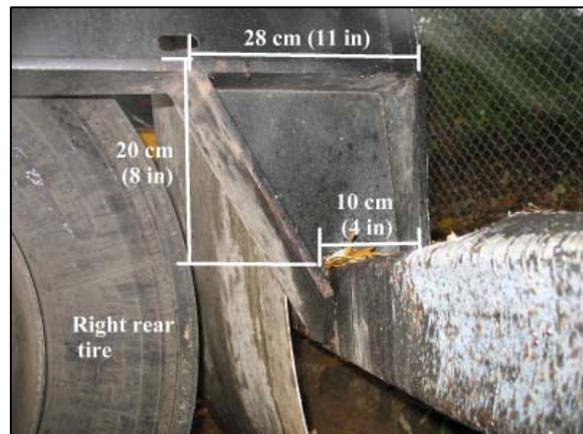
**Figure 4: Lateral view of the inboard aspect of the right vertical support.**

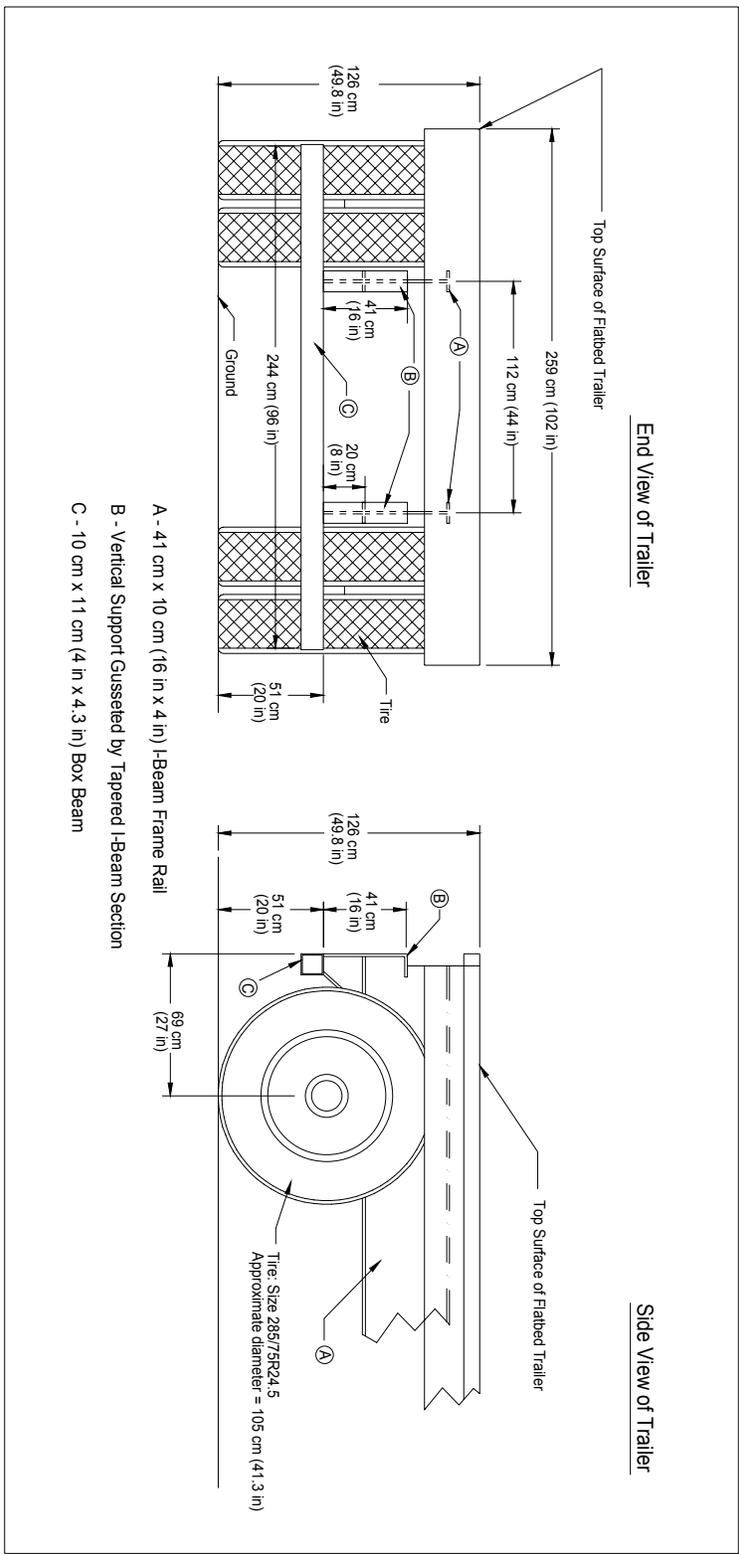
Figure 5: Schematic of the pre-crash configuration of the rear impact guard.

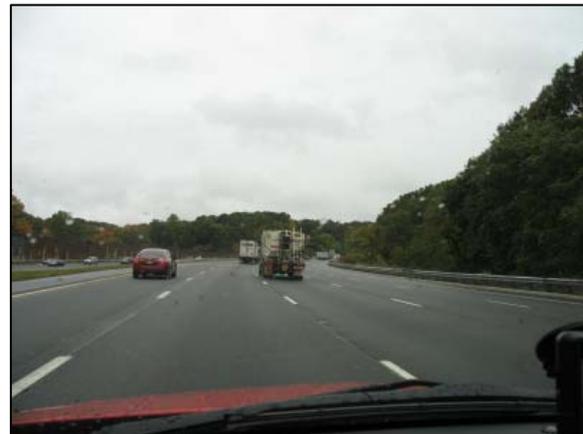
**Figure 6: Westbound trajectory view approaching the area of the crash.**

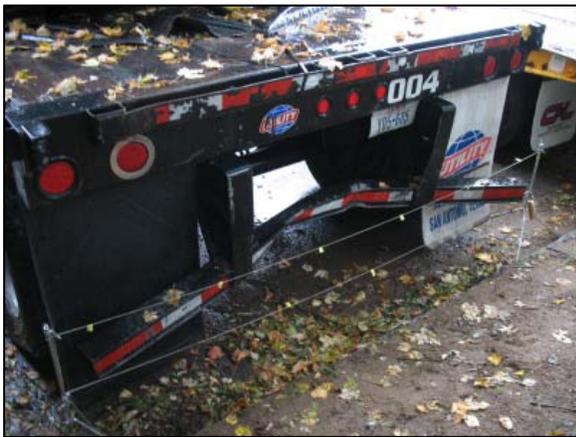
The trailer's rear impact guard sustained moderate damage as a result of the impact. **Figure 7** is a left oblique view of the rear impact guard. **Figure 8** is an overhead view of the deformation of

the center aspect of the guard. The direct contact began at the rear impact guard's right vertical support and extended 160 cm (63 in) to the left across the bumper's unsupported center section, the left vertical support and the left outboard aspect of the bumper. A reference line parallel to the rear plane of the trailer was established and a profile of the deformed horizontal box-beam bumper was measured. The bumper deformed in a U-shaped pattern. The bumper was not deformed outside the region of direct contact; rather the bumper deflected rearward outboard of the vertical supports resulting in a negative deflection value at the C1, C5 and C6 locations. The measurement protocol requires that these negative crush values are listed as zero. The residual profile of the bumper was as follows: C1 = 0, C2 = 3 cm (1.0 in), C3 = 15 cm (5.9 in), C4 = 16 cm (6.3 in), C5 = 0, C6 = 0. The maximum deflection measured 24 cm (9.5 in) and was located 7 cm (2.9 in) right of the centerline. Additional measurements relative to the reference line were taken at the welded junction of the bumper and each vertical support. The forward deflection of the left vertical support measured 2 cm (0.8 in). The forward deflection of the right vertical support measured 3 cm (1.1 in). These deflections resulted from minor bending and torsion of the vertical tapered I-beam sections.

Figure 7: Left rear oblique view of the rear impact guard.

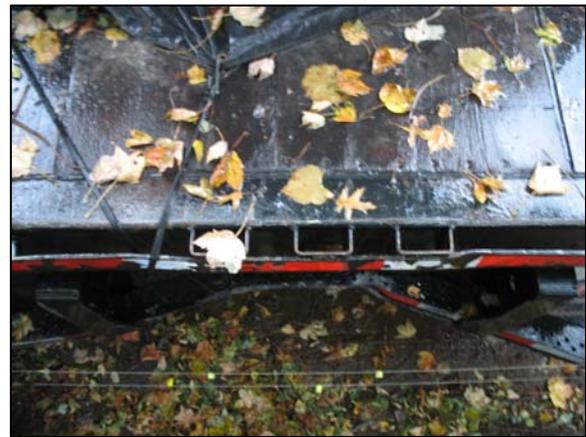
Figure 8: Overhead view of the deformation of the center aspect of the guard.

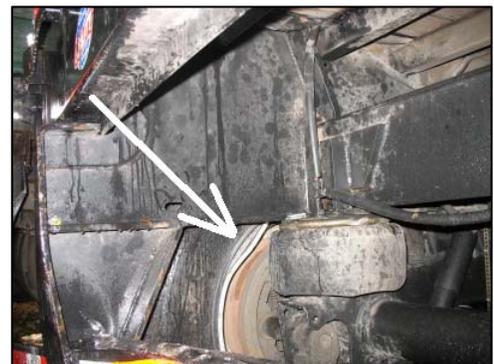
Figure 9 is an oblique view of the inner left rear dual tire. The left aspect of the Ford's front structure impacted the tire and rim resulting in deformation to the wheel rim. The inboard left rear tire was aired out. There did not appear to be any damage to the components of the left rear suspension. The trailer forward aspects of the trailer and the tractor were not damaged.

Figure 9: View of the deformed inboard left rear wheel rim.

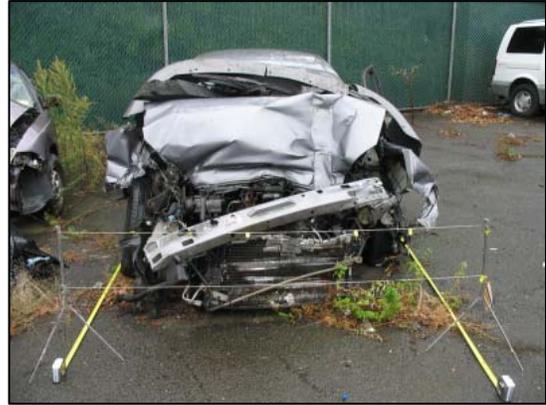
The Ford Taurus sustained severe frontal damage as a result of the underride crash. **Figure 10** is the front view of the Ford. The imprint of the trailer's left vertical support was observed on the left aspect of the deformed hood. **Figures 11 and 12** are the left and right lateral views of the Ford, respectively. The direct contact damage sustained by the Ford extended across the entire 168 cm (66 in) end-width. The left aspect of the bumper fascia was fractured and the entire cover had separated from the vehicle. The left end of the bumper reinforcement beam had separated from the frame. The outboard 22 cm (8.5 in) of the beam exhibited direct impact damage; the remainder of the beam was not damaged. The left uni-body frame rail was crushed rearward 53 cm (20.8 in) from contact with the left rear wheel/tire of the trailer. The right frame rail underrode the center aspect of the rear impact guard and was not damaged. The components and vehicle structure above the level of the right frame rail sheared away from the frame and crushed rearward. Crush profiles were measured along the leading edge of the hood and along the lower engine cradle to document the extent of damage to the Ford. The average of these profiles was used as input values into the WinSMASH model in order to determine the severity of the crash. The average crush was as follows: C1 = 63 cm (24.8 in), C2 = 44 cm (17.3 in), C3 = 44 cm (17.3 in), C4 = 37 cm (14.6 in), C5 = 34 cm (13.4 in), C6 = 36 cm (14.2 in). The maximum crush (not averaged) measured 73 cm (28.7 in) and was located at the left front corner of the hood. The left front tire/wheel was crushed rearward into the aft aspect of the wheelhouse at the lower A-pillar. The left wheelbase was reduced 18 cm (7.0 in). The right wheelbase dimension was unchanged. The lower aspect of the windshield was fractured by the rearward crush of the hood. The front left door was opened by extrication and would not close due to body deformation. The rear left and both right doors remained closed during the crash and were operational at the time of the SCI inspection. The front left, rear left, and front right glazing was disintegrated. The right rear and backlight glazing were intact. The Collision Deformation Classification (CDC) was 12FDEW3.

**Figure 10: Front view of the Ford.**

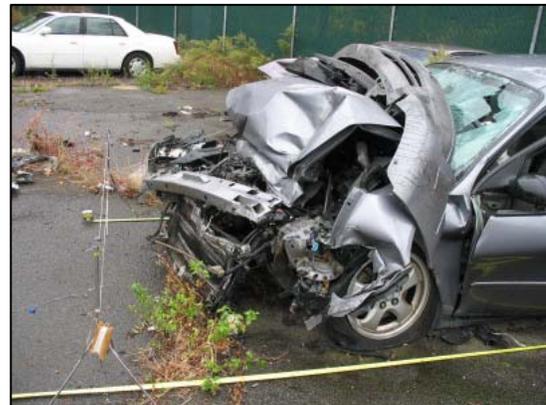
**Figure 11: Left lateral view of the extent of crush to the Ford.**

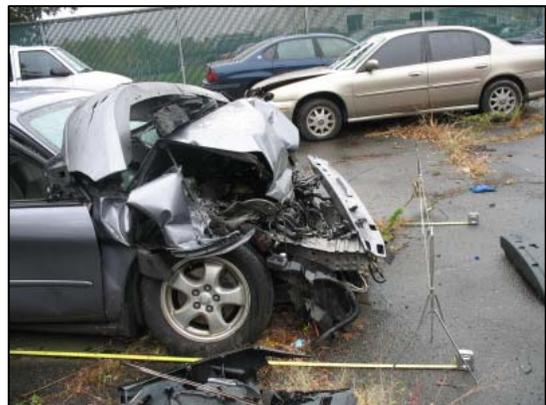
**Figure 12: Right lateral view of the extent of crush.**

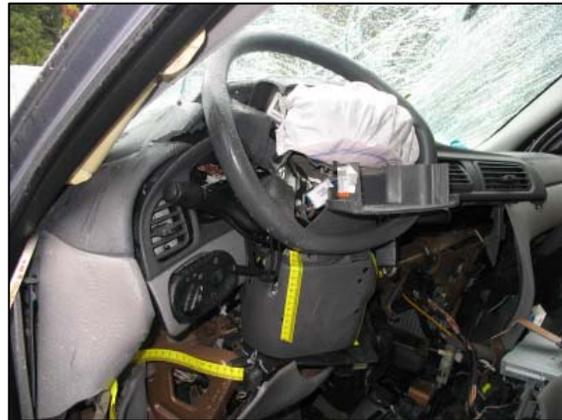
The steering column rotated upward and the four-spoke steering wheel rim was deformed forward as a result of loading from the unrestrained driver, (**Figure 13**). The steering column had rotated vertically 50 degrees. The right (inboard) steering column shear capsule completely fractured and released from the instrument panel. The upper sector of the steering wheel rim penetrated and holed the windshield. The hole measured 56 cm x 48 cm (22 in x 19 in). The upper rim protruded approximately 5 cm (2 in) beyond the plane of the laminate. The lower sector of the steering wheel rim was deformed 9 cm (3.5 in).

**Figure 13: View of the steering assembly deformation.**

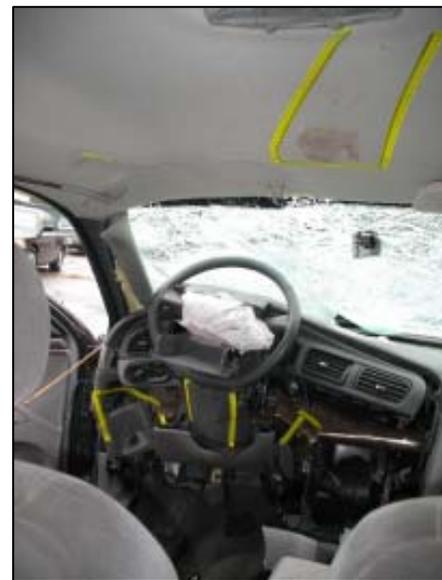
**Figure 14** is a view depicting the driver's interior contacts. The driver's lower extremities contacted the bolster panel evidenced by deformation to the metal structure of the lower instrument panel. The left lower extremity contact was located 25 cm (10 in) left of the steering column and 53 cm (21 in) above the floor. The contact was approximately 15 cm (6 in) in width and 18 cm (7 in) in depth. The right lower extremity contact was located 25 cm (10 in) right of

**Figure 14: View of the driver interior contacts.**

the steering column and 56 cm (22 in) above the floor. The depth of this contact measured 14 cm (5.5 in). The base of the steering column exhibited scuffing contact from interaction with the driver's abdomen and pelvis. The scuffed area measured 10 cm x 13 cm (4 in x 5 in) and extended downward onto the bolster panel. A 10 cm (4 in) diameter area of body fluid was located on headliner 53 cm (21 in) right of the side rail and 28 cm (11 in) rear of the windshield header. An 8 cm (3 in) wide region of spatter extended rearward from this contact to the dome light.

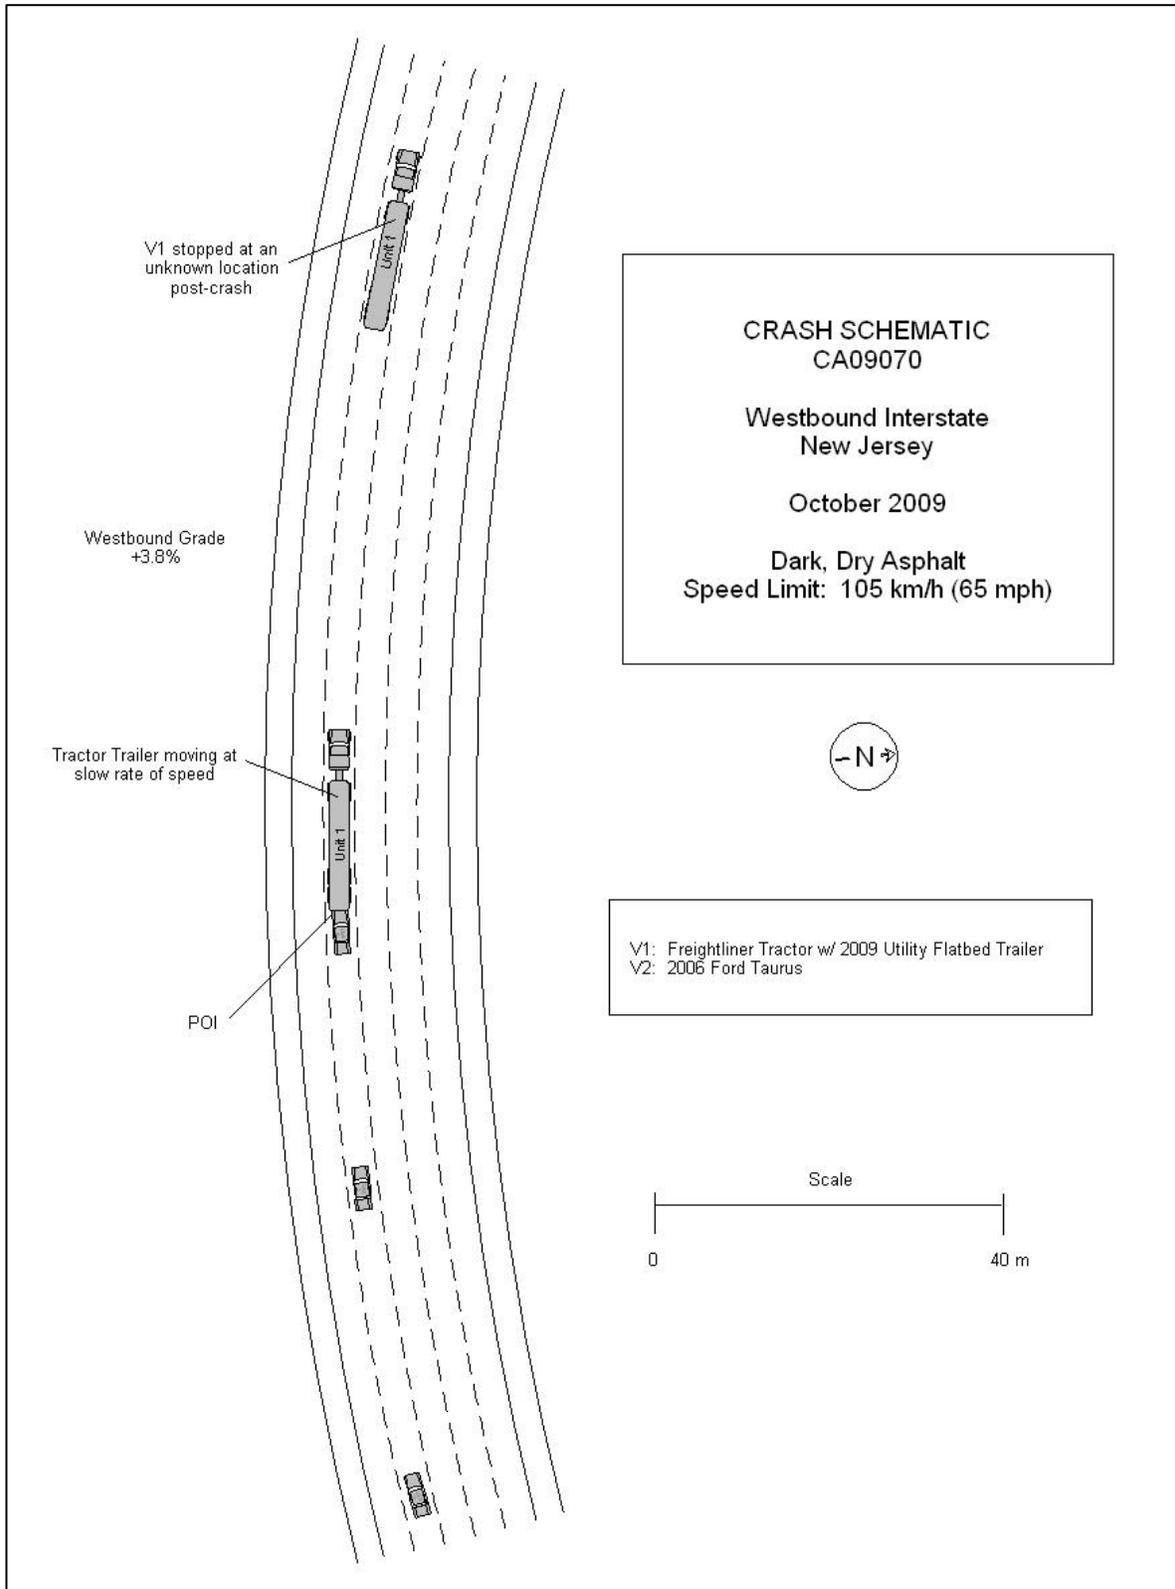
The crash occurred during the morning hours of October 2009 on the westbound lanes of an interstate highway in a rural setting. At the time of the crash, it was dark and the weather was not a factor. The westbound interstate highway was comprised of five 3.7 m (12 ft) wide lanes and had a large radius right curve. In the vicinity of the crash site, the highway had a positive grade of 3.8 percent. The impact occurred in lane 2 (second lane from the left). The speed limit in the area of the crash was 105 km/h (65 mph). **Figure 6** is a westbound trajectory view approaching the area of the crash. A schematic of the crash is attached to the end of this report as **Figure 15**.

Figure 15: Crash schematic.
