**CALSPAN ON-SITE CERTIFIED ADVANCED 208-COMPLIANT**

**SCI CASE NO.: CA09073**

**VEHICLE: 2008 DODGE CALIBER SE**

**CRASH DATE: OCTOBER 2009**

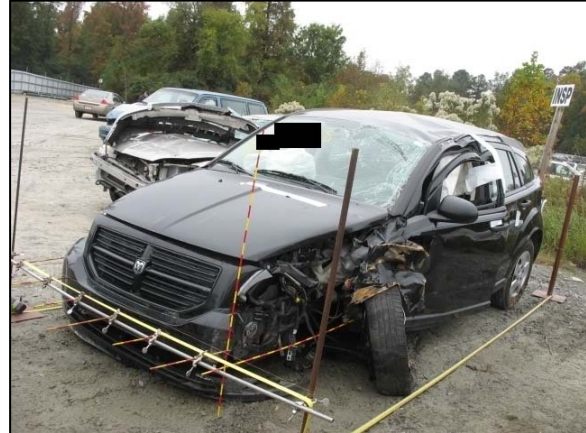
**Figure 1: Left front oblique view of the 2008 Dodge Caliber.**

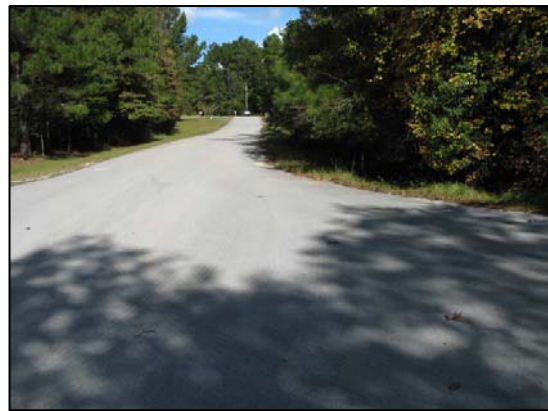
The unrestrained 30-year-old female driver of the Dodge operated the vehicle south in reverse from a residential driveway into a cul-de-sac. She then shifted into drive and accelerated quickly in a westbound direction of travel. **Figure 2** depicts the original trajectory of the Dodge. The vehicle departed the roadway to the right at the edge of the cul-de-sac at an angle of 15 degrees right of the roadway. The driver continued to accelerate as she approached the trees and landscape wall. Two 47.2 m (154.8 ft) long arcing tire marks through the roadside grass defined the vehicle's trajectory.

**Figure 2: Initial trajectory of the Dodge.**

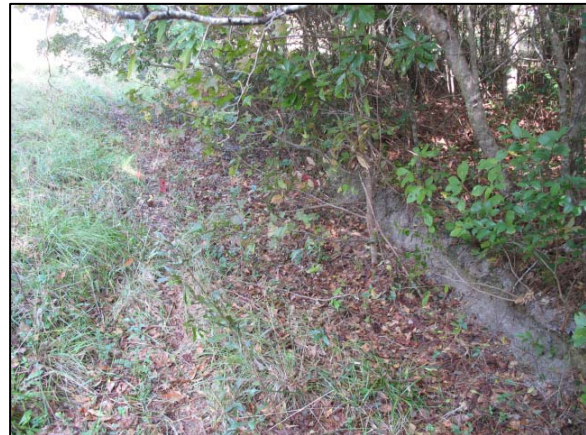
The right plane of the Dodge sideswiped the landscape wall and trees (**Figure 3**), resulting in minimal crush to the right front wheel flare and surface scratching that extended from slightly forward of the right front wheel flare to 36 cm (14.2 in) rear of the right rear axle (Event 1). The right side mirror was detached from the vehicle during the first event, and the surface scratching resulting from contact with tree branches extended vertically from the door sill level to the roof side rail. The direction of force for this initial impact was within the 12 o'clock sector. An analysis of this impact was outside the scope of the WinSMASH program.

**Figure 3: Landscape wall and trees sideswiped in initial impact.**

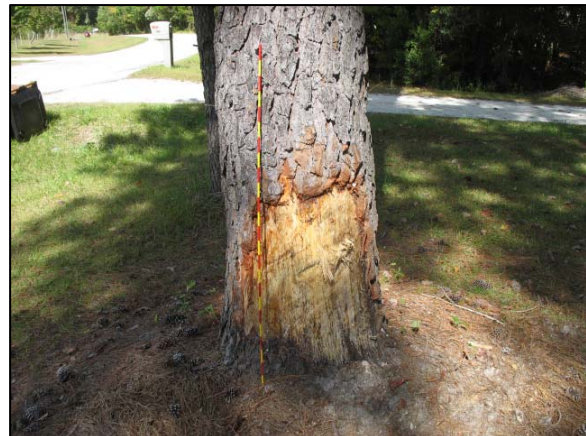
The Dodge continued to accelerate forward during this multiple impact crash sequence. The vehicle returned to the roadway, crossed the center of the road, and entered the oncoming lane. The driver then initiated an evasive steering input to the right. The Dodge crossed the roadway a second time and departed the road. The Dodge travelled a straight path from the departure as evidenced by 24 m (78.7 ft) long tire marks in the grass roadside. The left corner of the Dodge's front plane then impacted a 50 cm (19.7 in) diameter pine tree (Event 2). The vertical damage to the pine tree began 16 cm (6.3 in) above the ground extended to a height of 80 cm (31.5 in). The pine tree impacted in the second event is depicted in **Figure 4**. The direction of force for this impact was within the 12 o'clock sector to the Dodge. The EDR-reported speed of the Dodge at the time of the impact was 62 km/h (39 mph).

**Figure 4: Pine tree impacted in event 2.**

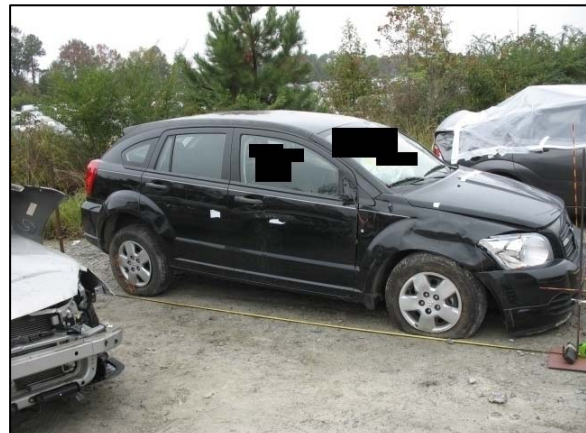
The right plane of the Dodge sustained minor sideswipe damage and the left aspect of the front plane sustained moderate damage as a result of this multiple impact crash sequence. On the right plane, the contact damage began 36 cm (14.2 in) aft of the right rear axle and extended forward 352 cm (138.6 in) to slightly forward of the right front wheel flare (**Figure 5**). The maximum crush was located 9 cm (3.5 in)

**Figure 5: Initial impact sideswipe damage to the Dodge.**

forward of the right front axle and measured 10 cm (3.9 in). A residual crush profile was documented along the full width of the right side damage at mid-door height, but included only minor surface scratches at the six C-locations. The six C measurements for the initial impact all equaled zero when free space was subtracted. The Collision Deformation Classification (CDC) for this impact was 12RDAS2.

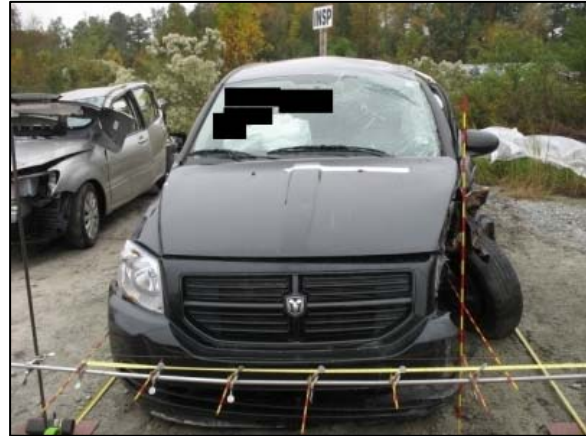
The front left corner of the Dodge sustained moderate damage in this frontal offset crash (**Figure 6**). The direct contact damage to the front plane began 50 cm (19.7 in) left of the vehicle's centerline at the left end of the bumper reinforcement. The direct contact damage extended left 28 cm (11 in) to the front left bumper corner and involved the soft structures and components of the left front fender. The combined direct and induced damage (Field L) extended along the full length of the front plane. The residual crush profile at the bumper elevation was as follows: C1 = 7 cm (2.8 in), C2 = 0 cm (0 in), C3 = 0 cm, C4 = 0 cm, C5 = 0 cm, C6 = 0 cm. Due to the nature of the corner impact, the residual crush profile was not representative of the severity of the crash. The damage resultant to the corner impact configuration wrapped around the left corner and extended 86 cm (33.9 in) rearward along the left plane to the A-pillar area (**Figure 7**). The left front suspension was directly involved in the impact. The windshield was completely fractured by the impact forces, with greater damage near the left A-pillar. The windshield was also fractured by the impact of the deploying passenger frontal air bag. There were no laminate tears in the windshield. The Event 2 impact resulted in induced buckling of the left half of the roof from the windshield header to the backlight header. The left front door glazing was disintegrated by the impact forces. All other glazing on the Dodge was undamaged. The left front door was opened by the property owner first on the scene post-crash, and would not close. The left rear and both right side doors remained closed and operational post-crash. The Collision Deformation Classification (CDC) assigned for this impact was 12FLEE5.

**Figure 6: Front view of the damaged Dodge.**

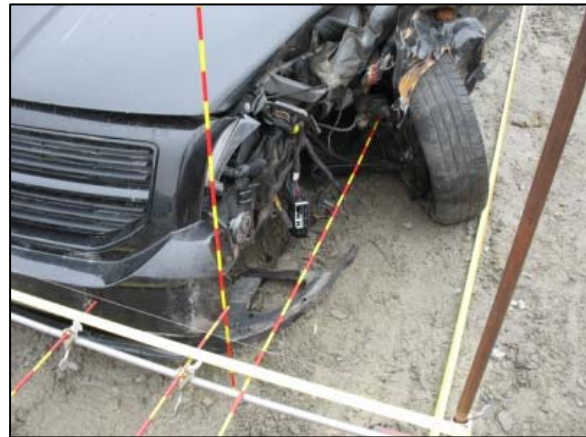
**Figure 7: View of the direct damage along the Dodge's left side.**

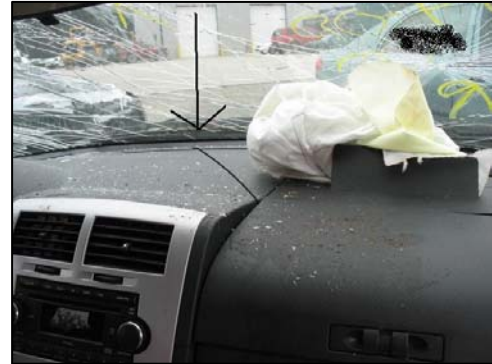
The interior of the Dodge sustained moderate-severity damage that was attributed to passenger compartment intrusion, occupant contact and air bag deployment. There was a scuff mark on the driver’s sun visor attributed to the driver’s head. This contact was located 6-17 cm (2.4-6.7 in) inboard of the left side of the visor, and 0-6 cm (0-2.4 in) forward of the rear edge of the visor. The driver’s left knee loaded the lower left Instrument Panel (IP) through the deployed knee air bag, resulting in a scuff mark and deformation to the lower left IP located 14-28 cm (5.5-11 in) inboard of the left side of the IP and 0-18 cm (0-7.1 in) above its lower edge. The lid of the center console, forming the center armrest, was displaced to the right 5 cm (2 in) as a result of contact with the right side of the driver’s abdomen. During the interior inspection, it was noted that a 16 cm (6.3 in) long wire related to upper glove compartment door had been displaced from its channel and protruded towards the front right seat. **Figure 8** depicts this wire spring. The steering wheel of the Dodge was turned to the 1 o’clock position at the time of the SCI inspection. The steering column shear capsule were inspected and found not to have moved. The longitudinal left toe pan intrusion measured 5 cm (2 in).

**Figure 8: Left wire glove compartment door spring protruding from IP.**

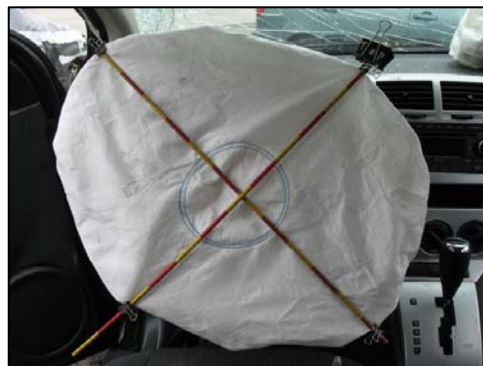
The driver's air bag was concealed within the center hub of the four-spoke steering wheel by two cover flaps. The upper flap measured 15 cm (5.9 in) in width and 6 cm (2.4 in) in height. The lower flap was triangular in shape, measuring 14 cm (5.5 in) in width at the horizontal tear seam, 10 cm (3.9 in) in width at the lower aspect, and 7 cm (2.8 in) in height. The driver's air bag (**Figure 9**) measured 50 cm (19.7 in) in diameter in its deflated state. The air bag was vented by two circular vent ports located on the upper rear aspect of the air bag.

**Figure 9: Driver's frontal air bag.**

The driver's air bag was tethered by two straps located at the 12 and 6 o'clock positions on a 15 cm (5.9 in) circular tether sewn to the center of the face of the air bag. There were three deployment transfer marks on the face of the air bag located in the lower left, upper left and upper right quadrants. No crash-related damage was present on the driver's air bag.

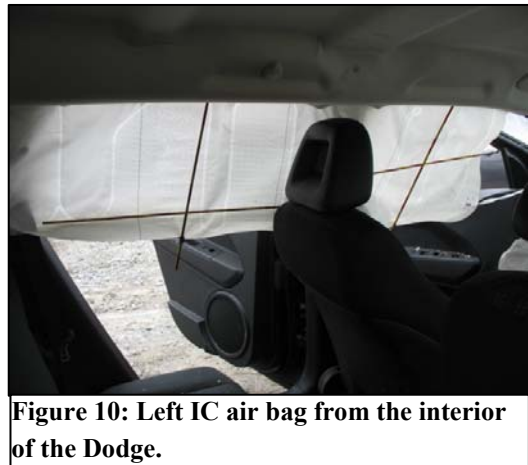
The Dodge was equipped with roof side rail mounted IC air bags. The left IC air bag deployed during this crash sequence. The right IC did not deploy. The deployed left IC measured 160 cm (63 in) in length. At the front seating position, the IC was 41 cm (16.1 in) in height and 36 cm (14.2 in) in height at the rear seating position. Vertically, the left IC air bag extended 12 cm (4.7 in) below the belt line at the front and 9 cm (3.5 in) at the rear. The IC provided complete longitudinal coverage from the C-pillar to the B-pillar and covered the front right window opening with the exception of a void at the A-pillar measuring 23 cm (9.1 in) in width, 15 cm in height at the rear and 9 cm in height at the front. The IC was tethered to the A-pillar by a web strap 45 cm (17.7 in) in length, and to the D-pillar by a web strap 38 cm (15 in) in length. **Figure 10** depicts the left IC air bag. The air bag was labeled with the following nomenclature: 6082455A SI/PA 6.6

**Figure 10: Left IC air bag from the interior of the Dodge.**

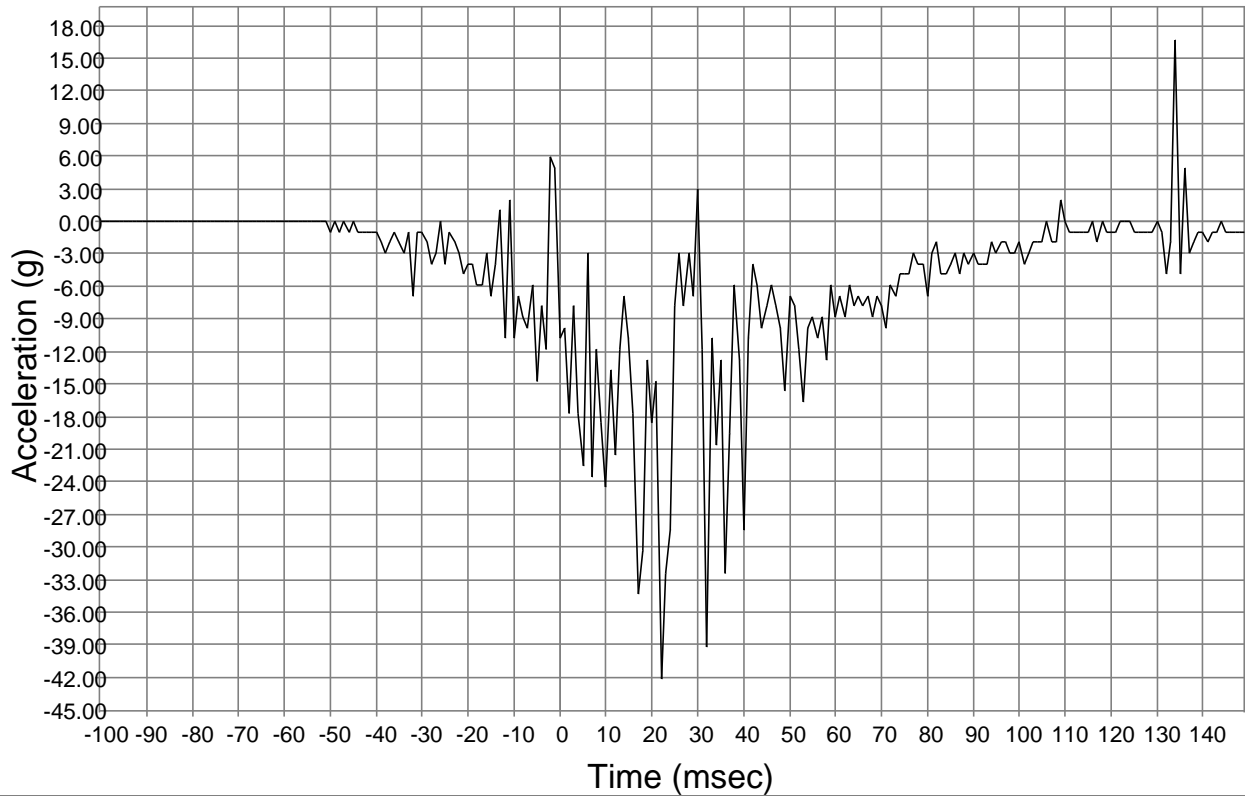
### Longitudinal Crash Pulse (Most Recent Event)

located outboard of the front bumper reinforcement. The Dodge's EDR recorded a maximum longitudinal acceleration of  $-42.2\text{ g}$  22 ms after the frontal air bags were commanded to deploy. The SCI team conducted an analysis of the EDR-recorded longitudinal crash pulse and determined the longitudinal delta-V of the Dodge was tree impact  $44.3\text{ km/h}$  ( $-27.5\text{ mph}$ ).
