CALSPAN ON-SITE AMBULANCE CRASH INVESTIGATION
SCI CASE NO.: CA09075

VEHICLE: 2006 FORD F-450 CHASSIS
W/ WHEELED COACH AMBULANCE TYPE I BODY

LOCATION: NORTH CAROLINA

CRASH DATE: OCTOBER 2009

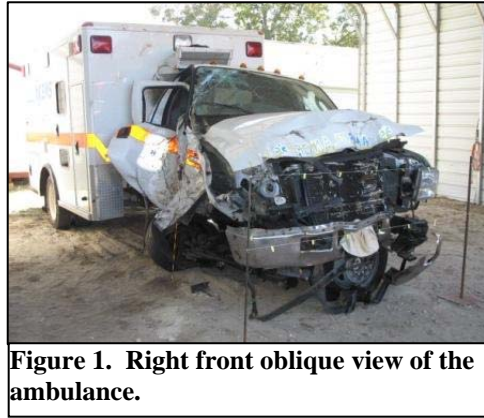
Figure 1. Right front oblique view of the ambulance.

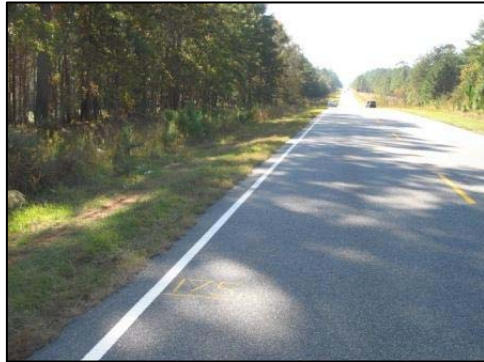
The crash occurred on a rural two-lane road during nighttime hours. At the time of the crash, the conditions were clear and dark as the area was not illuminated. The asphalt road surface was dry and the temperature was reported by a local weather station at 8 degrees C (46 degrees F). In the vicinity of the crash site, the road was straight with a series of subtle elevation changes. The east and westbound travel lanes were 3.4 m (11.2 ft) in width and were bordered by 0.3 m (1 ft) wide asphalt shoulders. The center line of the road consisted of a broken yellow center line at the crash site preceded by a no passing zone in the easterly direction. The north roadside consisted of grass and hard-packed sandy soil that transitioned to a shallow grade, terminating at the centerline of a drainage ditch 4.1 m (13.4 ft) outboard of the north edge line. The south road edge was the location of the crash. This roadside consisted of grass and weeds within a hard-packed sandy surface. The roadside was level 0.4-1.6 m (1.3-5.2 ft) outboard of the south edge line and transitioned to a shallow grade to facilitate water runoff away from the road surface. A tree line consisting of various soft wood pines was located 11.7 m (38.4 ft) outboard of the edge line. Numerous trees were struck by the ambulance ranging in diameters from 3-46 cm (1-18 in). The posted speed limit was 89 km/h (55 mph). **Figure 2** is an overall approach view of the crash site. The schematics of the crash are attached as **Figures 18** and **19**.

Figure 2. Overall westbound view of the crash site.

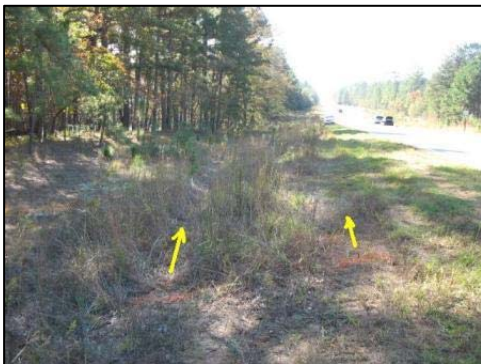
En route to the call and approximately 20 minutes into the drive, the driver relinquished directional control of the ambulance. The ambulance drifted left across the centerline of the two-lane road and departed the left road edge at a shallow angle of approximately 8 degrees in a tracking attitude. The ambulance continued along the roadside on a path that was nearly parallel to the roadway. The physical evidence at the crash scene consisted of rotating tire prints that clearly depicted the vehicle as tracking with no yaw or braking component evident in the marks. The dual-rear tires tracked over the front tire marks and created a raised ridge in the sandy soil surface between the rear tires. This ridge protruded above the compacted soil from the tires due to the weight of the ambulance. These tire marks continued uninterrupted over a longitudinal distance of 127 m (416 ft) from the point of road departure to the impact with the small diameter tree (**Figure 5**). The tire marks supported the lack of avoidance actions by the driver, either by braking or steering.

Figure 5. Rotating tire prints from the dual rear tires of the ambulance.

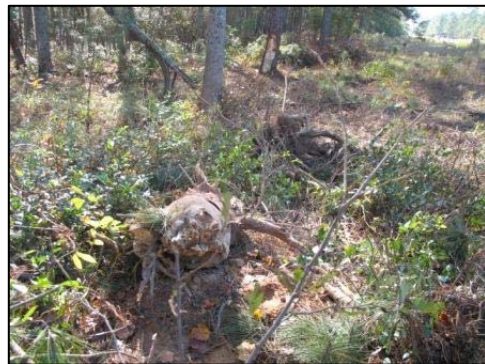
Figure 6. Struck trees along the trajectory of the ambulance.

The ambulance continued forward and struck a third tree that was approximately 30 cm (12 in) in diameter and located 139.1 m (456 ft) west of the point of departure. This tree was fractured and uprooted. A fourth tree that was approximately 20 cm (8 in) in diameter was subsequently struck by the front of the ambulance. This tree was also fractured and uprooted. This tree was located approximately 142.9 m (469 ft) west of the point of departure from the paved surface. **Figure 6** is a view of the struck trees along the trajectory of the ambulance.

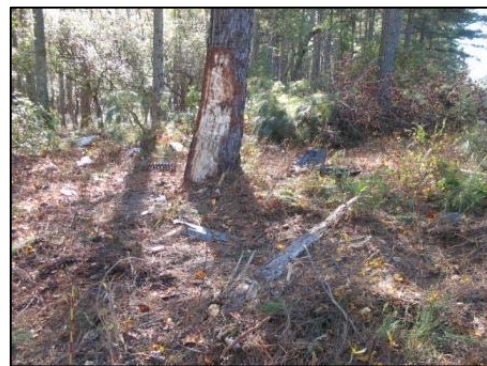
As the ambulance continued to rotate CCW to a near broadside trajectory, the right front door impacted a 46 cm (18 in) diameter tree (**Figure 7**) that was located 155.5 m (510 ft) west of the departure point and 17.2 m (56.5 ft) south of the road edge. The resultant direction of force from this impact event was within the 3 o'clock sector. The tree impact crushed the door to a maximum depth of 29 cm (11.5 in). The maximum crush was located 65 cm (25.75 in) forward of the aft edge of the door. Based on the damage to the door and the B-pillar, it appeared that the door hinges had separated prior to this event. The

Figure 7. 46 cm (18 in) diameter tree struck by the right side of the ambulance.

crush to the door was greater than the crush at the sill level due to this separation. There was no crush at the roof side rail area of the cab. The door latch remained engaged during this event. The separation of the door hinges prior to the lateral impact with the tree resulted in an altered crush profile that was not representative of the total energy associated with this event. The right frame rail of the chassis was displaced laterally by the combination of the frontal and side impacts, and the displacement of the front axle. This extensive induced damage could not be incorporated into the inputs for the side crush profile; therefore this event was classified as outside the scope of the WinSMASH reconstruction program.

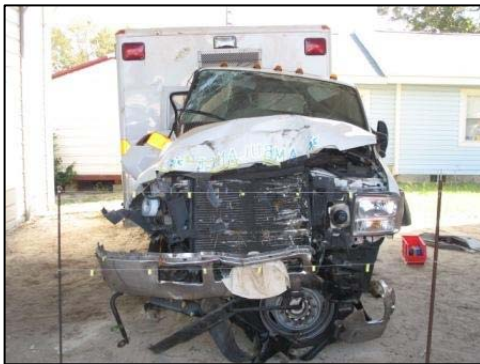
The frontal area of the ambulance impacted five trees that were identified at the crash site. Six distinct impacts were noted to the hood face of the vehicle. One of these closely spaced areas of deformation was related to secondary contact from a fractured tree as the ambulance continued forward.

A large diameter tree impact was located on the hood face 12-41.6 cm (4.75-16.4 in) left of the vehicle's centerline. A small diameter tree impact was located 7-11 cm (2.75-4.5 in) right of center with a third impact located 15-24 cm (6.1-9.4 in) right of center. A fourth large diameter tree impact was located 20-40 cm (8-15.9 in) right of center that overlapped the previously mentioned event. A fifth tree impact was located 51-59 cm (20.1-23.25 in) right of center and the sixth was located 72-86 cm (28.5-33.9 in) right of center. These frontal impacts deformed the hood face and crushed the chrome bumper. The two large diameter trees crushed into the air conditioning condenser. The left aspect of the bumper fractured at the inboard aspect of the left frame rail. The combined induced and direct contact damage was documented along the bumper from the left frame rail to the right corner of the bumper and measured 157 cm (62 in). Six equidistant crush values were documented along this plane and were as follows: C1 = 0 cm, C2 = 22 cm (8.6 in), C3 = 17 cm (6.7 in), C4 = 11 cm (4.3 in), C5 = 6 cm (2.4 in), C6 = 3 cm (1.2 in). The maximum crush at bumper level was located at C2, 30 cm (12 in) left of the centerline.

The upper radiator support was also crushed by the multiple tree impacts. The combined induced and direct damage length (Field L) extended 152 cm (60 in) across the full width of the radiator support. The crush profile at this level was as follows: C1 = 0 cm, C2 = 0 cm, C3 = 10 cm (3.9 in), C4 = 15 cm (5.9 in), C5 = 26 cm (10.2 in), C6 = 39 cm (15.4 in). **Figure 8** is an overall view of the multiple tree impacts to the front of the ambulance.

Figure 8. Tree impacts and resultant damage to the front of the ambulance.

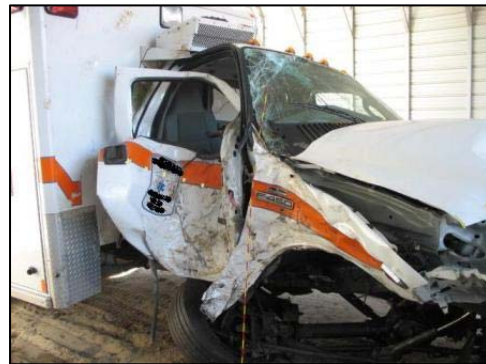
Figure 9. Right front side impact damage to the ambulance.

The right front fender exhibited tree contact damage that began 10 cm (3.75 in) aft of the leading edge of the fender and extended 121 cm (47.6 in) rearward to the right A-pillar area (**Figure 9**). The fender was crushed laterally into the substructure and subsequently disengaged as the mounting bolts pulled through the sheet metal at the top of the fender. The aft edge of the fender remained attached to the chassis by two bolts.

The leading edge of the right front door was crushed rearward by the above engagement. The rearward displacement of the door edge resulted in deformation of the hinges with fracturing of the mounting bolts into the door frame. The hinges were deformed rearward to a U-shape. The door was subsequently displaced rearward into the right B-pillar,

crushing the B-pillar approximately 10 cm (4 in) rearward against the body of the patient compartment. The door latch remained engaged during the crash event.

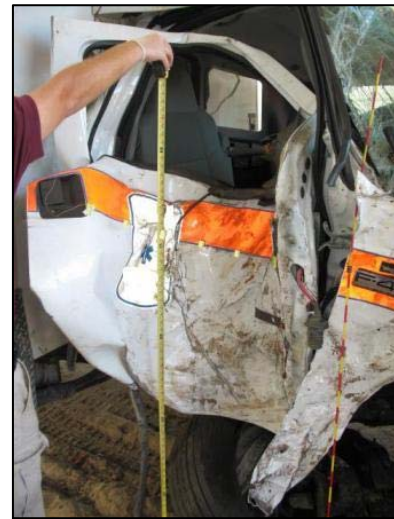
The right door of the Ford chassis impacted the 46 cm (18 in) diameter tree as the vehicle rotated CCW. The lateral impact deformed the door to a U-shape following the separation of the front hinges (**Figure 10**). The direct contact damage on the door began at the leading edge of the door and extended 52 cm (20.5 in) rearward. A reference line was taped across the damage profile of the door. The measured Field L for this damage pattern was 58 cm (23 in). A crush profile was documented along this profile and was as follows: C1 = 0 cm, C2 = 9 cm (3.5 in), C3 = 20 cm (7.9 in), C4 = 28 cm (11.1 in), C5 = 25 cm (9.75 in), C6 = 0 cm. The maximum crush along this profile was 29 cm (11.5 in) located 65 cm (25.75 in) forward of the rear edge of the separated door. The door sill was crushed approximately 10 cm (4 in); however, the resultant damage was not representative of the lateral impact event. Due to the separation of the door, an accurate Door Sill Differential (DSD) could not be obtained.

Figure 10. Damage to the right front door area.

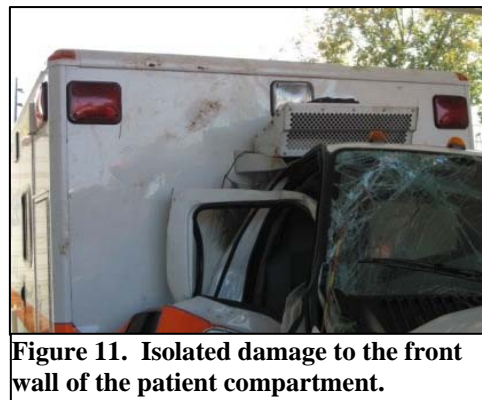
The exterior of the patient compartment sustained minor severity damage associated with this multiple event crash. There was no direct impact damage to the compartment. Isolated dents were noted to the forward wall of the patient compartment from contact with fractured tree branches (**Figure 11**). A dent was noted to the horizontal roof channel, left of the vehicle's centerline. The rearward compression of the right B-pillar minimally deformed the forward wall. Additional, but minor damage occurred to the forward wall of the patient compartment during the extrication activities as rescue personnel used hydraulic tools to cut the rear edge of the right door to release the latch assembly.

Figure 11. Isolated damage to the front wall of the patient compartment.

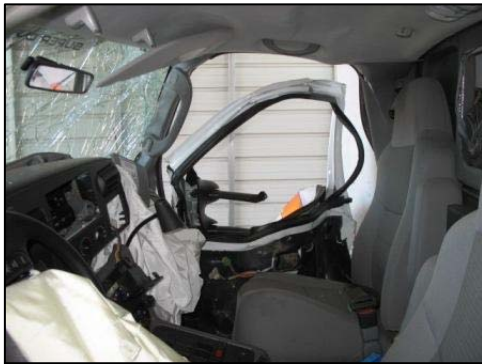
The front right passenger compartment was reduced in size by longitudinal and lateral intrusion of frontal and right side components. The maximum intrusion involved 39 cm (15.25 in) of longitudinal displacement of the right toe pan. The maximum lateral intrusion was 34 cm (13.5 in), located at the lower right A-pillar. **Figures 12 and 13** are views of the intrusion into the front right passenger compartment. The intrusions are detailed by location, magnitude and direction in the following table:

Position	Component	Magnitude	Direction
Front Right	Right toe pan	39 cm (15.25 in)	Longitudinal
Front Right	Lower right A-pillar	34 cm (13.5 in)	Lateral
Front Right	Right door sill	31 cm (12.4 in)	Lateral
Front Right	Right door panel	25 cm (10 in)	Lateral
Front Right	Right mid instrument panel	25 cm (10 in)	Longitudinal
Front Right	Upper roof side rail at A-pillar	6 cm (2.5 in)	Longitudinal

Figure 12. Intrusion of the front right passenger area.

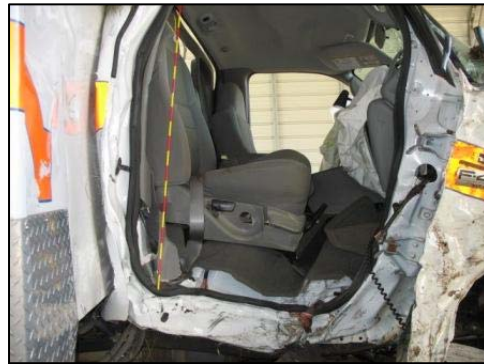
Figure 13. Exterior view of the intrusion into the front right passenger compartment.

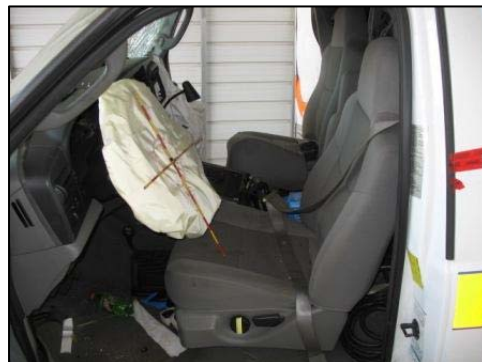
Figure 16. Deployed redesigned frontal air bags.

The front right air bag was concealed by a single rectangular cover flap in the right mid instrument panel. The flap was 34 cm (13.5 in) in width and 17 cm (6.5 in) in height. The cover flap was tethered to the instrument panel with four straps. The front right air bag was not tethered or vented directly into the passenger compartment. There was no occupant contact evidence or damage to the front right air bag. **Figure 16** is a lateral left view of the deployed frontal air bags.

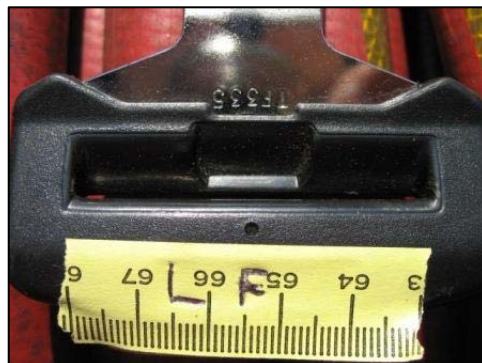
The driver's belt system yielded frictional abrasions on the latch plate from driver loading (**Figure 17**). There was no loading evidence on the belt webbing. The driver's belt webbing was cut at a point that was 192 cm (75.7 in) above the floor anchor. The front right belt webbing was cut 135 cm (53 in) above the anchor point. There was no loading evidence on the front right belt system (webbing or hardware). Body fluid was present on the lap belt portion of the webbing.

Figure 17. Frictional abrasion across the driver's latch plate.
